LAKE CARMİ PRIVATE ROADS EROSION INVENTORY REPORT 2019

Franklin Watershed Committee

Catie Bartone, ECO AmeriCorps 2018-2019

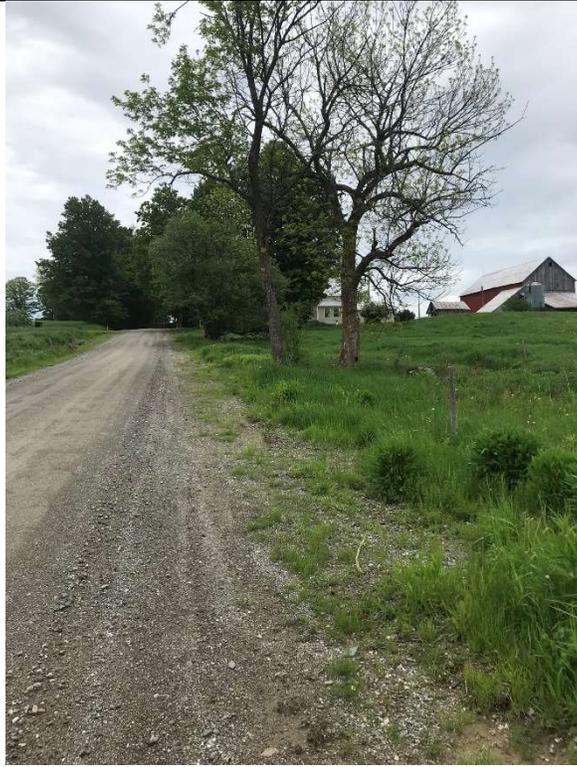
Gallup Road is a gravel road that runs roughly parallel to the Canadian border, east from Richard Road. A 600-foot section of roadside ditch, along the southern edge of the road, was observed to be

bare and actively eroding. In addition, the ditch has a steep back slope that is leading to slumping.

Significant evidence of sediment transport was observed. The ditch could be stabilized by making it wider, with a parabolic-shaped bottom. The ditch may need to be stone lined in sections where it is not possible to achieve a sustainable back slope. Stone check dams could also be employed in order to reduce flow velocities, limit sediment transport, and potentially create opportunities for infiltration in the ditch.

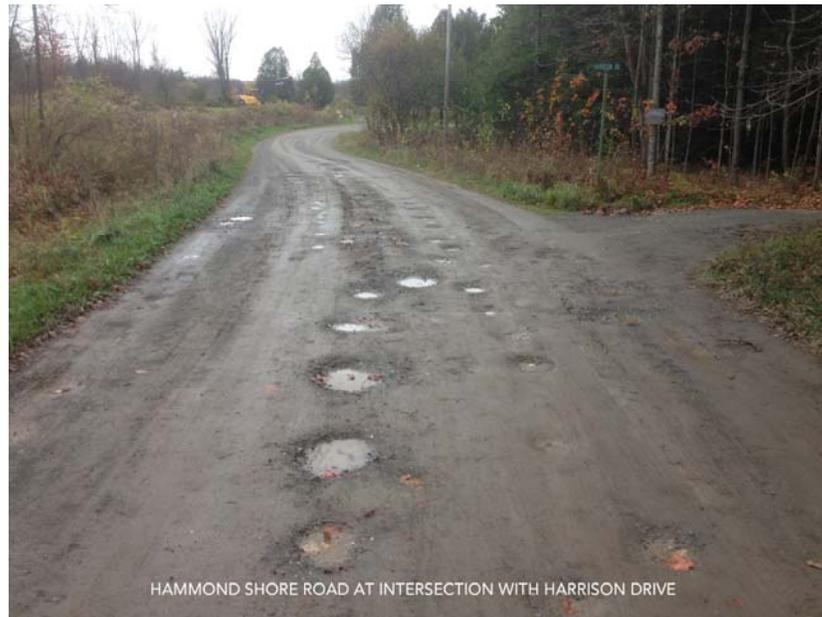
particularly at the intersection with Harrison Drive. Both roads have a relatively flat cross section (i.e., no crown). A substantial vegetated ditch runs along the east side of Hammond Shore Road to a culvert near the intersection with Harrison Drive. The culvert receives runoff from the ditch and from a small stream that extends from agricultural fields located to the south and east. From the culvert, the stream flows along Harrison Drive to another culvert under Harrison Drive, then to another culvert beneath a driveway and lawn, discharging at the shoreline of the lake. The culvert is reported to discharge heavy amounts of sediment into the lake during storm events.

No significant erosion was observed on or along the roads with the exception of at either end of the culvert beneath Harrison Drive. The ditches along Hammond Shore Road appeared to be adequately sized and vegetated with no signs of blockage or scouring. A hydrologic / hydraulic analysis was not performed to evaluate the culverts. There was no physical evidence of failure at the culverts at the time of this inspection; however, it is known that the culvert under Harrison Drive was completely washed out last year (observed during another project completed by KAS), indicating that both culverts are likely not adequately sized.

The erosion observed in the vicinity of the culvert at Harrison Drive can be corrected by constructing a proper headwall or at either end of the culvert. Currently, strips of sawmill scrap wood and steel from a salvaged guardrail have been laid along the road and do not adequately retain the road material. They should be replaced with a proper timber or stone headwall that is constructed tight to the culvert and substantial enough to retain road materials behind it.

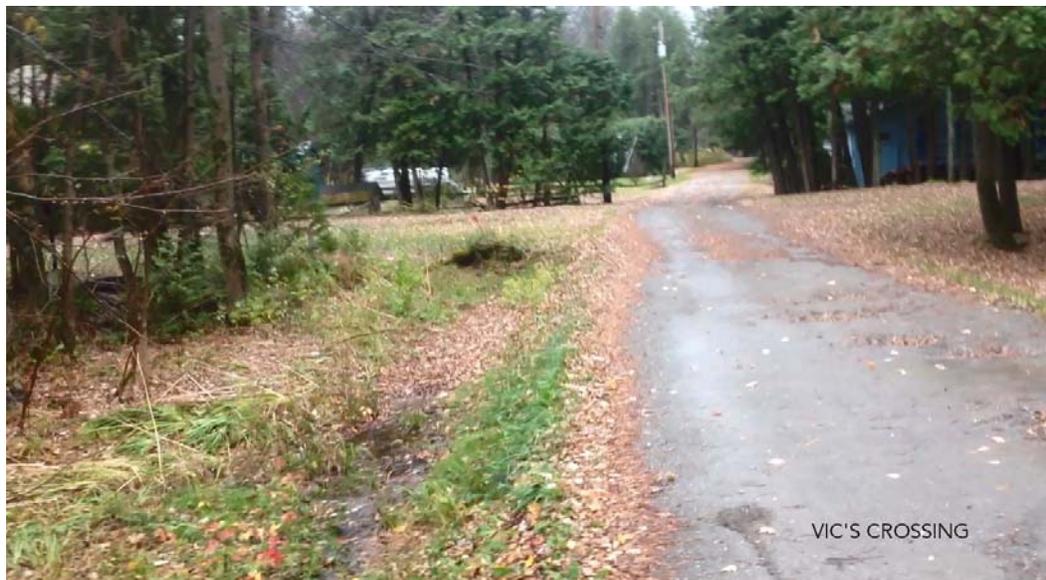
establishes. It may also be necessary to extend a shallow ditch or swale from the culvert discharge to the lake to prevent surface water from impacting either of the two camps.

Some of the culverts located along Vic's crossing appeared to be damaged / crushed or were likely undersized. These should be replaced and the outlets stabilized with stone or vegetation if the flow is small. If possible, a minimum culvert diameter of 18" should be used with a minimum of one foot of fill over it. The inlet and outlet of each culvert should be protected with stone and headwalls should be used if the ends of the culverts are close to the edge of the road. It may be necessary to construct a ditch at the outlets of the new culverts or otherwise re-grade the ground surface at the outlets since many of the existing culverts are very shallow.

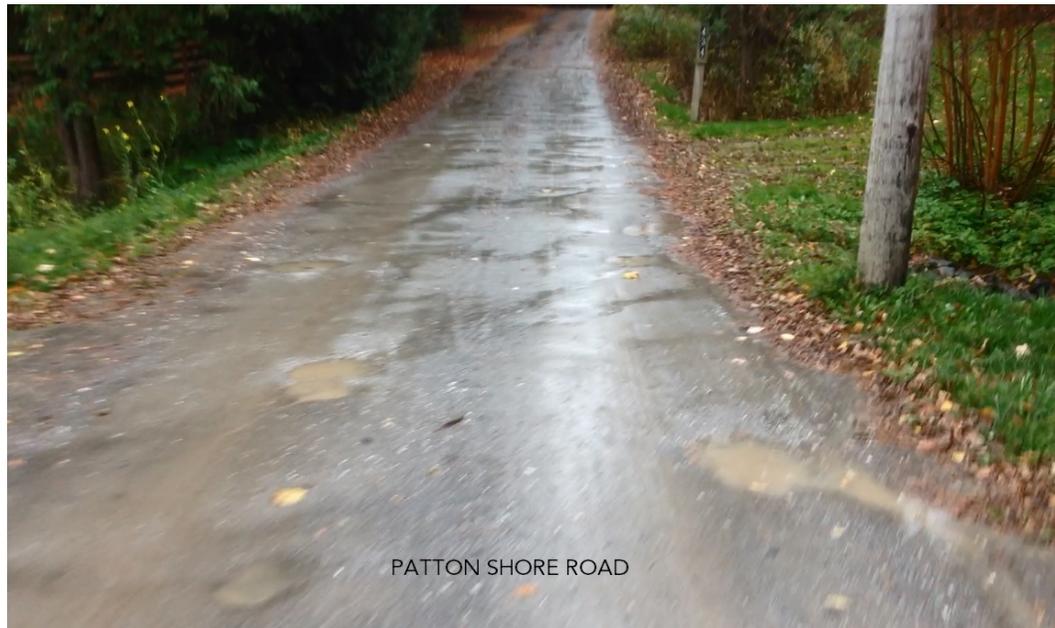
focused on the area between Scottish Lane and Ledge Drive and included those two side roads. Both Scottish Lane and Ledge Drive traverse hills that rise up from the elevation of Patton Shore Road. Neither of the two side roads had ditches and there was evidence of minor longitudinal erosion on the road surfaces where surface water had concentrated and discharged onto Patton Shore Road. A culvert is located under Patton Shore road between the two side roads that conveys a small stream. No ditches were present along the side of Patton Shore Road in this area, except for one perpendicular to the road between the culvert outlet and the lake. Water in this ditch reportedly carries a significant amount of sediment discharging into the lake during storm events.

Like the other roads inspected for this project, the most obvious problems is potholes along the full extent of the road. This can be corrected by reconstructing or re-grading the road as described for the other roads evaluated. It is recommended to build the road up in the areas of exposed ledge.

To minimize the amount of sediment washing from the Ledge Drive and Scottish Lane road surfaces, a ditch should be constructed on one side of each of these roads. Due to the slope, the ditch should be made as wide as possible with the space that is available (up to 6-8 feet wide) and vegetated with stone check dams spaced 50 to 60 feet apart. It may be necessary to also construct a ditch on the west side of Patten Shore Road to divert flow from each of these two new ditches to the culvert.

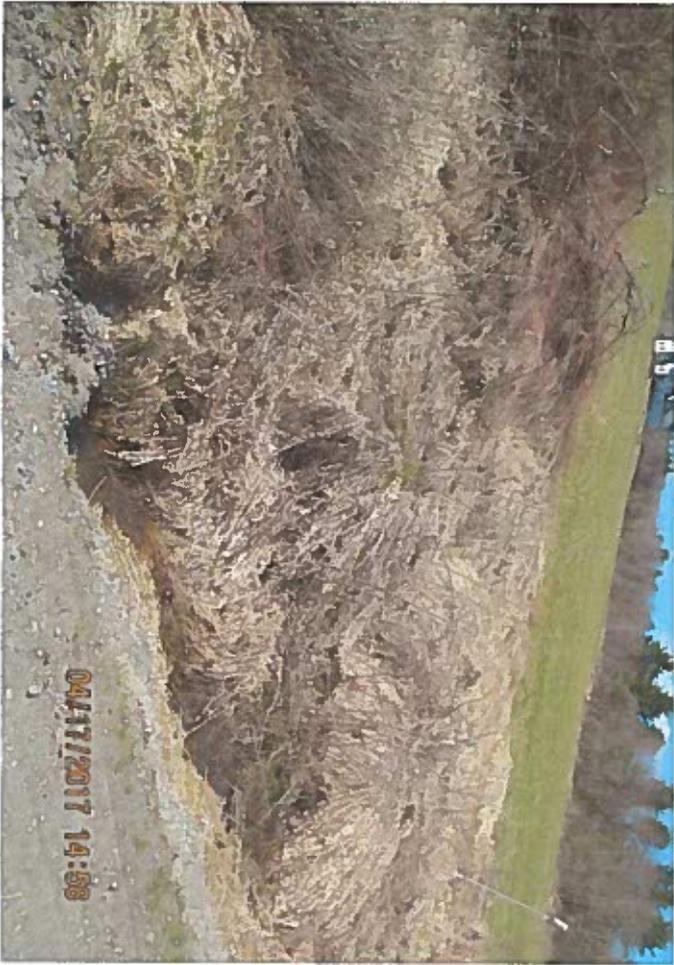
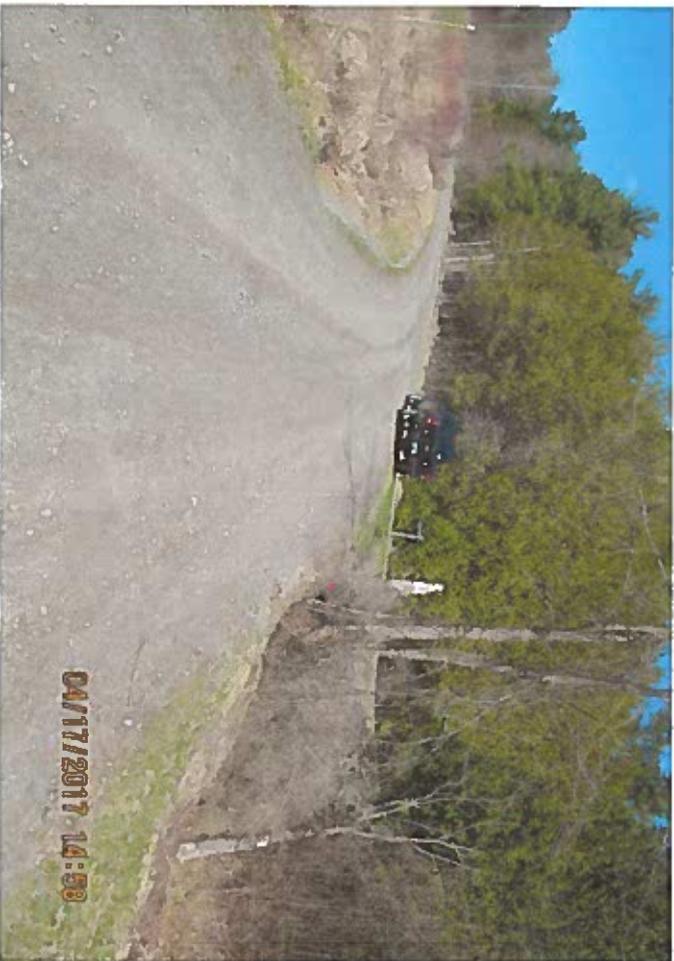
Franklin Watershed		Infrastructure Site Inventory for Water Quality Improvements	
		Remarks:	
Road Name	Wescott Shore Rd.		
TH #	N/A		
Site ID	WSR - 4		
GPS	N-44.96213°		
	W - 72.89361°	50' +/- ' North of Camp 593	
Drainage Structure Type: Road - Ditch - Road Slope - Other	Road Culvert - Corrugated Metal Pipe		
Erosion Frequency	Spring Runoff - Rain Storms		
Dimensions	12" X 20'		
Priority - Low - Moderate - High	Low		
Roadway Width	14'	Traveled Way	
Surface Type	Gravel		
Road Grade: % Grade	2%		
Distance to edge of Lake Carmi	337		
Name of Stream			
	Inventory Date:	04/18/17	
Recommended Treatment:			
Install new 24" X 30' Corrugated Metal 10' Round Plunge Pool - Outlet	3 C.Y, Type 1 Stone @\$50		\$150.00
Estimated Cost:			
10' Round Plunge Pool - Outlet	3 C.Y, Type 1 Stone @\$50	\$	150.00
		\$	150.00
Notes:

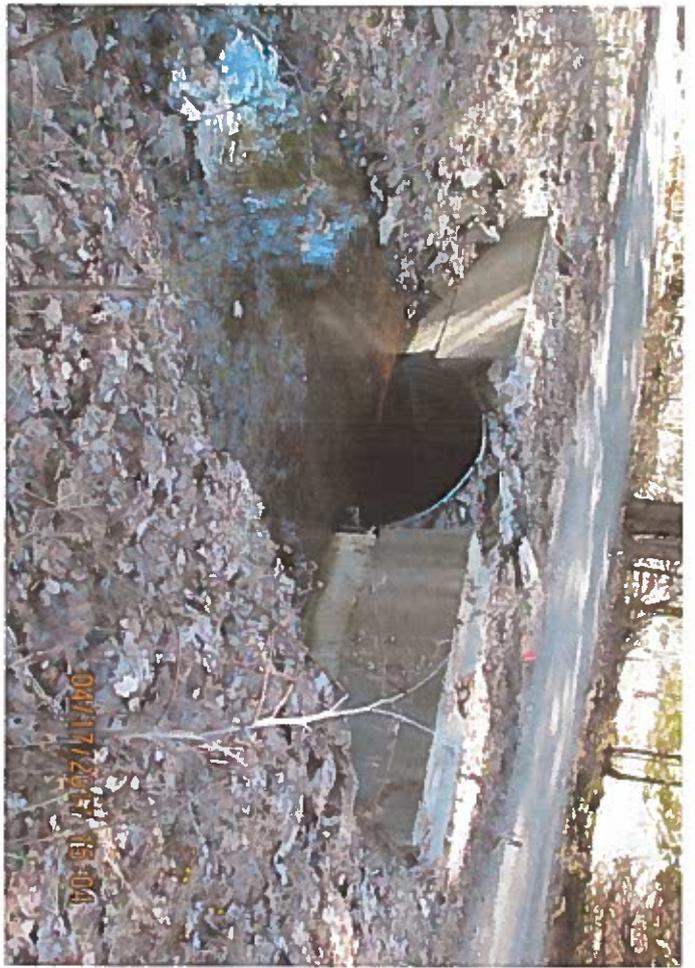
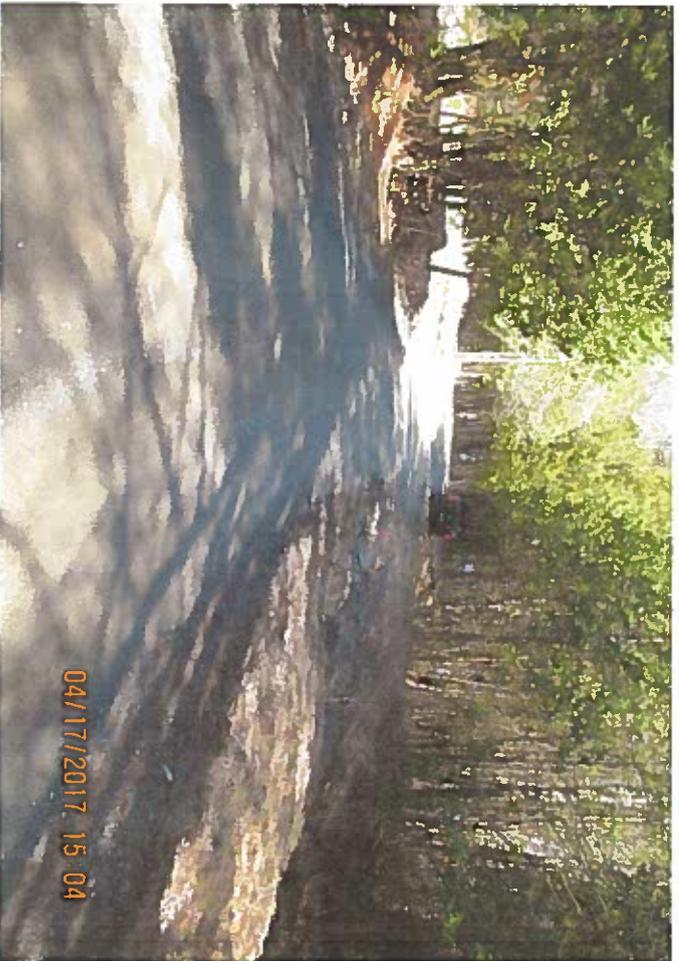
Franklin Watershed		Infrastructure Site Inventory for Water Quality Improvements
		Remarks:
Road Name	Wescott Shore Rd.	
TH #	N/A	
Site ID	WSR - 5	
GPS	N-44.96405°	
	W-72. 89196°	200'+/- ' North of Tanner Junction Rd.
Drainage Structure Type: Road - Ditch - Road Slope - Other	Road Culvert - Corrugated Metal Pipe Arch	Concrete Headwalls - New recently
Erosion Frequency	Spring Runoff - Rain Storms	
Dimensions	5.5' X 3.3' X 30'	
Priority - Low - Moderate - High	Low	
Roadway Width	14'	Traveled Way
Surface Type	Gravel	
Road Grade: % Grade	0%	
Distance to edge of Lake Carmi	318%	
Name of Stream		
	Inventory Date:	4/18/17
Recommended Treatment:		
Clean Plunge Pool - Outlet		\$ 50.00
Estimated Cost:		
Labor	2 Hrs.	\$ 50.00
		Total - \$50.00
Notes: Some silt in Plunge Pool @ outlet.

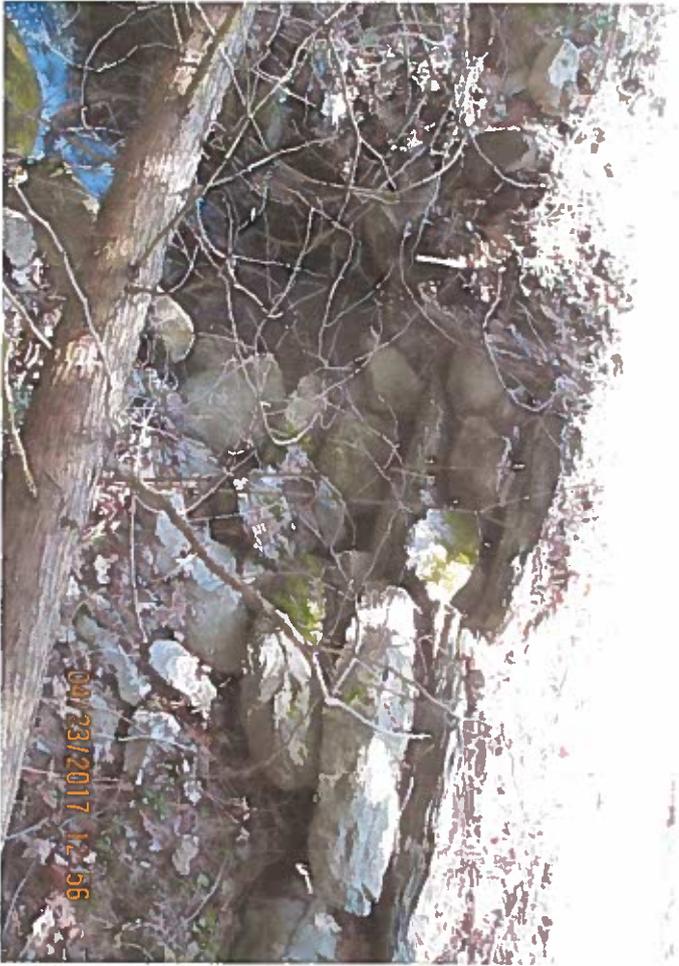
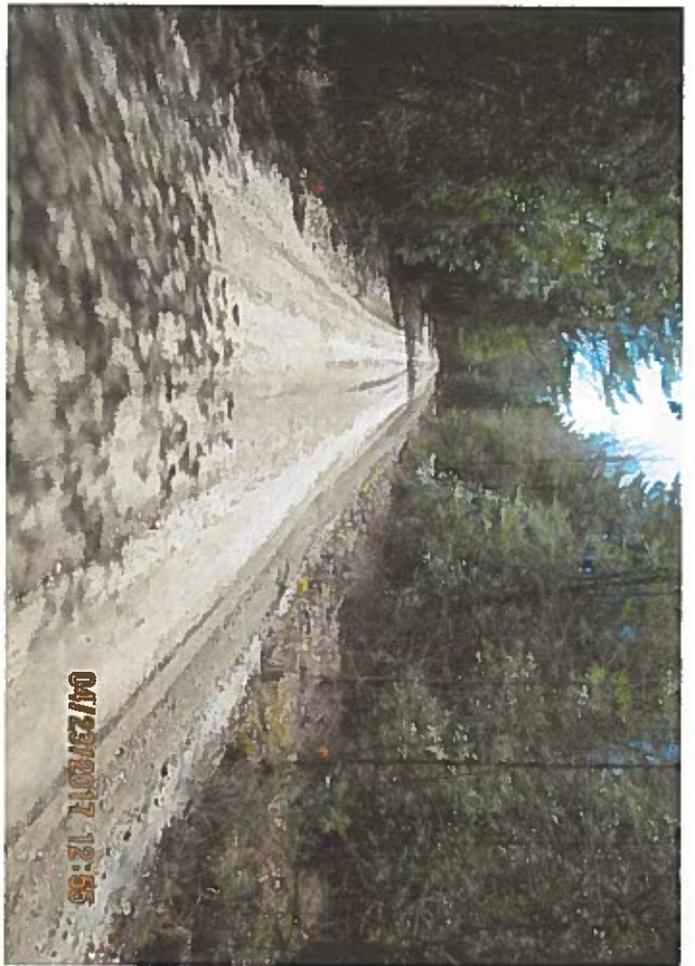
WSR-6

Franklin Watershed		Infrastructure Site Inventory for Water Quality Improvements	
		Remarks:	
Road Name	Wescott Shore Rd.		
TH #	N/A		
Site ID	WSR - 6		
GPS	N-44.96687° W-72. 89092°	40' +/- ' South of camp 187	
Drainage Structure Type: - Ditch - Road Slope - Other	Road Road Culvert - HDPEP	Good Condition	
Erosion Frequency	Spring Runoff - Rain Storms		
Dimensions	24" X 20'		
Priority - Low - Moderate - High	Low		
Roadway Width	14'	Traveled Way	
Surface Type	Gravel		
Road Grade: % Grade	0%		
Distance to edge of Lake Cami	318%		
Name of Stream			
	Inventory Date:	4/24/17	
Recommended Treatment:			
Construct 10' Round Plunge Pool - Outlet			
Check Dams north and South of Inlet in Roadway Ditches			
Estimated Cost:			
10' Round Plunge Pool - Outlet	3 C.Y, Type 1 Stone @\$50	\$	150.00

(2) Check Dams	3 C.Y, Type 1 Stone @\$50	\$	150.00
		Total	\$300.00
Notes: Some silt in Plunge Pool @ outlet.

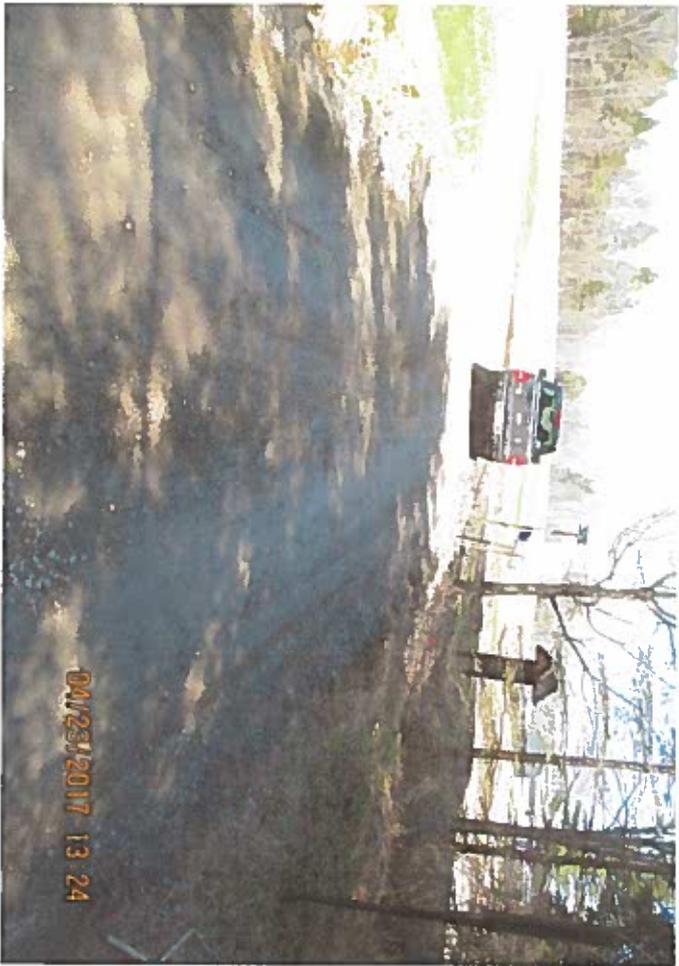
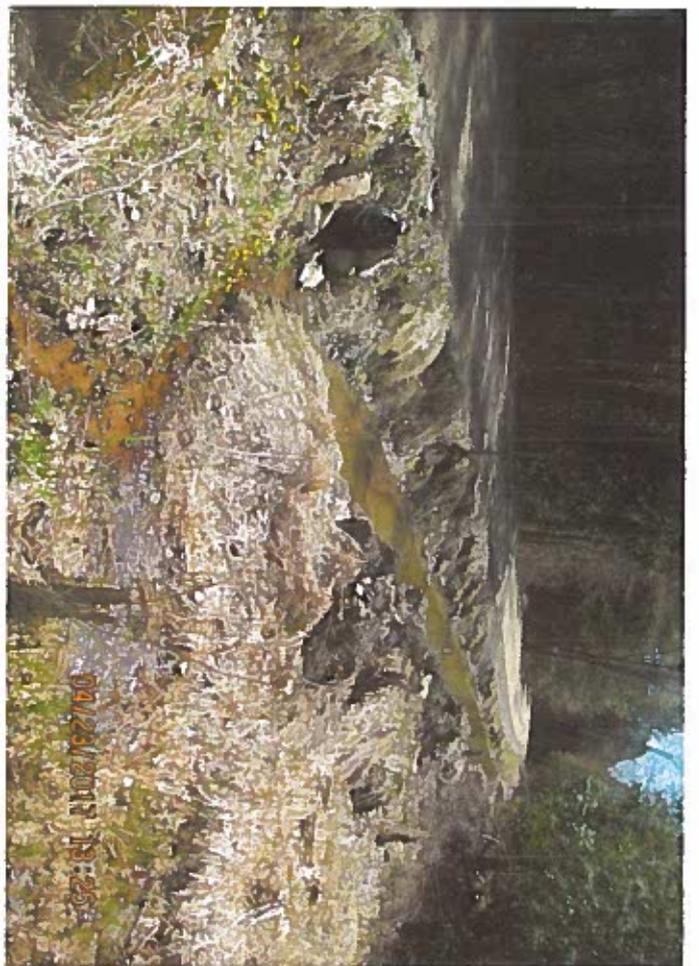
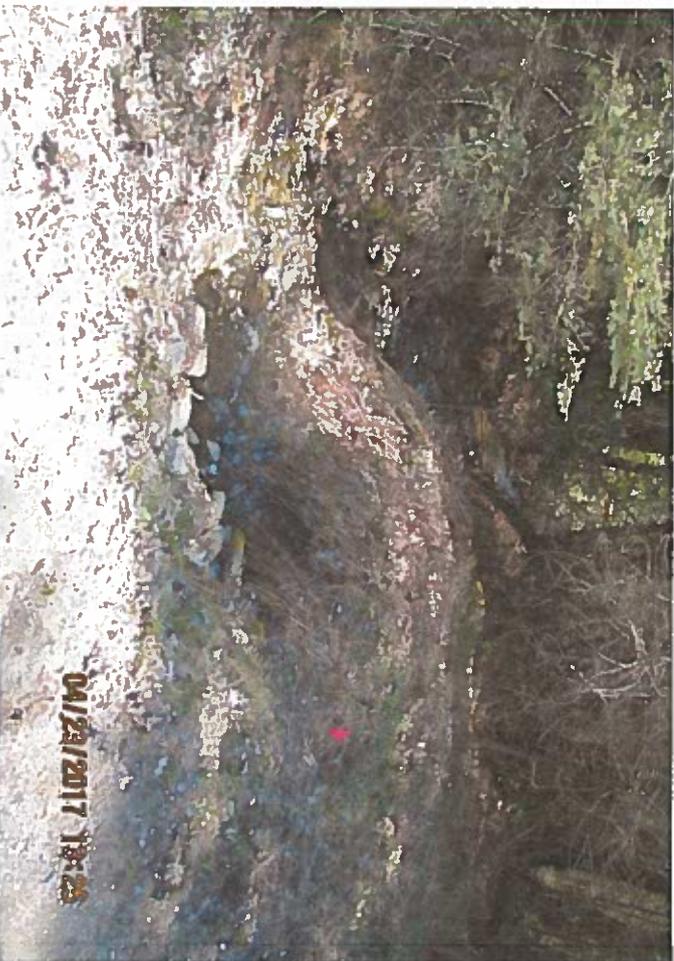
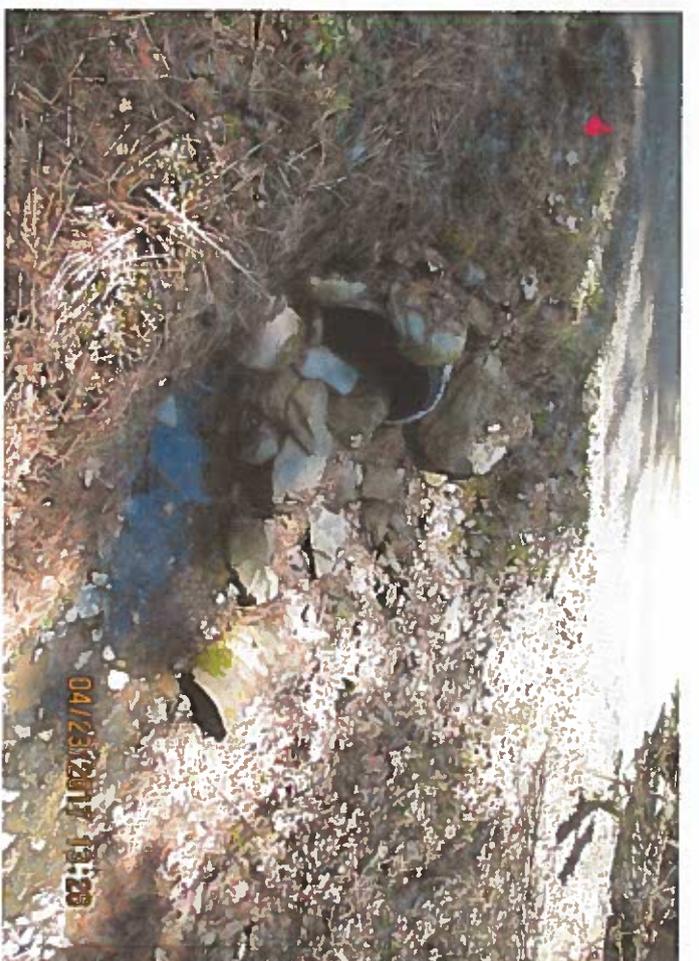
Franklin Watershed		Infrastructure Site Inventory for Water Quality Improvements	
		Remarks:	
Road Name	Wescott Shore Rd.		
TH #	N/A		
Site ID	WSR - 8		
GPS	N-44.96931°		
	W-72. 88903°	50 +/- ' South of Mullen Ed.	
Drainage Structure Type: - Ditch - Road Slope - Other	Road Road Culvert - HDPEP	Good Condition	
Erosion Frequency	Spring Runoff - Rain Storms		
Dimensions	24" X 20'		
Priority - Low - Moderate - High	Low		
Roadway Width	14'	Traveled Way	
Surface Type	Gravel		
Road Grade: % Grade	1%		
Distance to edge of Lake Carmi	311'		
Name of Stream			
	Inventory Date:	4/24/17	
Recommended Treatment:			
Construct 10' Round Check Dam - Inlet			
10' Round Plunge Pool - Outlet			
Stone Headwall both Inlet & Outlet need repair/reconstruct.			
Estimated Cost:

(2) - 10' Round Plunge Pool - Outlet	6 C.Y, Type 1 Stone @\$50		\$300.00
Headwalls	Labor & Materials	\$	300.00
		Total	\$600.00
Notes: Some silt in Plunge Pool @ outlet.

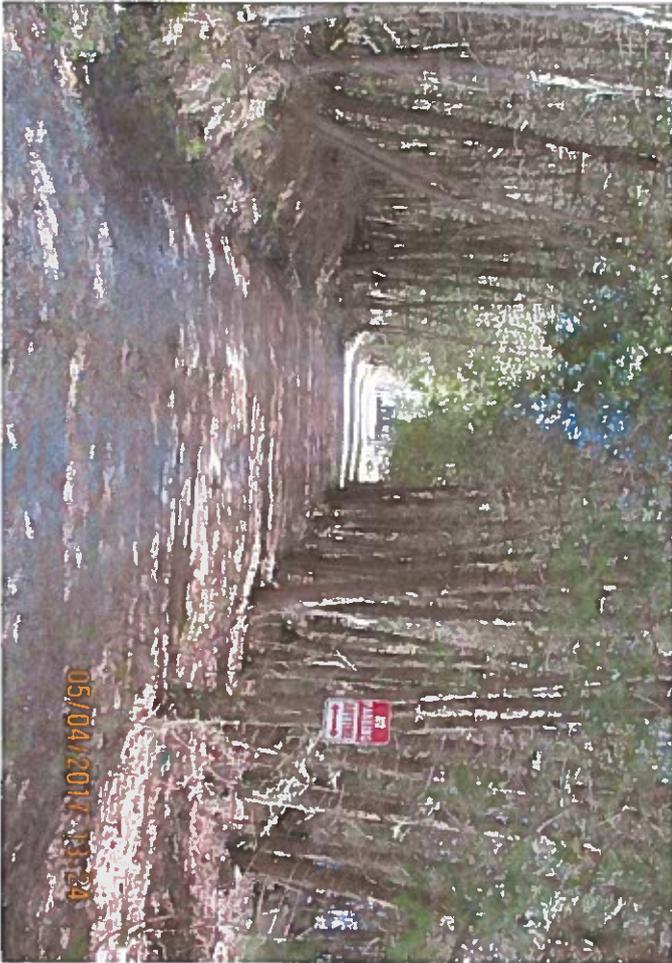
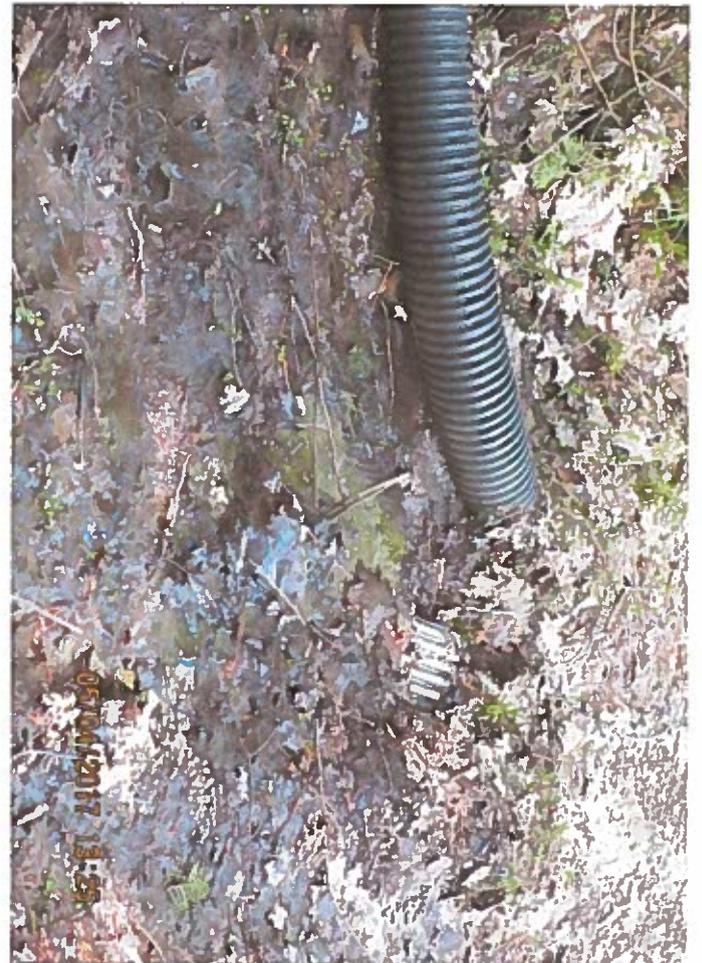
Franklin Watershed		Infrastructure Site Inventory for Water Quality Improvements	
		Remarks:	
Road Name	Patterson Point Rd.		
TH #	N/A		
Site ID	PPR -1		
GPS	N-44.96208°		
	W-72. 89275°		
Drainage Structure Type: Road - Ditch - Road Slope - Other	Road Culvert - HDPEP	Good Condition	
Erosion Frequency	Spring Runoff - Rain Storms		
Dimensions	6" X 20'		
Priority - Low - Moderate - High	Low		
Roadway Width	10	Traveled Way	
Surface Type	Gravel		
Road Grade: % Grade	0%		
Distance to edge of Lake Carmi	122%		
Name of Stream			
	Inventory Date:	4/24/17	
Recommended Treatment:			
Install 12" min. culvert			
Construct 8' Check Dam - Outlet			
Grade ditches to match new culvert - inlet			
Estimated Cost:			
12" X 20' Culvert	20 X \$70 = \$1400	\$	1,400.00
2 C.Y. Type 1 Stone	2X \$50= \$100	\$	100.00
Grading Ditches	\$200 Est.	\$	200.00
		Total	\$1700.00
Notes: Some silt in Plunge Pool @ outlet.

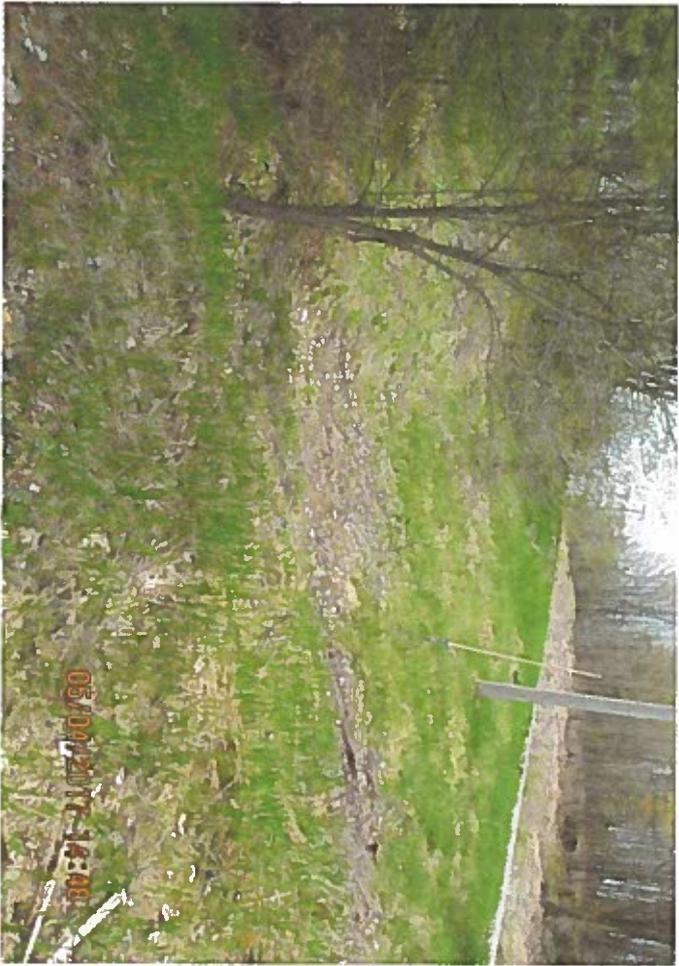
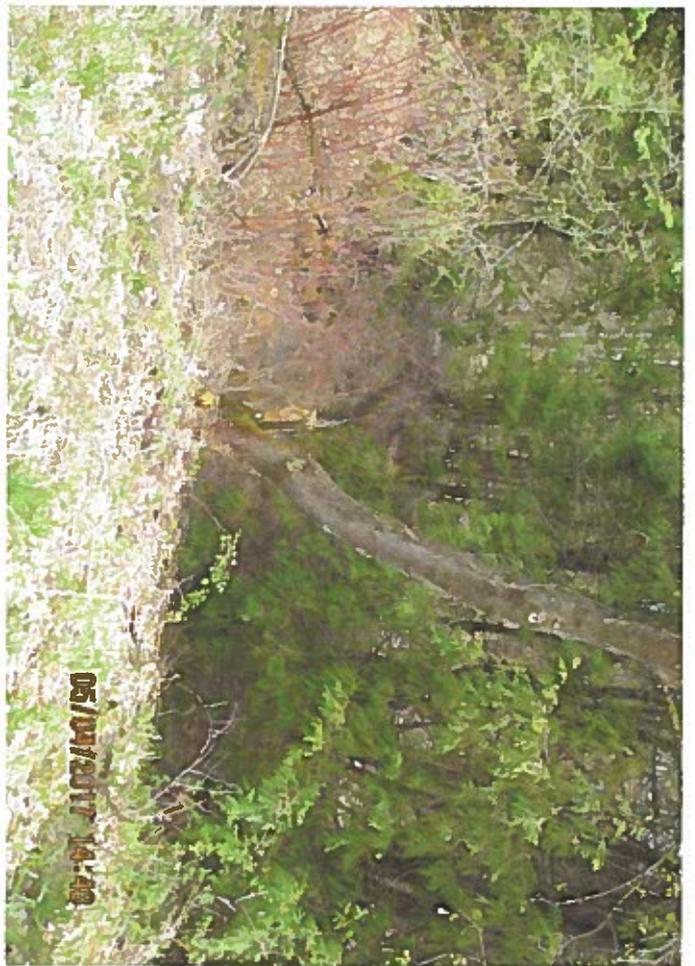
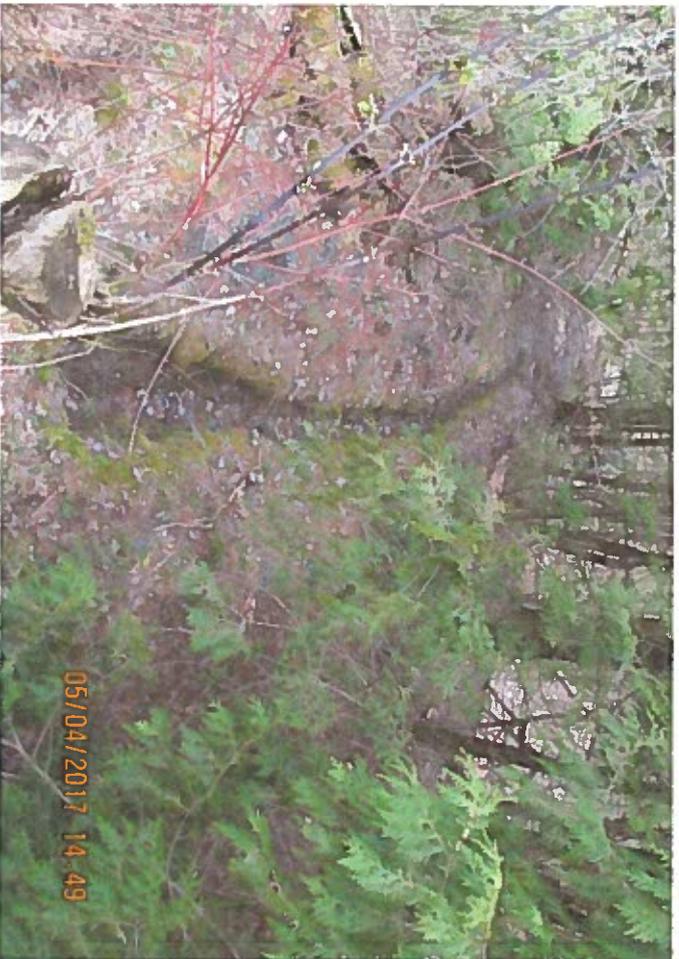
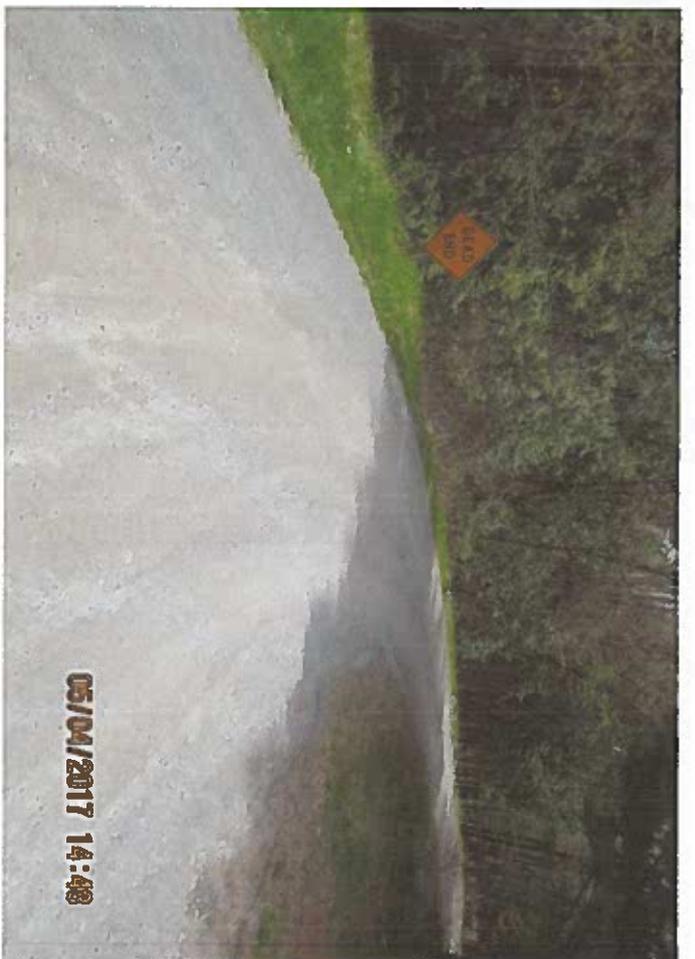
Franklin Watershed		Infrastructure Site Inventory for Water Quality Improvements
		Remarks:
Road Name	Black Woods Road	
TH #	N/A	
Site ID	BWR - 5	
GPS	N-44.97675°	60 +/- South of Sandy bay Rd.
	W - 72.88653°	
Drainage Structure Type: Road - Ditch - Road Slope - Other	Road Culvert - Concrete Pipe	
Erosion Frequency	Spring Runoff - Rain Storms	
Dimensions	18" X 60'	Fair Condition
Priority - Low - Moderate - High	Moderate	
Roadway Width	13	Traveled Way
Surface Type	Gravel	
Road Grade: % Grade	2%	
Distance to edge of Lake Carmi	345'	
Name of Stream		
	Inventory Date:	05/04/17
Recommended Treatment: 1. Stone line existing ditch (20' +/-) - Outlet. 2. Stone Check Dam on stream upstream of culvert		
Estimate		
10' Stone Check Dam	3.5 C.Y. Stone Fill- Type 1@\$50	\$175.00
20 L.F. Stone Ditch.	5 C.Y. Stone Fill- Type 1@\$50	\$250.00
	Total	\$425.00
Notes:

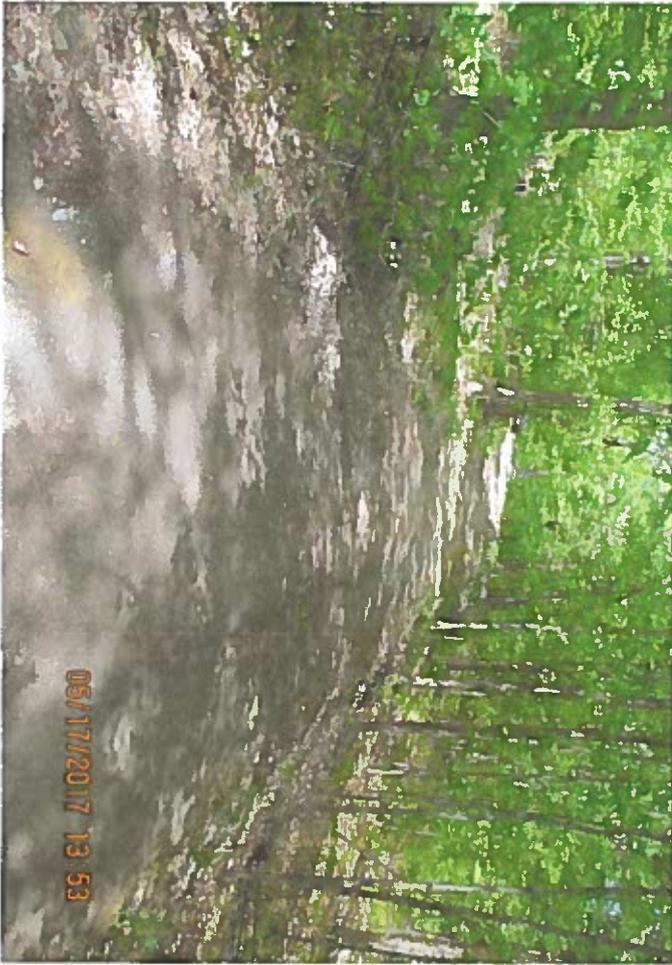
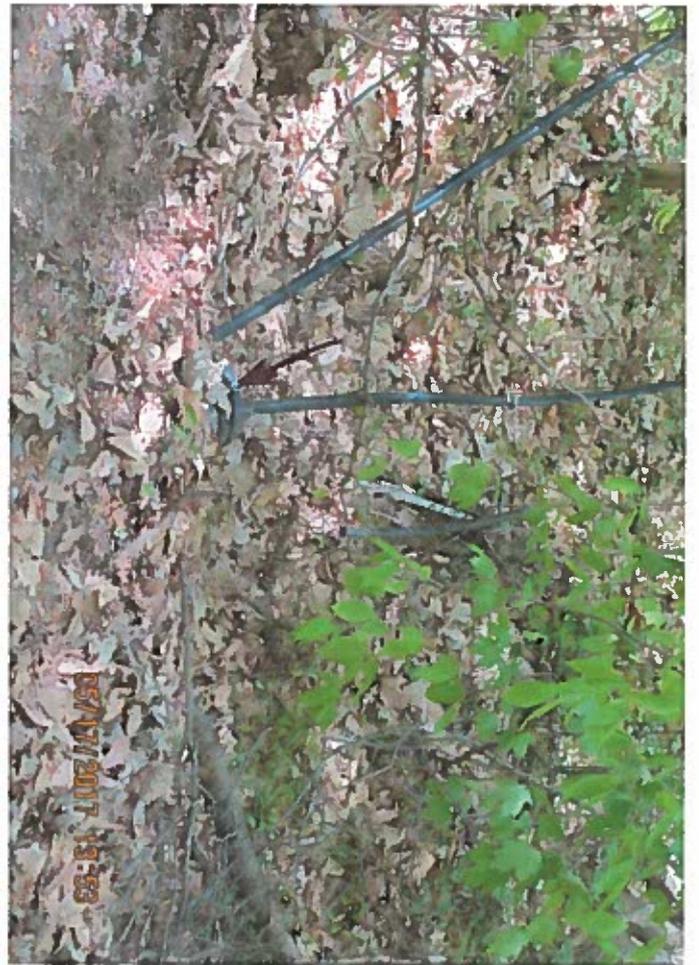
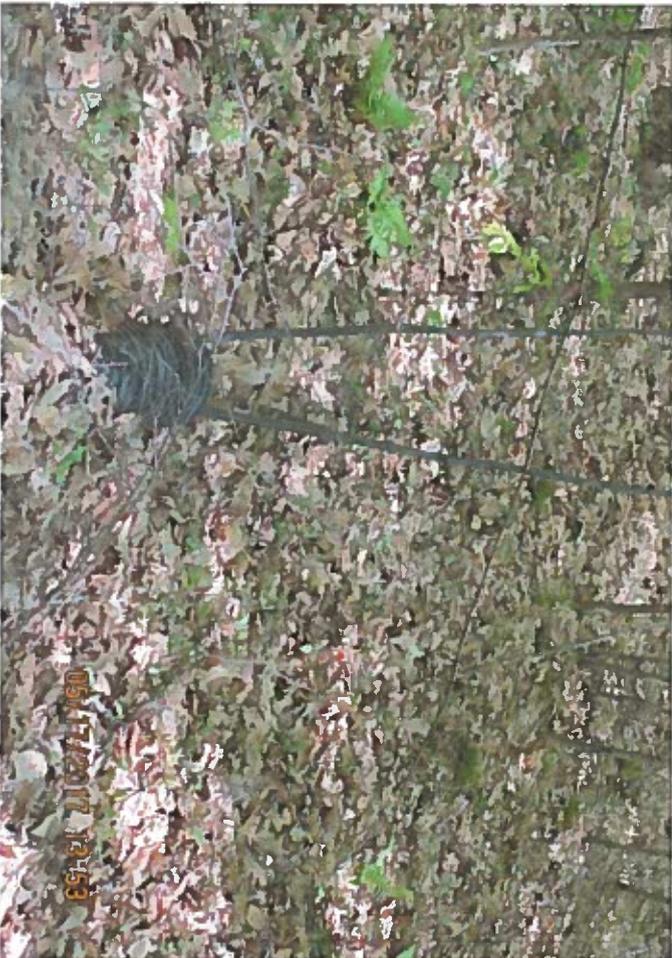
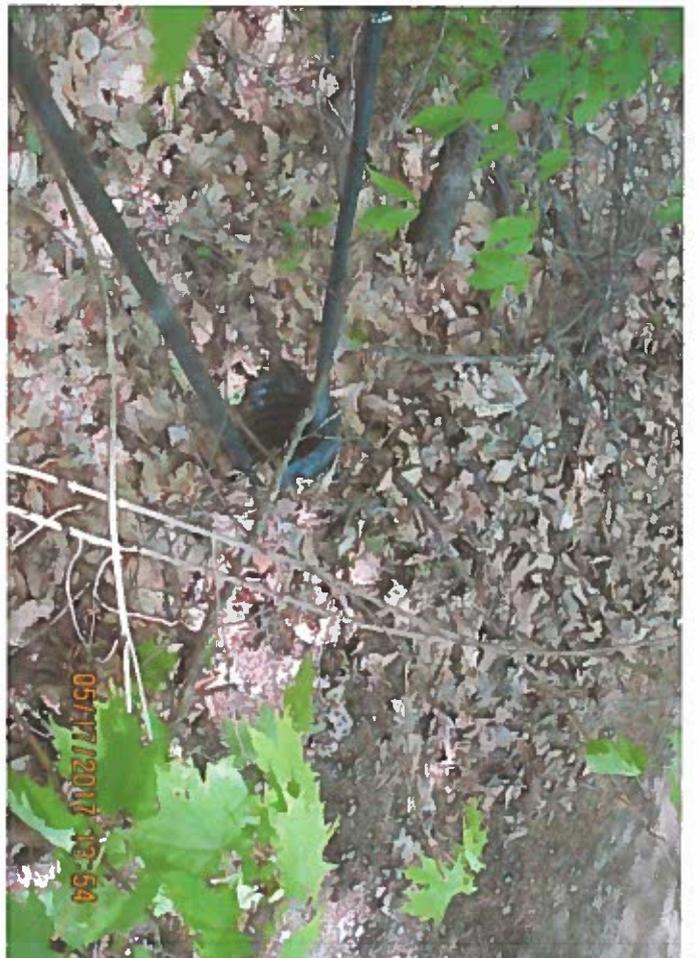
Remarks:
Road Name	Titemore Woods Rd.	
TH #	N/A	
Site ID	TWR - 3	
GPS	N-44.98232° W - 72.88265°	
Drainage Structure Type: Road - Ditch - Road Slope - Other	HDPEP Culvert	Good Condition
Erosion Frequency	Spring Runoff - Rain Storms	
Dimensions	8" X 20'	
Priority - Low - Moderate - High	Low	
Roadway Width	10	Traveled Way
Surface Type	Earth and Grass	
Road Grade: % Grade	0%	
Distance to edge of Lake Carmi	990'	
Name of Stream		
	Inventory Date:	05/17/17
Recommended Treatment: No treatment recommended at this time.		
Notes: Culvert also used as sap transfer line.

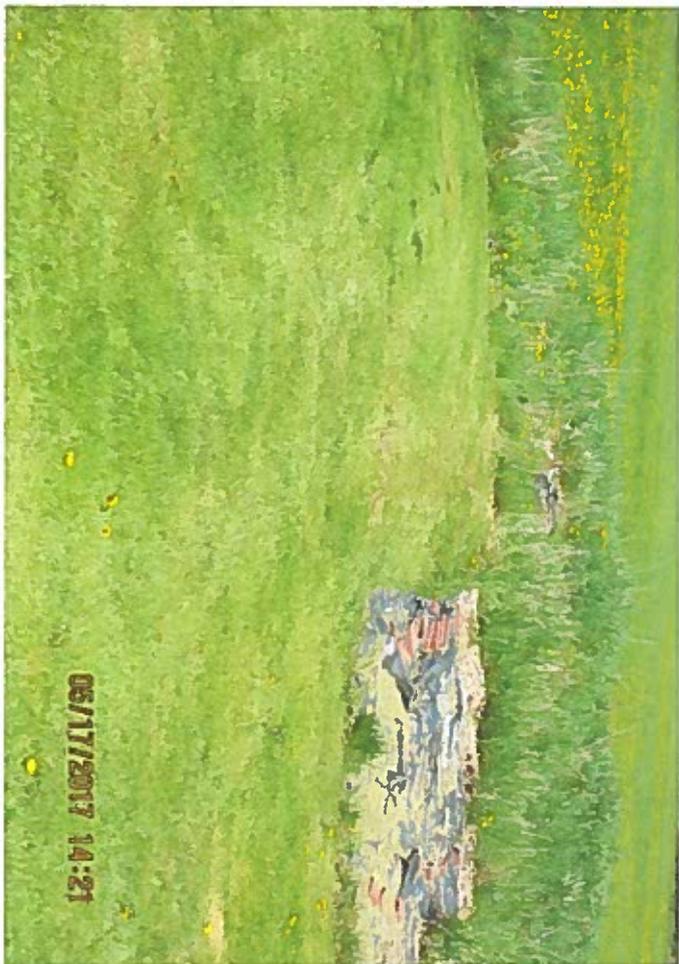
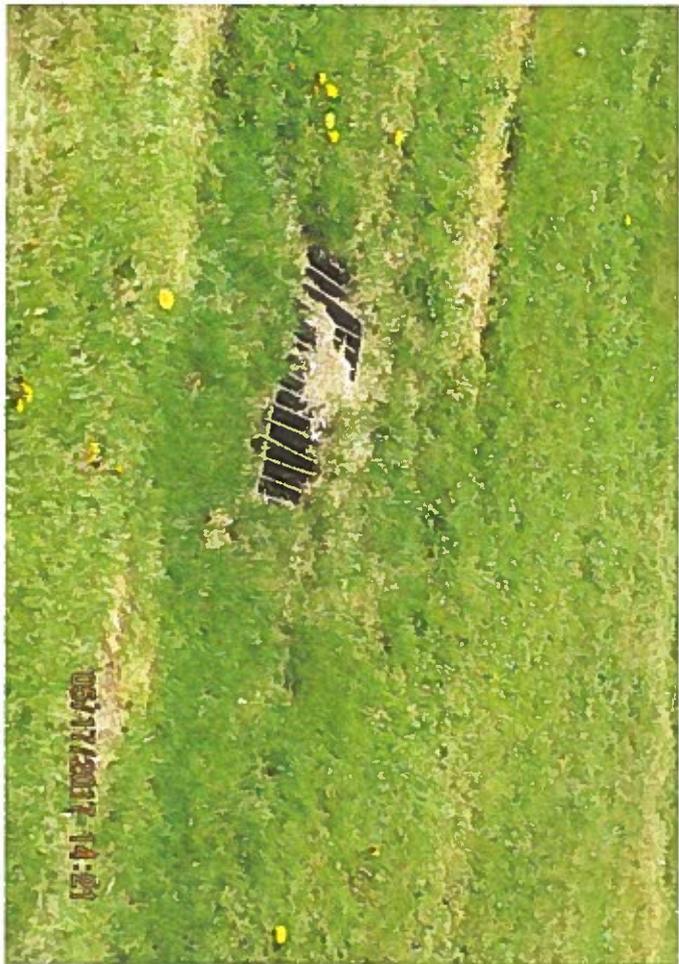
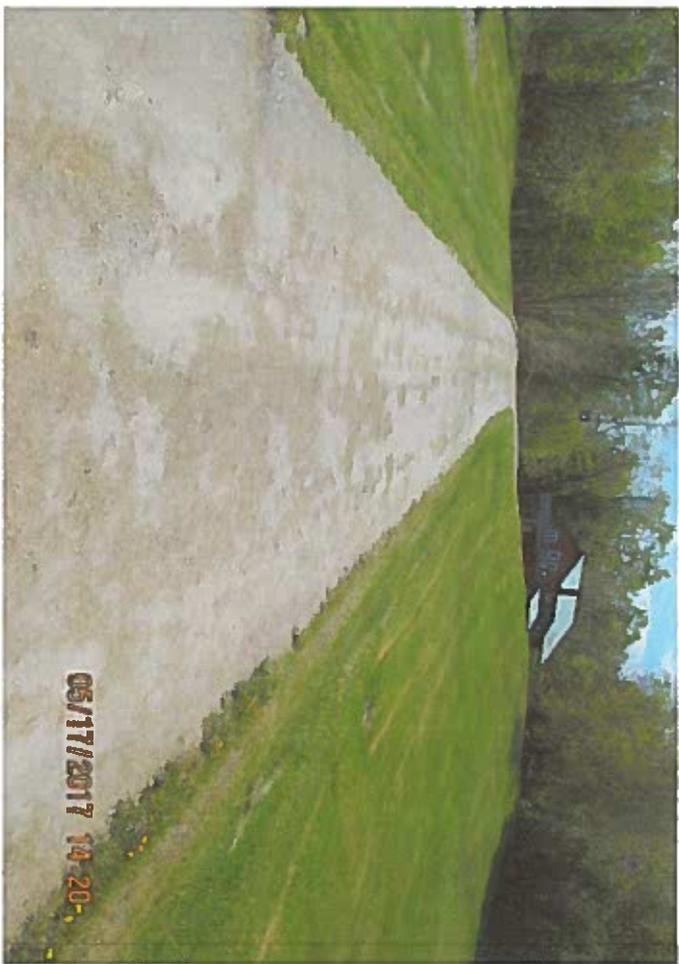
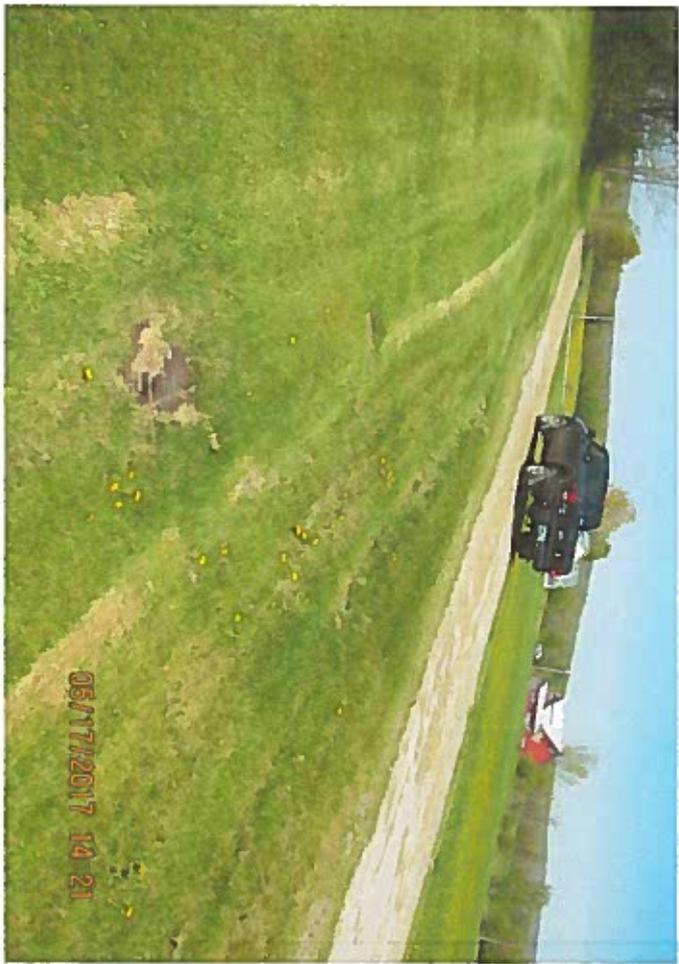
Franklin Watershed		Infrastructure Site Inventory for Water Quality Improvements
		Remarks:
Road Name	Titemore Woods Rd.	
TH #	N/A	
Site ID	TWR - 6	
GPS	N-44.98528°	
	W - 72.88322°	
Drainage Structure Type: Road - Ditch - Road Slope - Other	Concrete Catch Basin with Grate	Fair Condition
Erosion Frequency	Spring Runoff - Rain Storms	
Dimensions	2' X 2' +/-	
Priority - Low - Moderate - High	Moderate	
Roadway Width	10	Traveled Way
Surface Type	Gravel	
Road Grade: % Grade	0%	
Distance to edge of Lake Carmi	1685'	
Name of Stream		
	Inventory Date:	05/17/17
Recommended Treatment: None - Grass covered inlet and outlet.		
Notes: Was not able to locate outlet.
