# 2020 Stream Walk of Marsh Brook

December 28, 2020

Prepared by:  
Staci Pomeroy  
Regional River Scientist for VT DEC  
Rivers Program

Prepared for:  
Lake Carmi Watershed Association

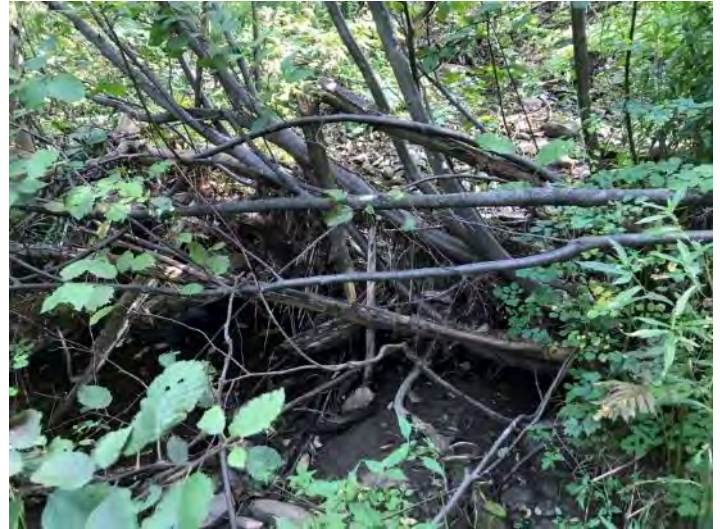
Wood riparian vegetation became a larger factor in this area of stream. The stream banks and floodplain has extensive woody riparian vegetation in this area; as well as there being significant alder growth that is directly along the bank and extending into the channel (Figure 6). More wood debris was also seen in the channel, contributing to connection to the floodplain, channel adjustments, channel braiding, sediment storage, and habitat in the channel.

*Figure 6: Alder tress across channel holding sediment*

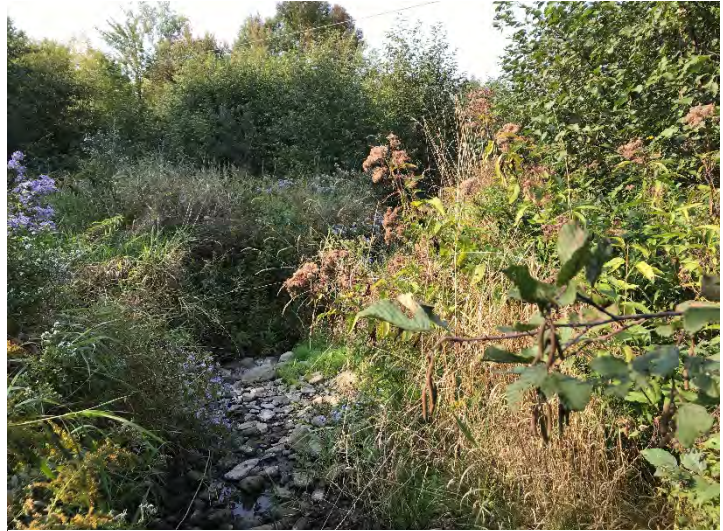
Through most of the segment, incision was minor to moderate; with lower floodplains developing in historically incised channels. One area where the channel remains more incised and still showing evidence of historic management, in the area of the power line crossing (Figure 9). In this area the channel become much narrower and deeper than the upstream and downstream channel dimensions.

*Figure9: Incised channel under power line*

- Area could be a location to explore potential for restoration project to reduce incision through floodplain connection.

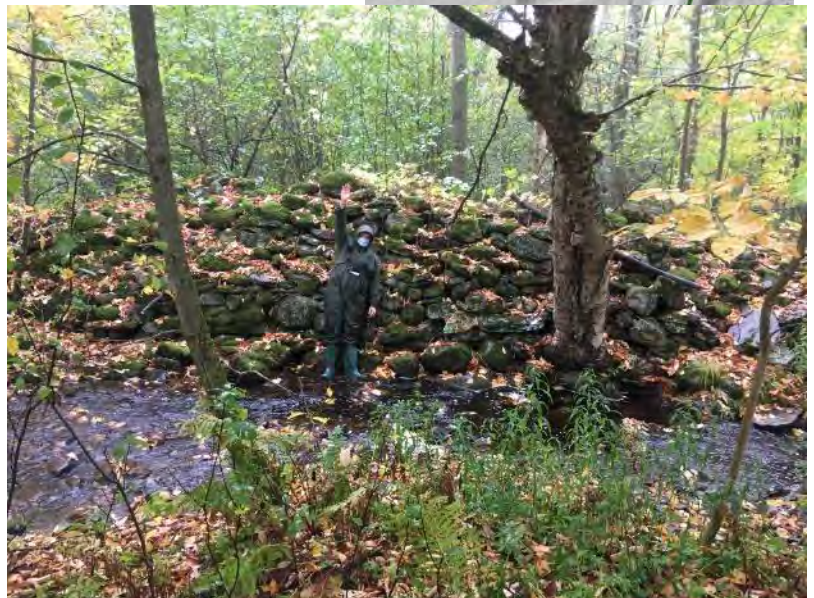
Approximately 520 ft downstream of the State Park Road (Rte. 236), there is evidence of an old dam. This can be seen on the LIDAR (Figure 10). In talking with a local landowner, this was likely associated with a historic mill. A large section of the old dam remains across the left (looking downstream) side of the valley. The structure is a very large dry-stacked stone wall (Figure 11). It is difficult to determine the full extent that the historic structure has contributed to the current condition of the stream. Historically, the structure may have contributed to upstream aggradation (build up) of sediment in the area of the impoundment, and downstream channel incision by creating hungry water. Hungry water is river flow with excess transport capacity. It has more stream power to transport than

*Figure11: Picture of old dam*

available sediment. As a result, it tends to erode its bed and banks to compensate. When the longitudinal continuity of sediment transport is interrupted (e.g., from dams), hungry water results. The remaining portion of the dam does affect flooding in this area by creating a barrier across the left side of the floodplain. The valley wall across from the remaining dam section is very steep and evidence of past erosion/mass failure were noted. The erosion appears to be stabilizing, with limited bare soils seen and vegetation beginning to be established on the slope. This area is still vulnerable to erosion due to its location on the steep valley wall and limited floodplain access.

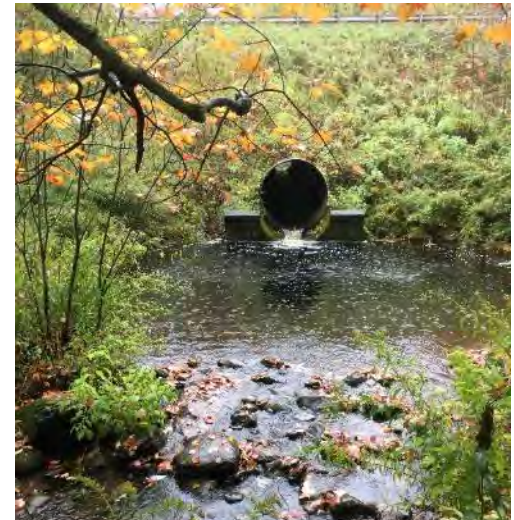
This segment has a culvert stream crossing on State Park Road (Rte. 236). A culvert assessment completed in 2011, showed that the current structure width, 6 ft., is considerably undersized, only 40% of the affective bankfull width, 15ft. On the downstream side, the structure contributes to significant scour and erosion (Figure 12), creating a large sour hole and erosion issues around the failing culvert outlet wall. The structure is rated as an aquatic organism passage structure due to the large perch at the outlet and low flow in the structure. On the upstream side, the under sized structure is causing sediment build up (Figure 13); contributing to a poor alignment with the stream and culvert inlet, as well as erosion along the streambanks as the river makes a sharp turn to enter the culvert. The wingwalls are stacked stone and there is evidence of erosion between the culvert and the wingwalls.

*Figure12:State Park Road (Rte. 236)  
culvert outlet*

- Over the entire distance of stream walked, the structure is the most noteworthy feature that is directly causing erosion in the stream channel. Planning for replacement of the undersized structure should be looked at to determine potential time frame in VTrans structure work. This would be considered a priority project due to the structure being geomorphically incompatible; contributing to a significant erosion at the outlet, sediment aggradation and planform adjustment at the inlet, and creates an aquatic organism passage issue.

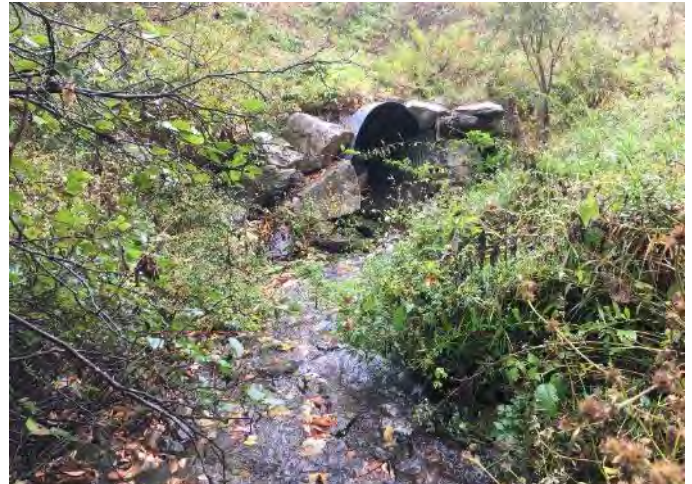
*Figure13: State Park Road (Rte. 236) culvert inlet*

On the upstream side of the culvert, the road drainage across from the state park entrance is contributing to a gully formation along the valley wall leading to the brook. There has been some rip-rap work done on the upper most part of the gully where the runoff enters the gully, but erosion continues along remaining bank and channel before entering the brook. As with the downstream right side (looking downstream) the herbaceous vegetation was very tall, making it difficult to see if any areas of erosion were associated with flow in the ditch and/or along the bank.

- Further investigation of the road drainage on both sides of the road and either side of the culvert is warranted to determine if erosion issues can be addressed, document condition of areas not able to be seen due to high vegetation and consider if additional ditch practices to slow/reduce water being delivered to the stream would be feasible.

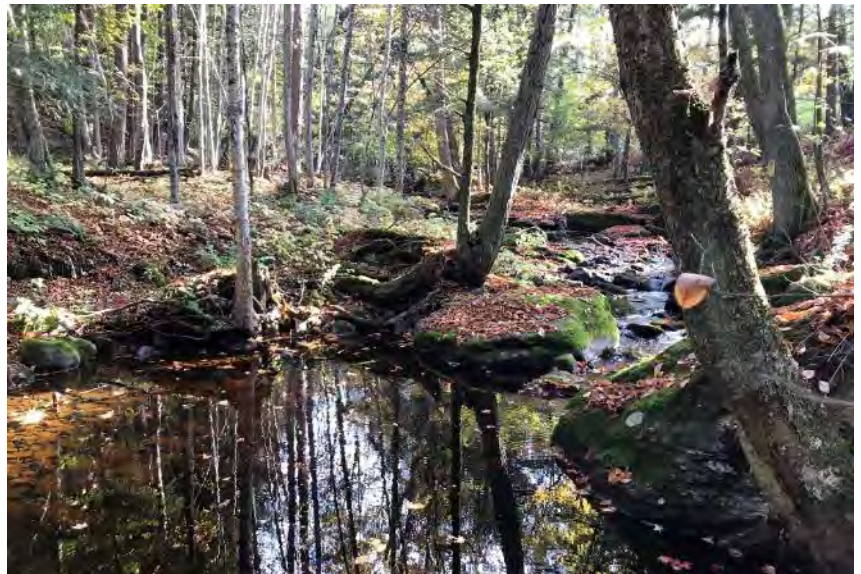
This upper portion of the segment has had a wooded riparian area since at least the 1962 orthophotos. There are large trees along the stream banks (Figure 14) and a mixed forest in the floodplain. The understory tended to be more open with the denser canopy cover. This has also likely contributed to the large wood that was seen in the stream channel. The wood was seen to be providing sediment storage and habitat in the channel.

*Figure 14: Well established large trees on streambank*

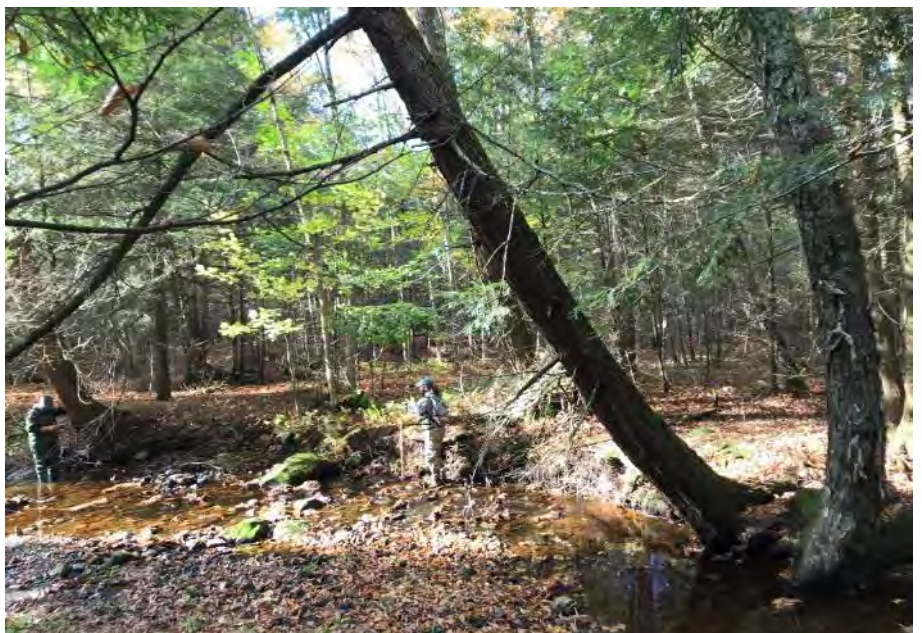
Figure17: Area showing historic floodplain and lower floodplain

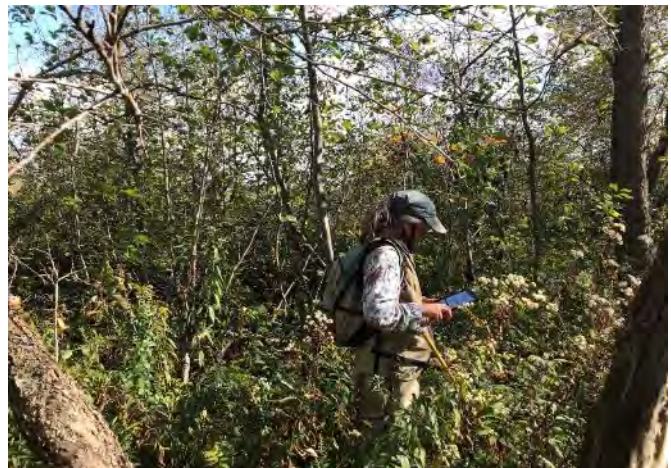
Moving up from the small tributary confluence the stream bed became small gravels and cobbles. Once again, the alders became dominant along the channel and the floodplain (Figure 20). The channel has access to floodplain through much of the segment. Minimal erosion was noted in this segment.

Figure 20: Dense vegetation along banks and floodplain

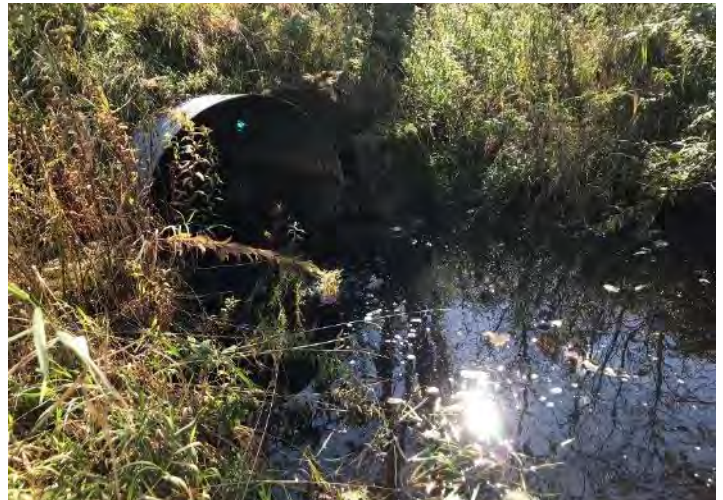
**Segment B:** Segment B starts at the Towle Neighborhood culvert crossing and continues upstream about 900 ft to the confluence of a small tributary entering from the south. The Towle Neighborhood Rd. crossing is a 4 ft corrugated metal pipe. There is minimal impact from the culvert on the stream channel in this area. The slope is low and there is sufficient water throughout the structure and no perch at the outlet (Figure 21). Some erosion of the downstream banks was noted. There is no header around the outlet of the structure and some erosion was noted on either side of the culvert.

- Based on the watershed size, 1.6 sq. mile, and VT hydraulic geometry curve (VT HGC) bankfull estimate, the structure size should be approximately 16 ft wide. The wetland stream type and cohesive soils would suggest a narrower bankfull width, than suggested by the VT HGC, would be likely to occur in this segment of the stream. The channel has also been managed overtime in this area, creating a potentially different bankfull width than expected. Review with town to determine if any known issues with the culvert (ie: beaver and/or debris plugging; flooding, condition) and timing for potential culvert replacement. Effort is for general planning for future work that may be needed on the structure in this area.

*Figure 21: Towle Neighborhood Rd. culvert*

- Replacing the undersized culvert with a larger structure will help reduce scour on the downstream side and impounding on the upstream side.
- Small tributary and Wetland restoration potential for tributary coming in from south. Impacts from historic channel management still affecting stream and wetland condition. Area important to look at for holistic approach along both segment B & C.

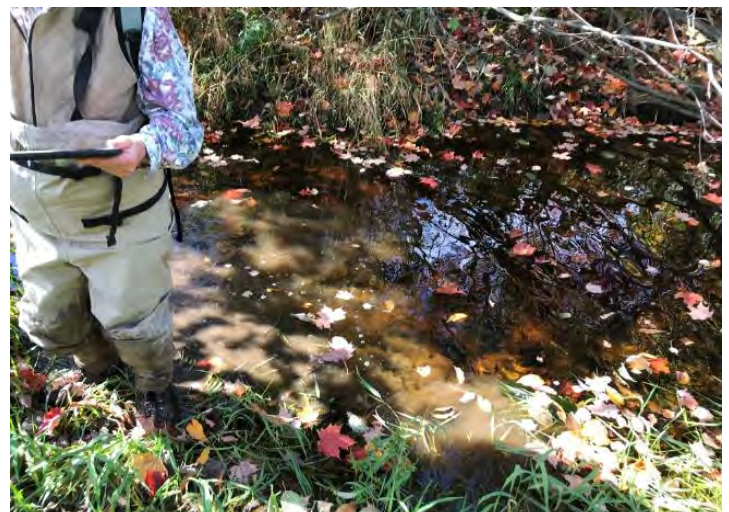
On the upstream side of the culvert there was a sharp change in the stream type and bed materials. Once again, the stream transitioned into a wetland stream, being narrower and deeper. Unlike downstream wetland section that had fine gravels and sand beds, that were generally firm underfoot; this streambed materials in this segment were muck and very soft underfoot. Fine sediments and material were stirred up when walking in the channel (Figure 22)

*Figure 22: Fine sediment and muck clouded water*

- The landowner noted that this area has had frequent beaver influence over the years and channel management to try and address flooding of the fields due to beavers and water back up. A review of the 1857 map (Franklin Historical Society) (Appendix B) shows there was a sawmill impoundment in this area. It is unclear the extent of the impoundment, or how long it was in place; but is a part of the story in this area and may have contributed to the type of legacy soils seen in the floodplain along the channel. The 1962 orthophoto shows the stream still maintained a few meanders in its planform. By the 1995 orthophoto the channel had been fully straightened. The stream has incised in this area and there was limited lower floodplain noted. The low valley slope and undersized culvert are contributing to this area being more depositional and impounded.

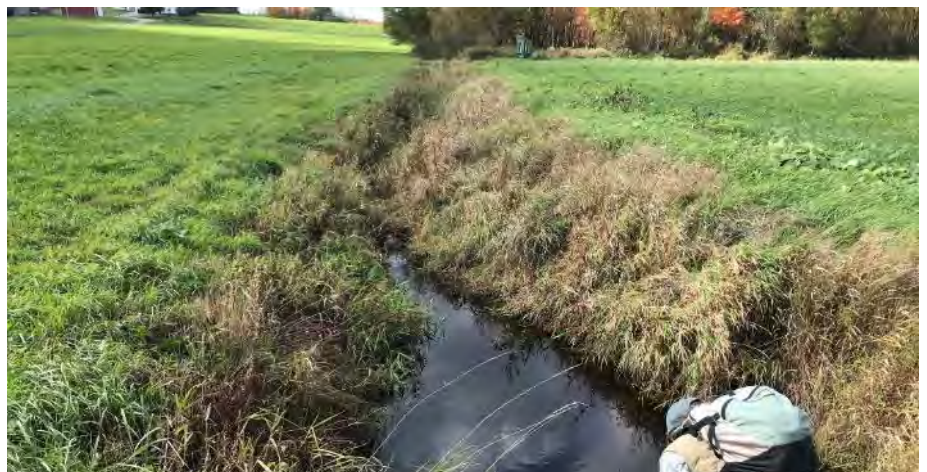
Imagery review show this segment has been managed essentially as a field ditch since at least the 1962 orthophoto. The stream is incised and has no lower floodplain available (Figure 23). Due to the incision and very straight condition of the channel, it is functioning as a transport reach; meaning sediments being delivered to

*Figure 3: Channel managed as a farm ditch*

it are quickly passing to downstream reaches. There is no woody riparian buffer and hay is mowed up to the top of the channel bank.

- Buffer planting as a standalone project is not suggested. Planting around the incised channel may provide benefits but will also lock the channel in the straightened condition. Working with landowner to move mowing back from the top of bank to allow for natural revegetation along the stream bank over time, while allowing some natural channel adjustments to potentially occur.
