LAKE CARMİ PRIVATE ROADS EROSION INVENTORY REPORT 2019

Franklin Watershed Committee

Catie Bartone, ECO AmeriCorps 2018-2019

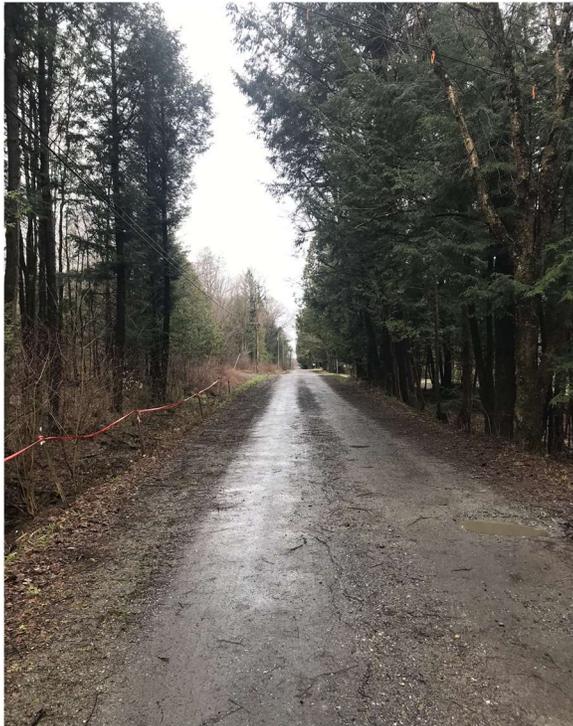
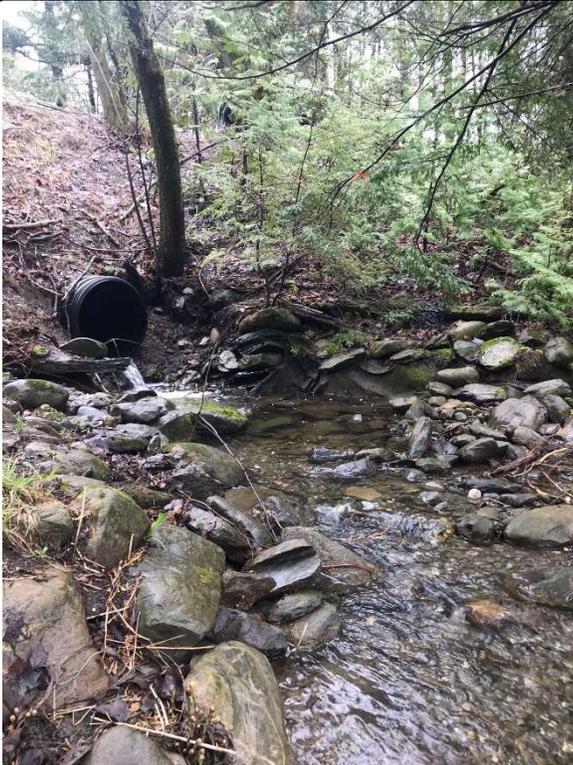
No significant erosion was observed on or along the roads with the exception of at either end of the culvert beneath Harrison Drive.

The ditches along Hammond Shore Road appeared to be adequately sized and vegetated with no signs of blockage or scouring.

There was no physical evidence of failure at the culverts at the time of the time of inspection.

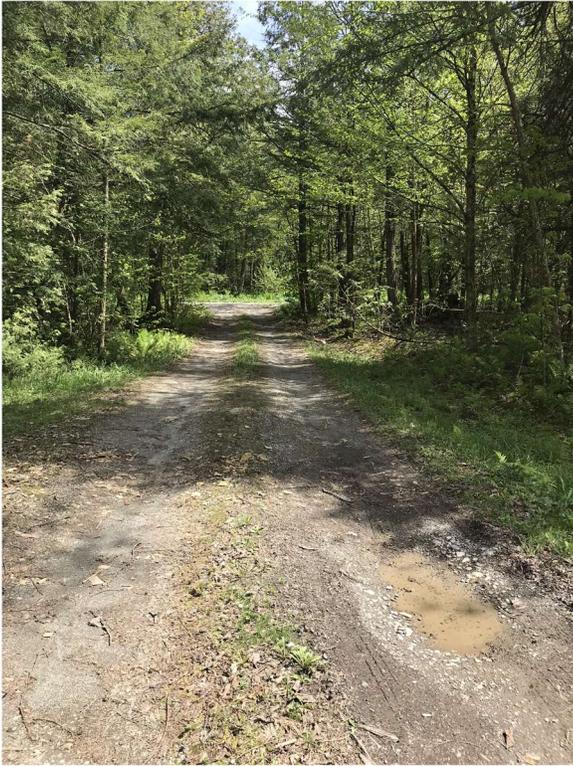
Hemlock Lane has many potholes and poor drainage, and little to no evidence of vegetated ditching. It is important that these short, private roads coming off of Hammond Shore Road are also maintained in an adequate manner, as they are the closest roads to the lake in the entire watershed, and could be carrying sediment from some of the more major private roads, such as Hammond Shore Road.

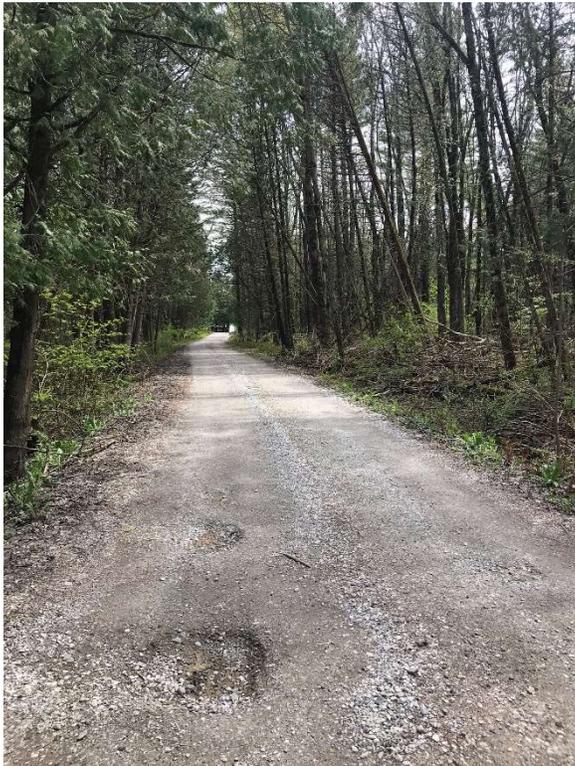
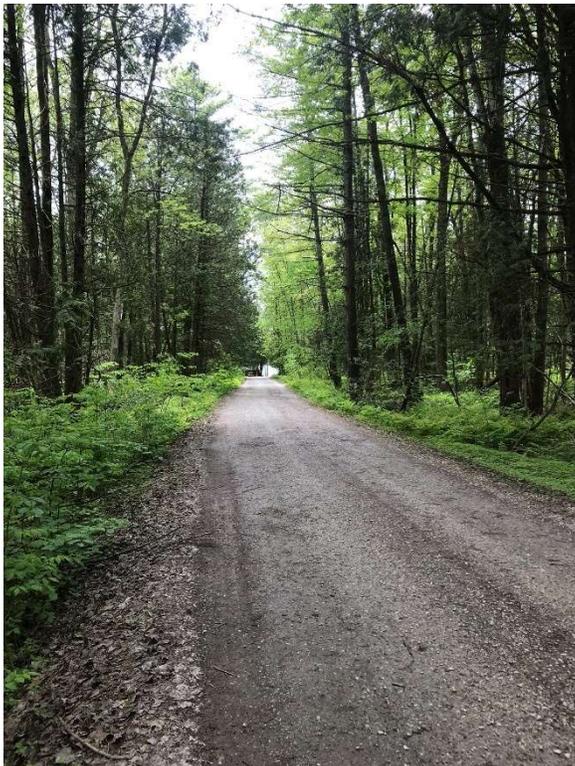
Shore Road is located off of Lake Road (VT Route 120) and seems to have varying conditions.

The first photo seen here on the left is from a sampling trip taken in late May. The second photo is from an initial private roads inventorying trip in early June. Within two weeks of taking a picture from the same location, there is a visible difference in road condition and vegetation.

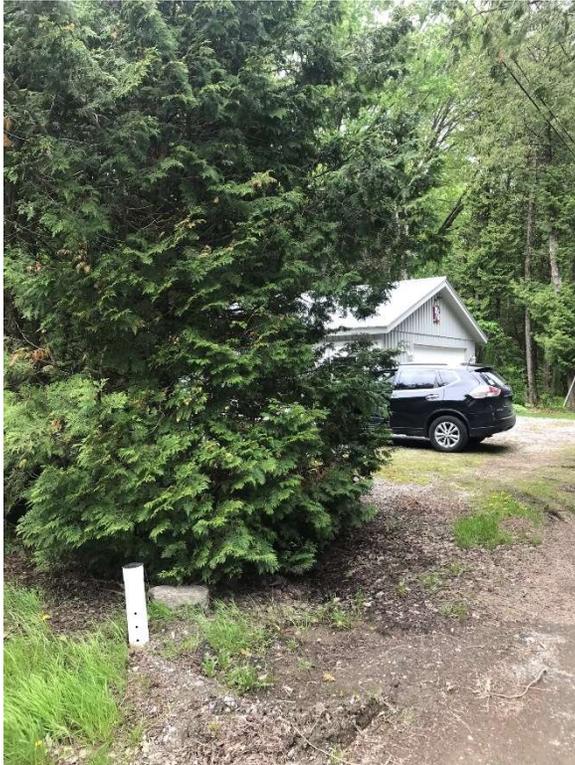
Vic's Crossing has some drainage issues reported by the homeowners in the neighborhood. However, it has been observed that the drainage issues may be due to a contiguous wetland.

The first photo on the left is where the reported drainage issues had been occurring on Vic's Crossing, underneath the cedar trees pictured. The second picture below is a picture of the contiguous wetland on Vic's Crossing.

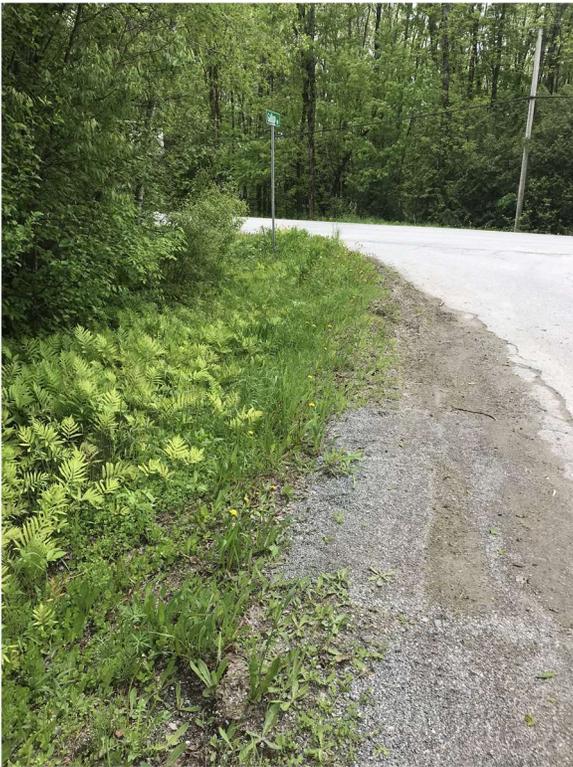
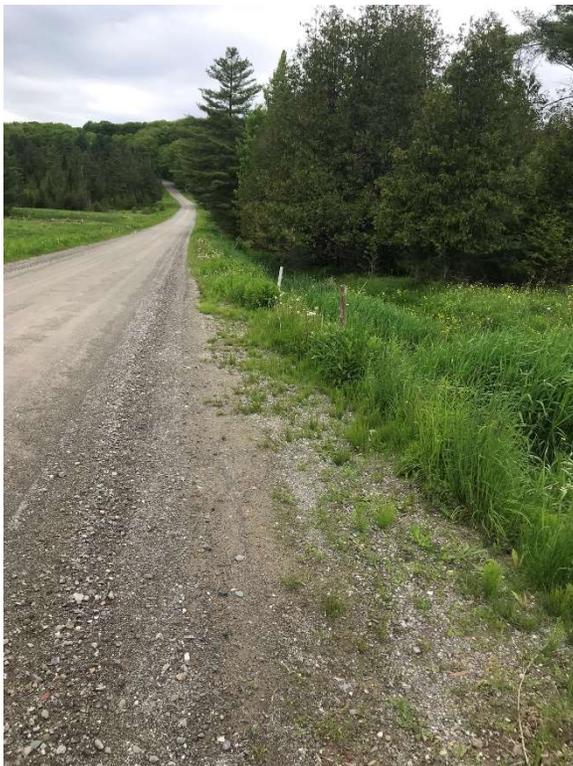
Gallup Road

In this segment, banks are unstable coming off of road into the ditching. For this segment, a 600-foot section of roadside ditch, along the southern edge of the road, was observed to be bare and actively eroding. In addition, the ditch has a steep back slope that is leading to slumping.

Better stormwater ditching is needed here. There are also many potholes, indicative of poorly drained soils and/or insufficient crowning or road tilting. This can be corrected by reconstructing or re-grading the road. It is recommended to build the road up in the areas of exposed ledge. Due to the slope, the ditch should be made as wide as possible with the space that is available (up to 6-8 feet wide) and vegetated with stone check dams spaced 50 to 60 feet apart.

Significant evidence of sediment transport was observed. The ditch could be stabilized by making it wider, with a parabolic-shaped bottom. The ditch may need to be stone lined in sections where it is not possible to achieve a sustainable back slope. Stone check dams could also be employed in order to reduce flow velocities, limit sediment transport, and potentially create opportunities for infiltration in the ditch.

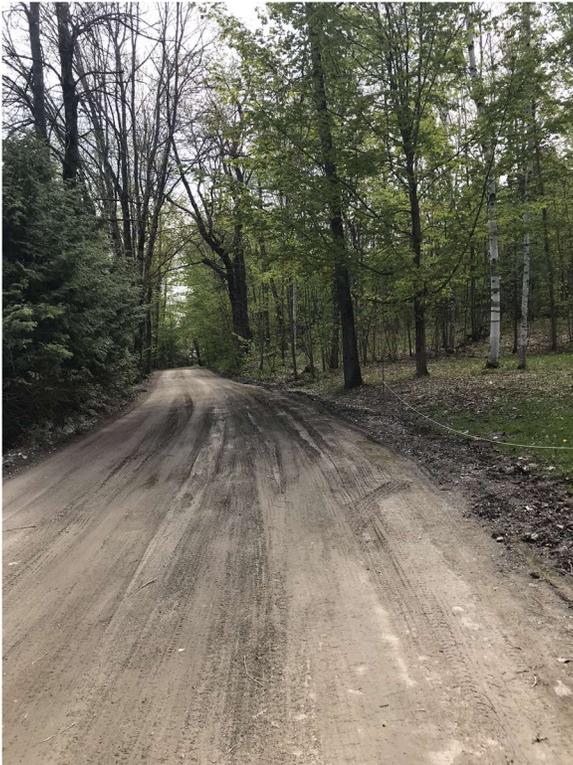
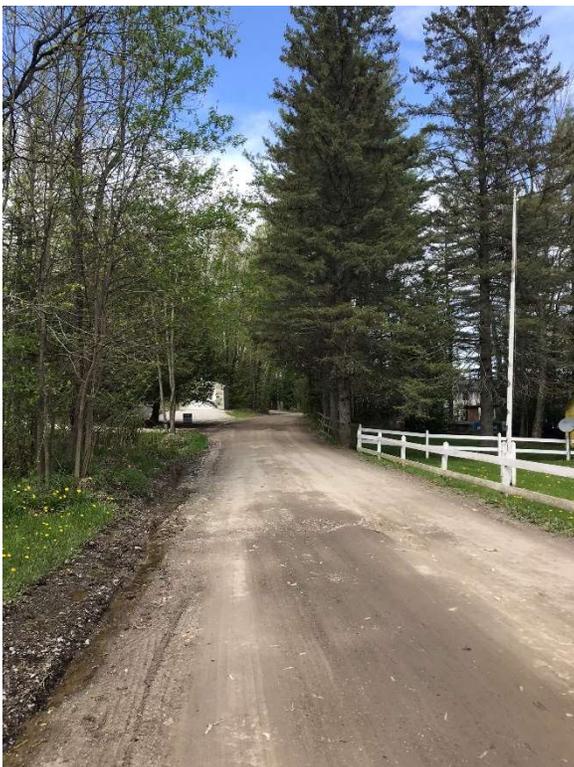
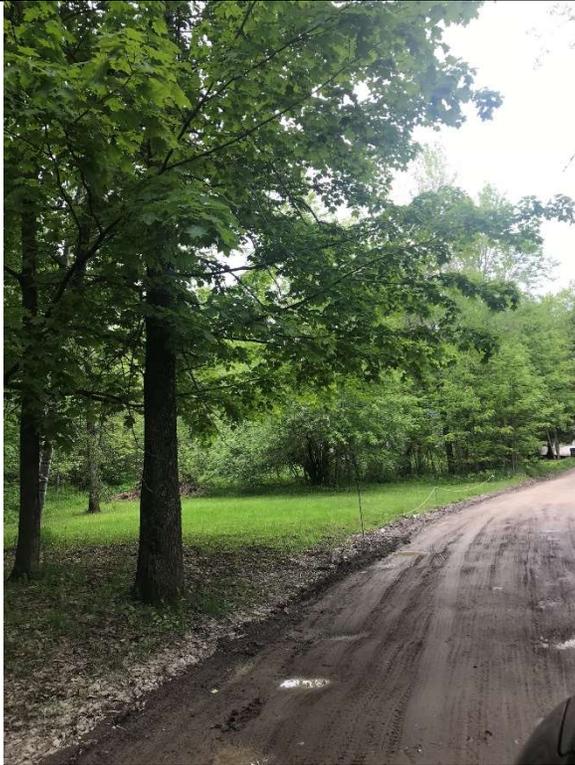
Patton Shore Road

Like the other roads inspected for this project, the most obvious problems are potholes along the full extent of the road. This can be corrected by reconstructing or re-grading the road as described for the other roads evaluated. It is recommended to build the road up in the areas of exposed ledge.

To minimize the amount of sediment washing from the Ledge Drive and Scottish Lane road surfaces, a ditch should be constructed on one side of each of these roads. Due to the slope, the ditch should be made as wide as possible with the space that is available (up to 6-8 feet wide) and vegetated with

stone check dams spaced 50 to 60 feet apart. It may be necessary to also construct a ditch on the west side of Patten Shore Road to divert flow from each of these two new ditches to the culvert.

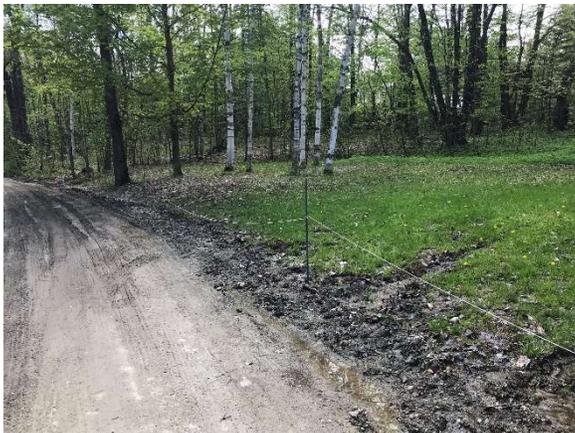
Patton Shore Road has visible corrugations, also called washboards, a series of ridges and depressions across the road surface caused by lack of surface cohesion and excessive vehicle speeds.

Corrected by improving the cohesive qualities of the road surface: remix with a good percentage of fines, scarify the road surface while damp, regrade, re-crown, and roll the surface.

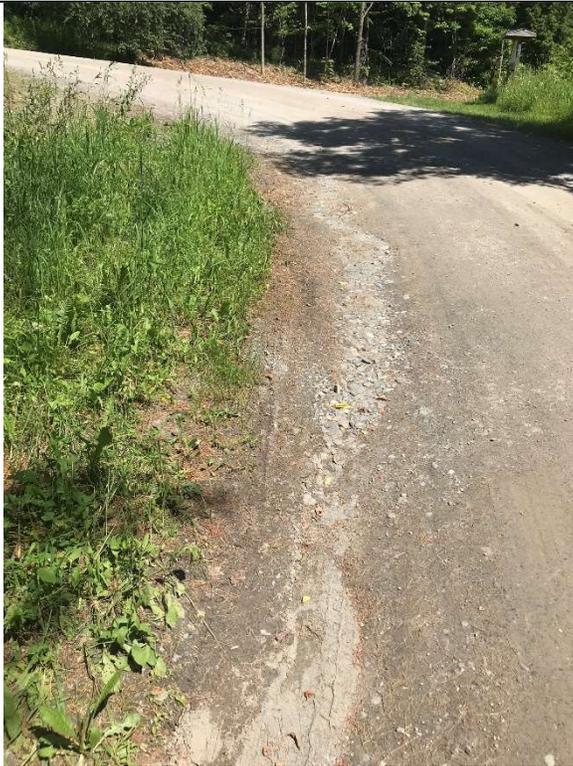
Black Woods Road

Black Woods has considerable evidence of channelized flow leading directly to the lake.

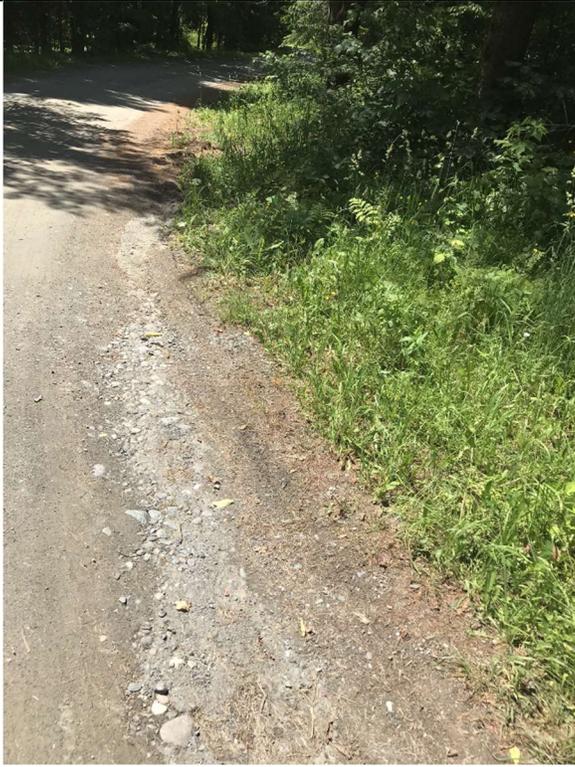
Patton West

Bank stabilization is necessary here. Bank stabilization is the vegetative or structural means used to prevent erosion or failure of any slope.

Failure of a bank occurs when a section of the bank slides.

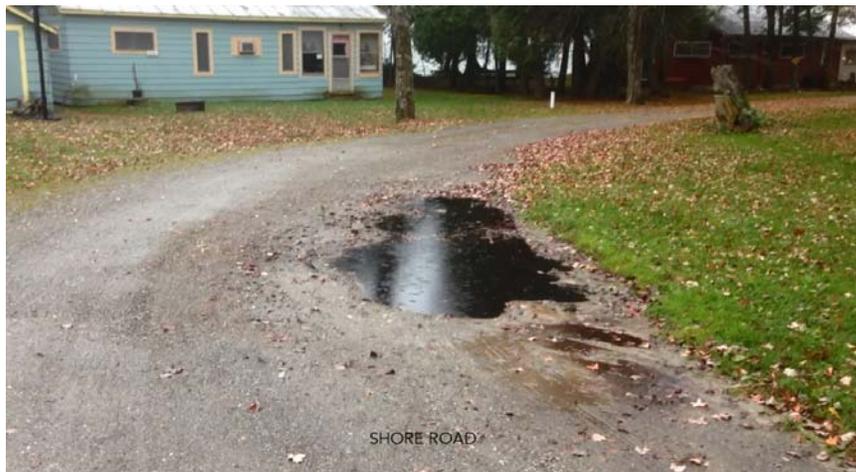
half of Shore Road runs from Lake Road through a wooded undeveloped section of land that appeared to be very wet at the time of the inspection. Potholes are an obvious problem on both roads. Both roads are relatively flat in profile and in cross section. There was no sign of significant erosion on either of the roads.

A large puddle was observed on Shore Road at the curve as the road transitions its alignment to be parallel with the shoreline of the lake. No culverts or ditches were observed along Shore Road.

Potholes and drainage around the roads appeared to be the most significant issues at Shore Road and Vic's crossing. The potholes are best addressed by reconstructing or re-grading the road as recommended for Hammond Shore Road. The only major drainage issue along Shore Road is at the curve. Building up the road or re-grading here would likely not be sufficient as water from the north side of the road would still be allowed to pool. It is recommended that a ditch be constructed along the inside edge of the curve so that water drains to the south and west towards and beyond an existing tree stump at the side of the road. It may be necessary to remove the tree stump. A culvert should be installed under Shore Road just to the east of the tree stump to discharge approximately between the two camp buildings located here. It is recommended that the ditch be seeded and mulched so that vegetation

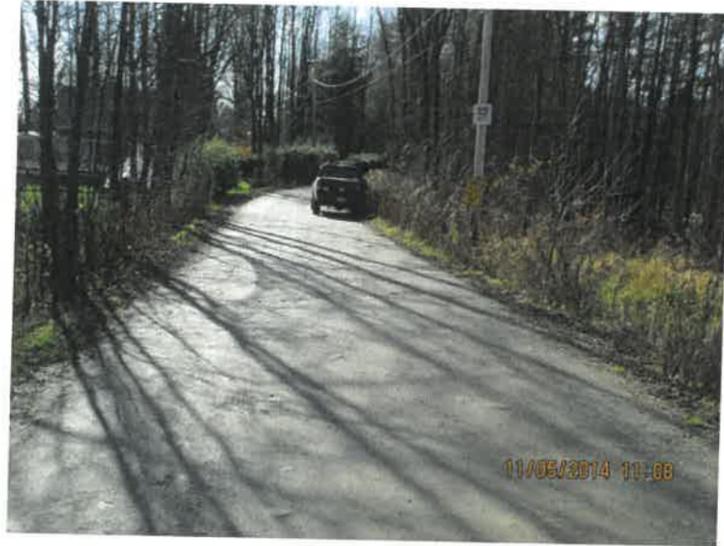
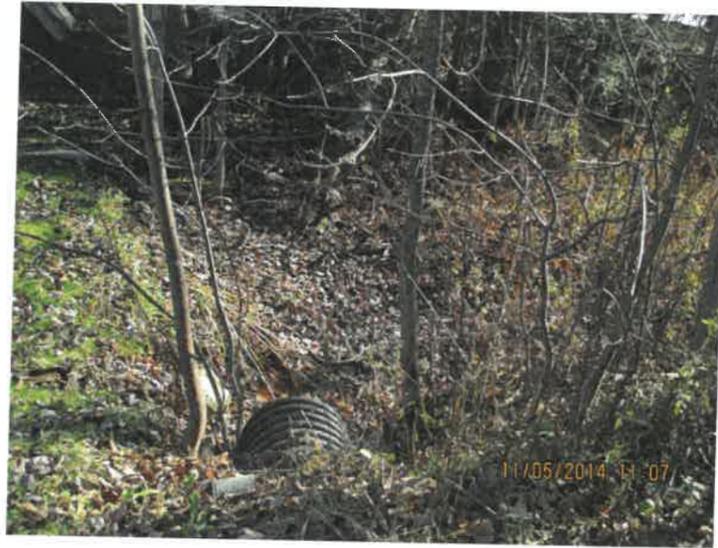
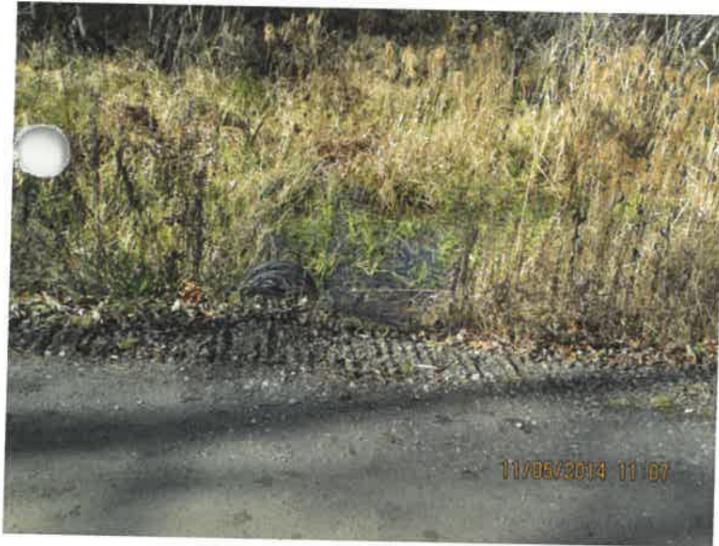
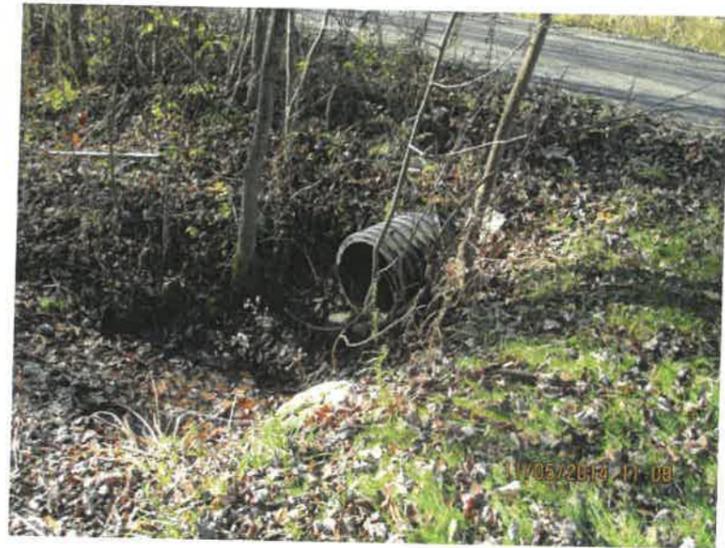
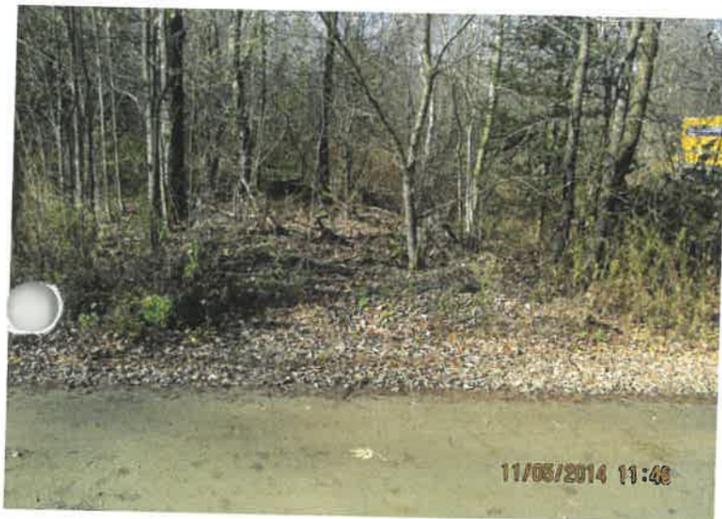
Patton Shore (1) Pictures

Remarks:
Road Name	218 Patton Shore Rd.	
TH #	N/A	just after 218 Patton Rd
Site ID	PS - 2	
GPS	44.98624° 72.87477°	
Drainage Structure Type: Road - Ditch - Road Slope - Other	Culvert outlet - ditch	
Erosion Frequency	Spring Runoff - Rain Storms	
Dimensions	(12"-15") X 58' CMP	Poor Condition - 12" inlet - 15' outlet (Corrugated Metal Pipe)
Priority - Low - Moderate - High		
Roadway Width	14'	Traveled Way
Surface Type	Gravel	
Road Grade: % Grade	Flat	
Distance to edge of Lake Carmi	120' +/-	
Name of Stream	N/A	
		Inv. Date: 11/05/2014

1. - Replace culvert with new XXXXXX (Recommended size from Hydraulic Study) ?
2. - Construct 60' +/- stone lined swale at culvert inlet.
3. - Construct Stone Plunge Pool at culvert outlet.
4. - Construct Stone Check Dam at Lake edge.
5. - Apply gravel to crown roadway to allow for sheet runoff.

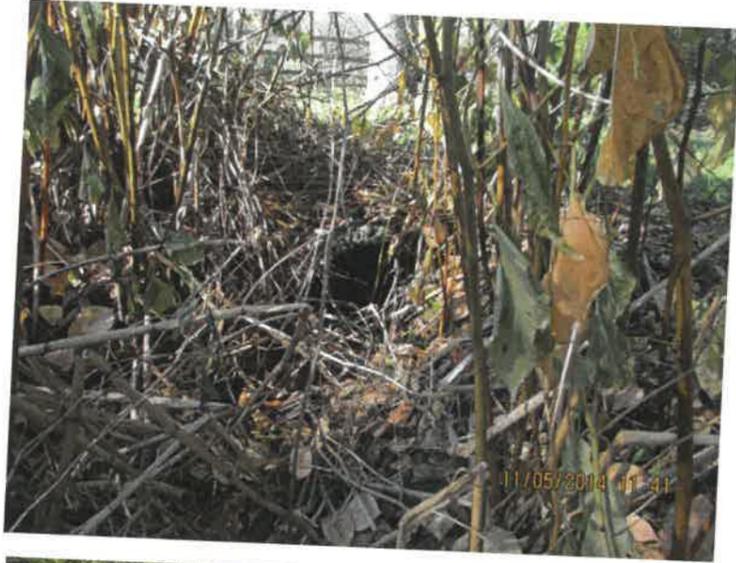
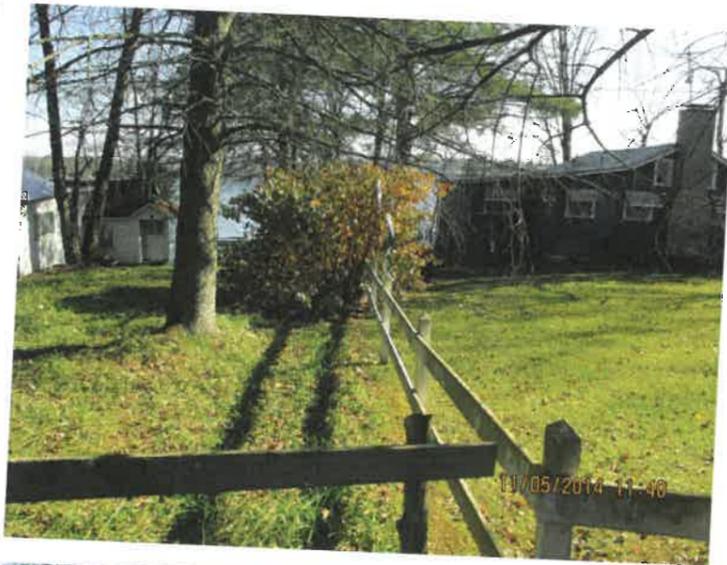
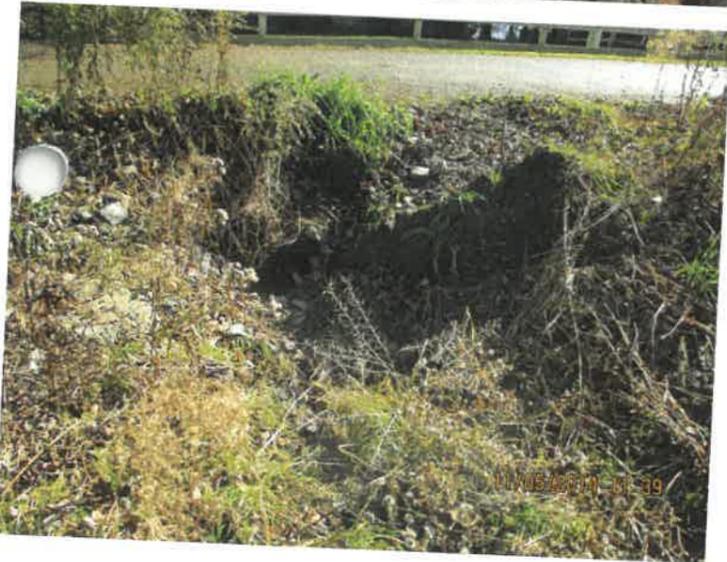
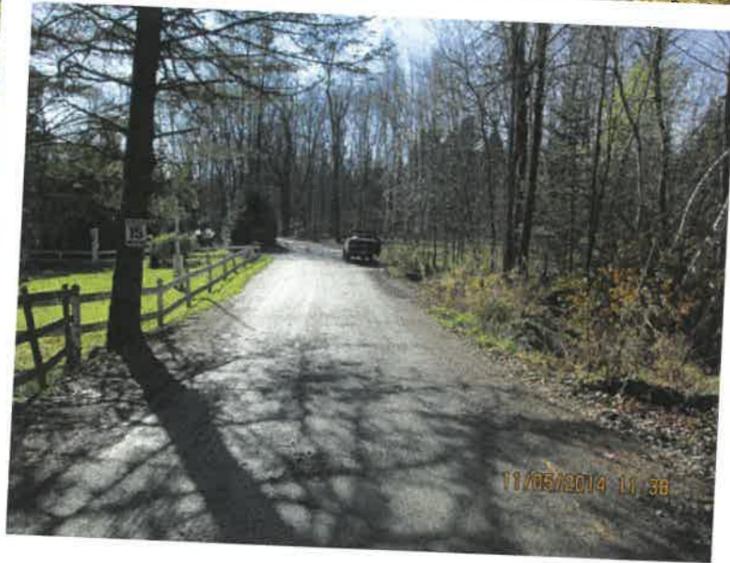
Patton Shore (2) Pictures

Remarks:
Road Name	Patton Shore Rd.	
TH #	N/A	before 421 Patton Shore
Site ID	PS - 3	
GPS	44.98441° 72.87595°	
Drainage Structure Type: Road - Ditch - Road Slope - Other	Culvert outlet - ditch	
Erosion Frequency	Spring Runoff - Rain Storms	
Dimensions	24" X 35' HDPEP Culvert	Good Condition
Priority - Low - Moderate - High		
Roadway Width	13'	Traveled Way
Surface Type	Gravel	
Road Grade: % Grade	Flat	
Distance to edge of Lake Carmi	75' +/-	
Name of Stream	N/A	
		Inv. Date: 11/05/2014

Recommended Treatment:
1. - Construct Stone Plunge Pool at culvert outlet.
2. - Construct Stone Check Dam at Lake edge.
3. - Apply gravel to crown roadway to allow for sheet runoff.

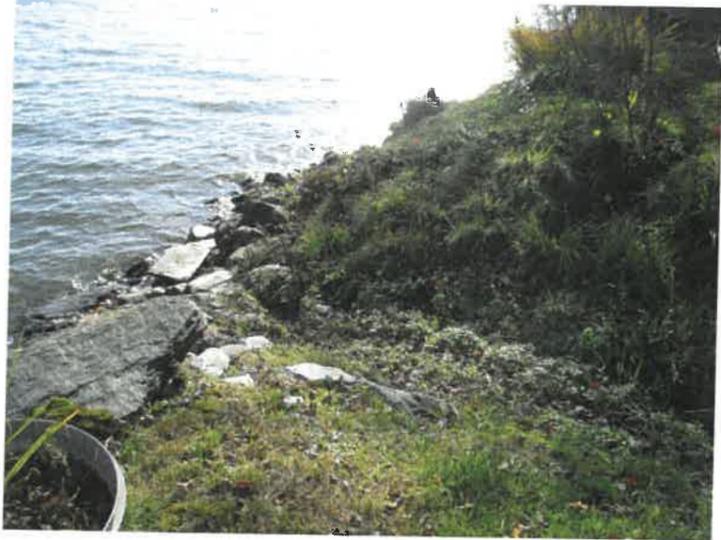
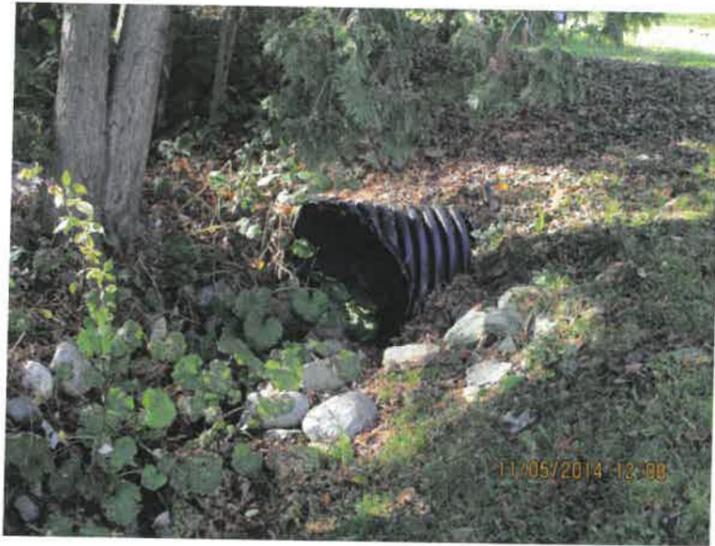
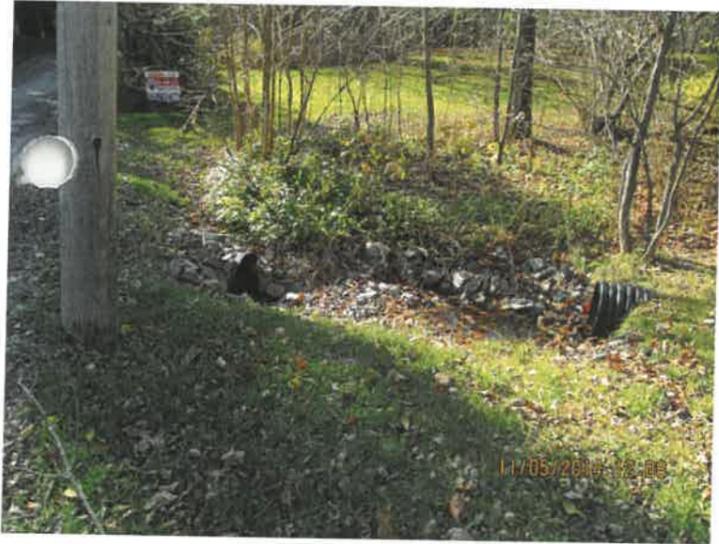
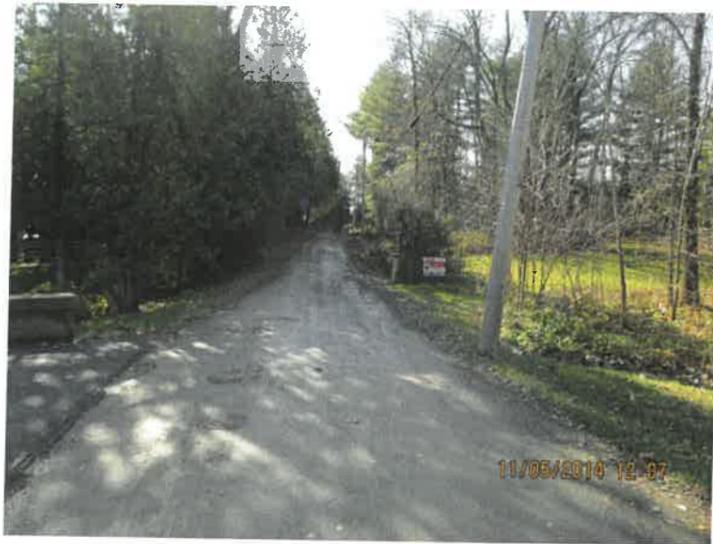
Patton Shore (3) Pictures

Road Name	555 Patton Shore Rd.	Remarks:
TH #	N/A	# 555 - Patton Shore Rd
Site ID	PS - 4	Lyman
GPS	44.98321°	
	72.87825°	
Drainage Structure Type: Road - Ditch - Road Slope - Other	Culvert outlet - ditch	
Erosion Frequency	Spring Runoff - Rain Storms	
Dimensions	36" X 20' HDPEP Culvert	Good Condition
Priority - Low - Moderate - High		
Roadway Width	14'	Traveled Way
Surface Type	Gravel	
Road Grade: % Grade	Flat	
Distance to edge of Lake Carmi	75' +/-	
Name of Stream	N/A

Recommended Treatment:
 1. - Construct Stone Plunge Pool at culvert outlet 12" above culvert invert elevation.
 2. - Clean outlet channel of debris.
 3. - Construct Stone Check Dam at Lake edge.
 3. - Apply gravel to crown roadway to allow for sheet runoff.

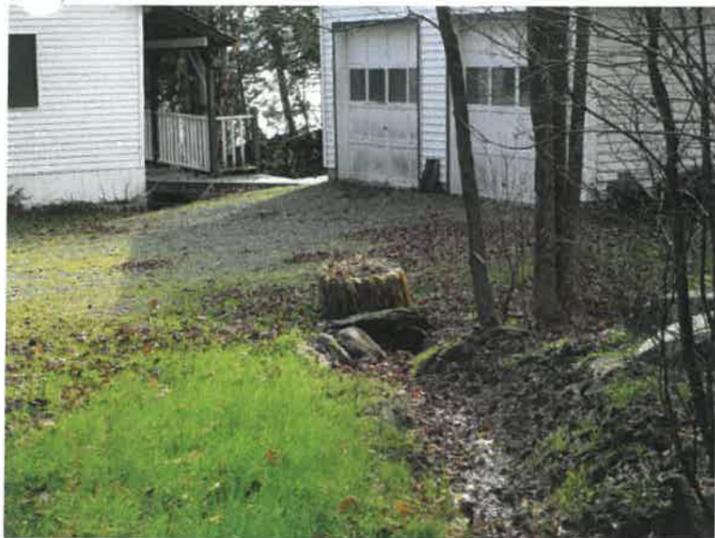
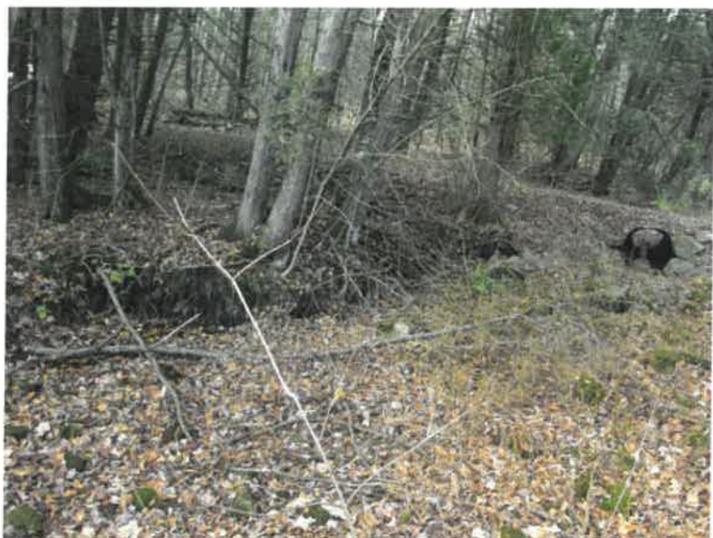
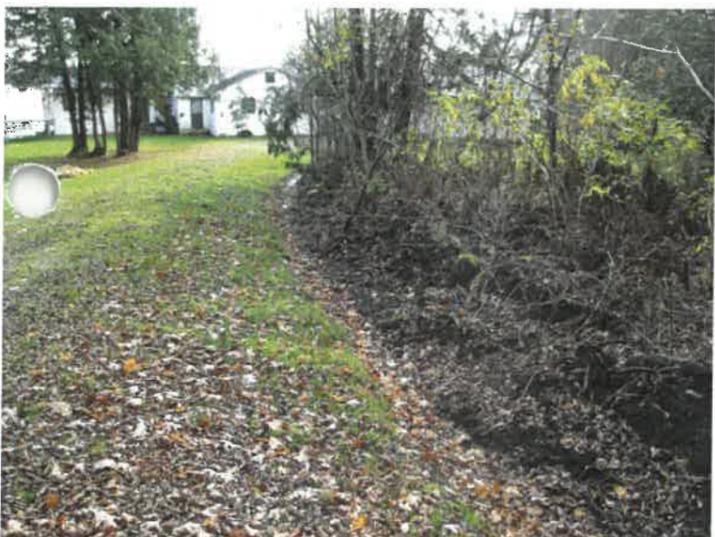
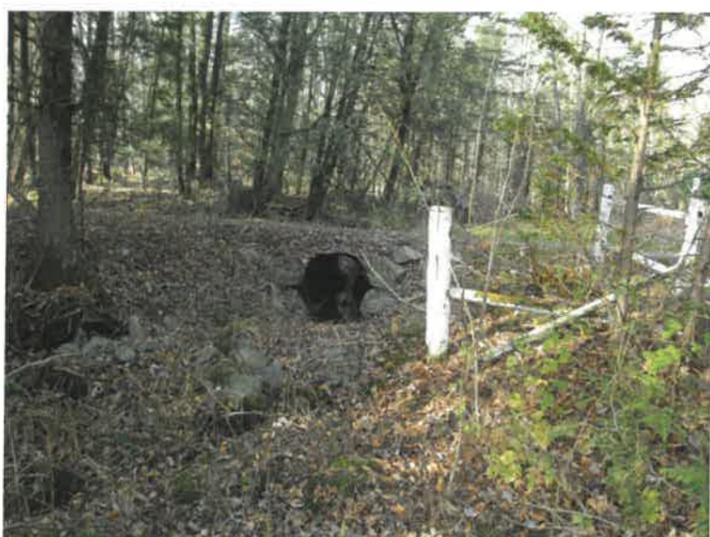
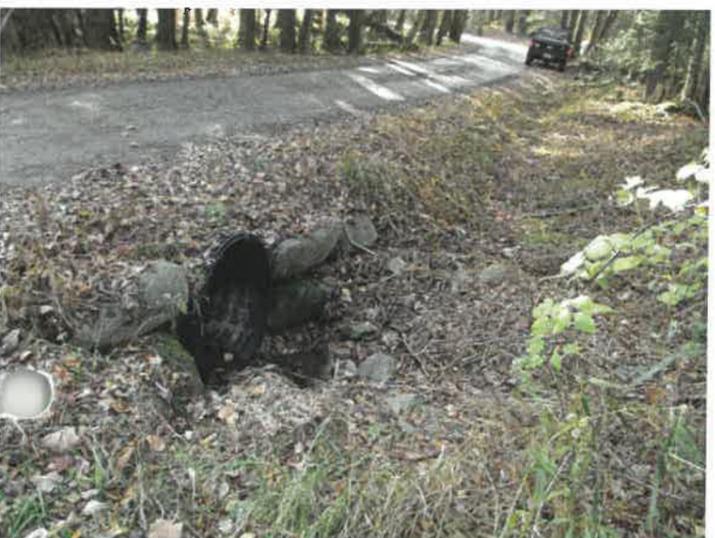
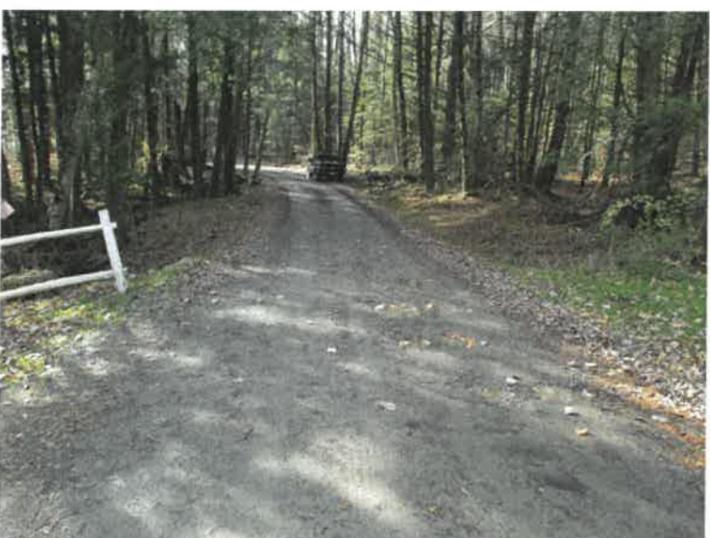
Patton Shore (4) Pictures

Franklin Watershed		Infrastructure Site Inventory for Water Quality Improvements	
		Remarks:	
Road Name	683 Patton Shore Rd.	# 683 PSR	
TH #	683 N/A		
Site ID	PS - 5	Loiselle Camp	
GPS	44.98166°

72.87936°		
Drainage Structure Type: Road Ditch - Road Slope - Other	Culvert outlet - ditch		
Erosion Frequency	Spring Runoff - Rain Storms		
Dimensions	56" X 39" X 33' CMP Culvert	Good Condition	
Priority - Low - Moderate - High			
Roadway Width	12'	Traveled Way	
Surface Type	Gravel		
Road Grade: % Grade	Flat		
Distance to edge of Lake Carmi	150' +/-		
Name of Stream	N/A		
		Inv. Date: 11/05/2014	
Recommended Treatment:

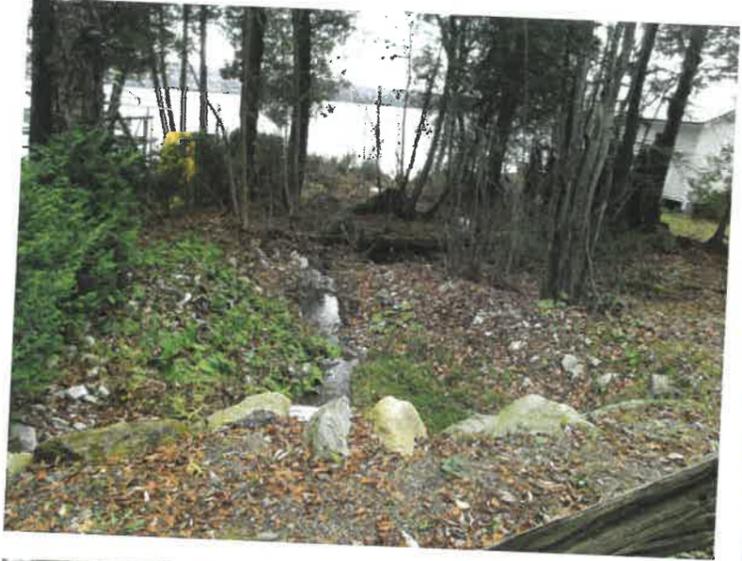
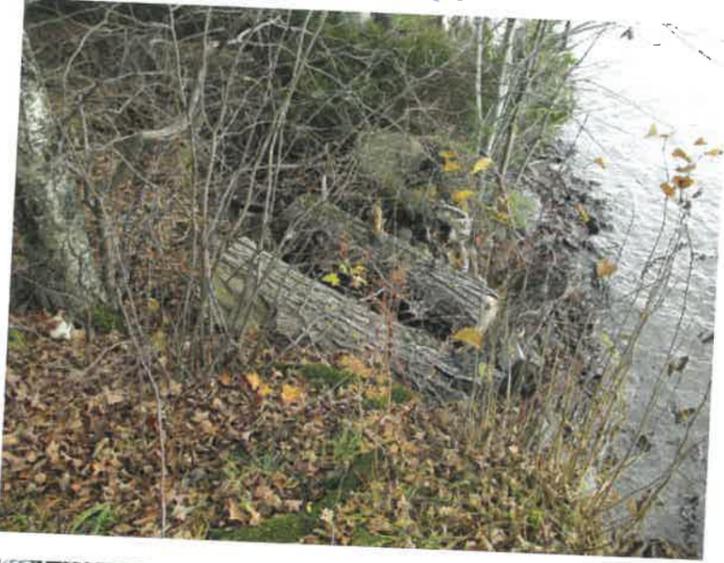
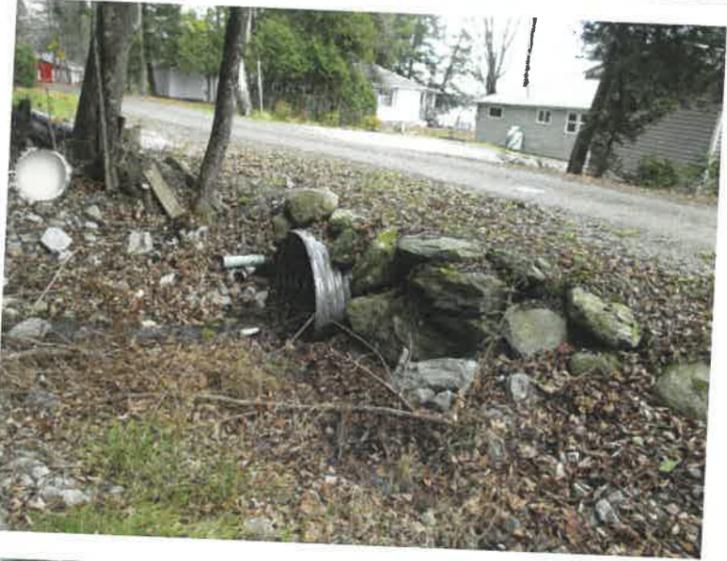
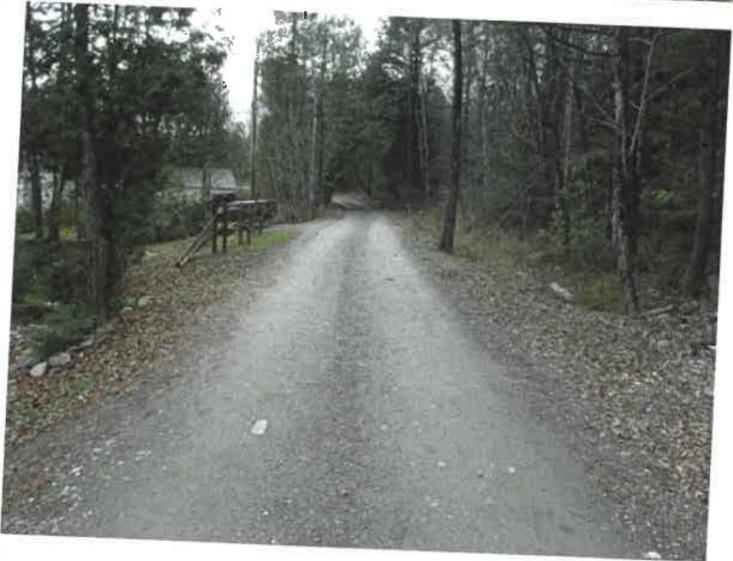
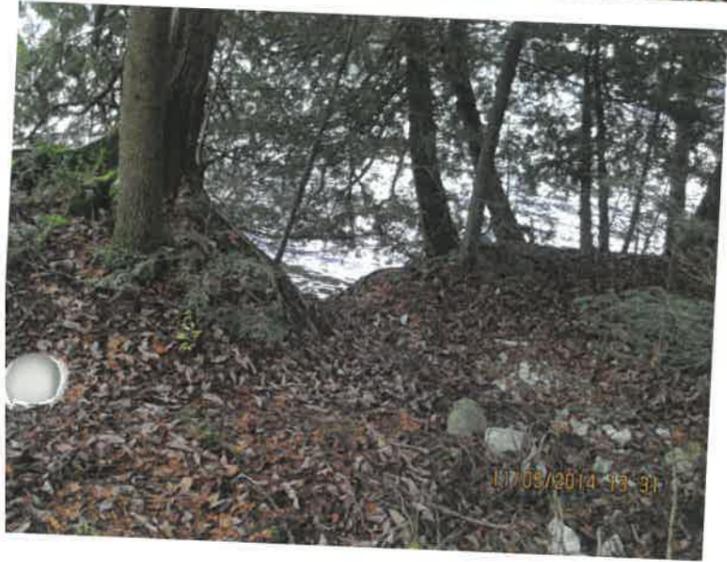
Patton Shore (5) Pictures

Road Name	735 Patton Shore Rd.	after	Remarks:
TH #	N/A	705	Patton Shore Road
Site ID	PS-6		Tatco camp
GPS	44.98321° -93110		
	72.87825° -87776		
Drainage Structure Type:	Road		
Ditch - Road Slope - Other	Culvert outlet - ditch		
Erosion Frequency	Spring Runoff - Rain Storms		
Dimensions	49" X 33" X 28' CMP Culvert		Good Condition- New
Priority - Low - Moderate - High			
Roadway Width	13'		Traveled Way
Surface Type	Gravel		
Road Grade: % Grade	Flat		
Distance to edge of Lake Carmi	140' +/-		
Name of Stream	N/A		
			Inv. Date: 11/05/2014

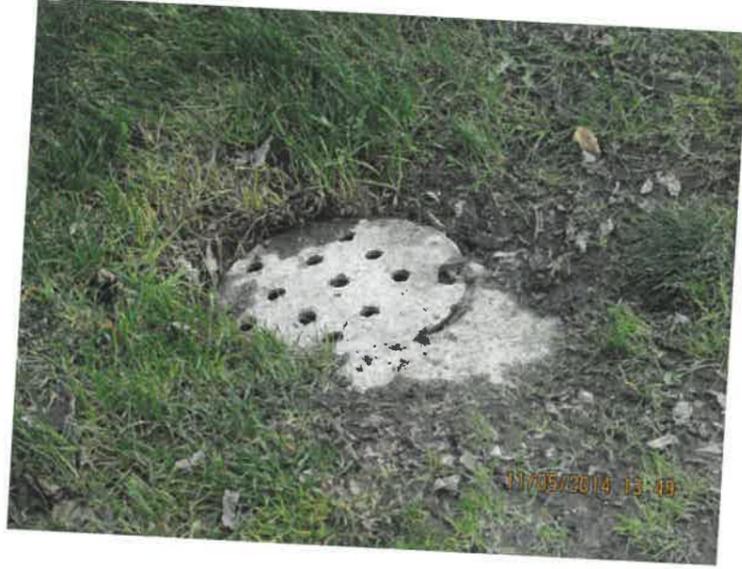
Vic's Crossing (1) Pictures

Road Name	Vic's Crossing	
TH #	N/A	
Site ID	VC- 2	
GPS	44.98910°	
	72.86622°	
Structure Type: Road - Ditch - Road Slope - Other	Roadway	Culvert inlet ditch has been stone lined
Erosion Frequency	Spring Runoff - Rain Storms	
Dimensions	12" X 140' HDPEP Culvert	Good Condition
Priority - Low - Moderate - High		
Roadway Width	12'	Traveled Way
Surface Type	Gravel	
Road Grade: % Grade	Flat	
Distance to edge of Lake Carmi	90' +/-	
Name of Stream	N/A

- Recommended Treatment:**
1. - Construct Stone Plunge Pool at culvert inlet - 12" above culvert invert elevation.
 2. - Apply gravel to crown roadway to allow for sheet runoff.

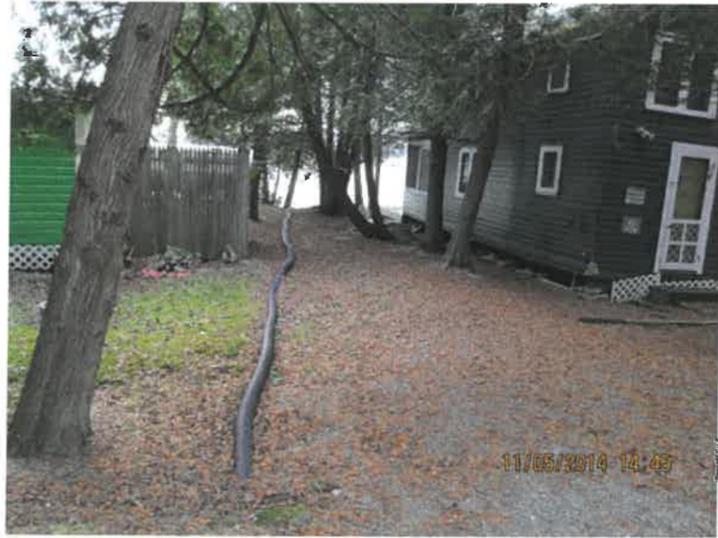
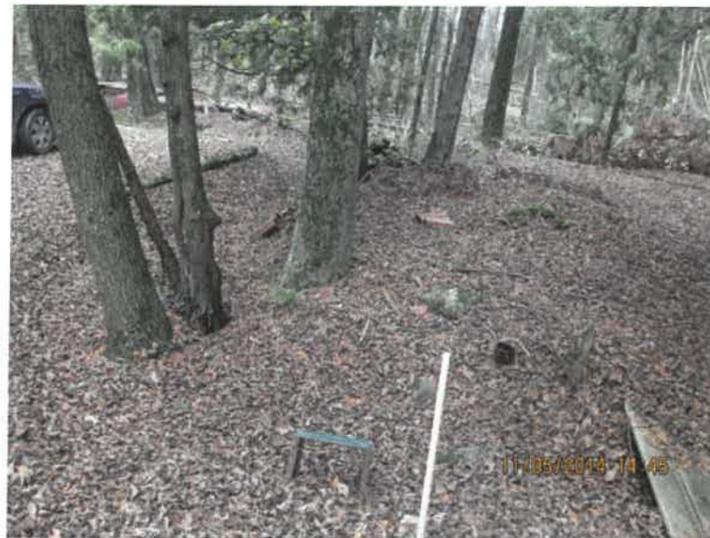
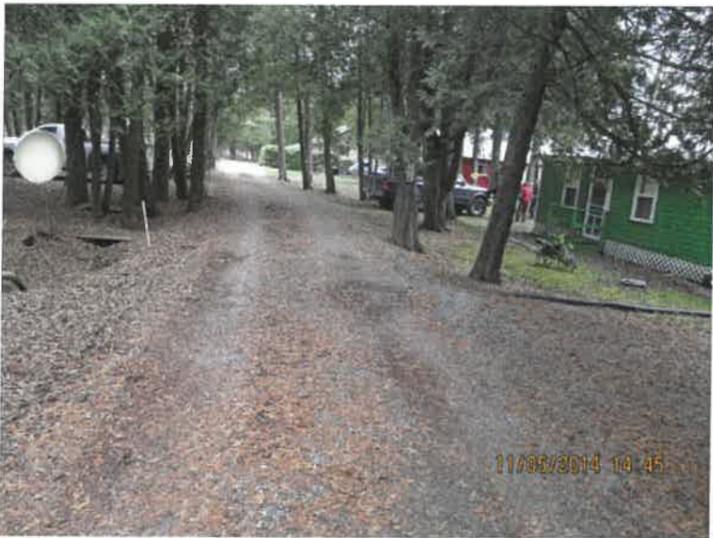
Vic's Crossing (6) Pictures

Road Name	Vic's Crossing	
TH #	N/A	
Site ID	VC- 6	
GPS	44.98759°	
	72.86494°	
Structure Type: Road - Ditch - Road Slope - Other	None	
Erosion Frequency	Spring Runoff - Rain Storms	
Dimensions	4" Flexible Plastic Pipe	
Priority - Low - Moderate - High		
Roadway Width	11	<i>Traveled Way</i>
Surface Type	Gravel	
Road Grade: % Grade	Flat	
Distance to edge of Lake Carmi	80' +/-	
Name of Stream	N/A	
		Inv. Date: 11/05/2014

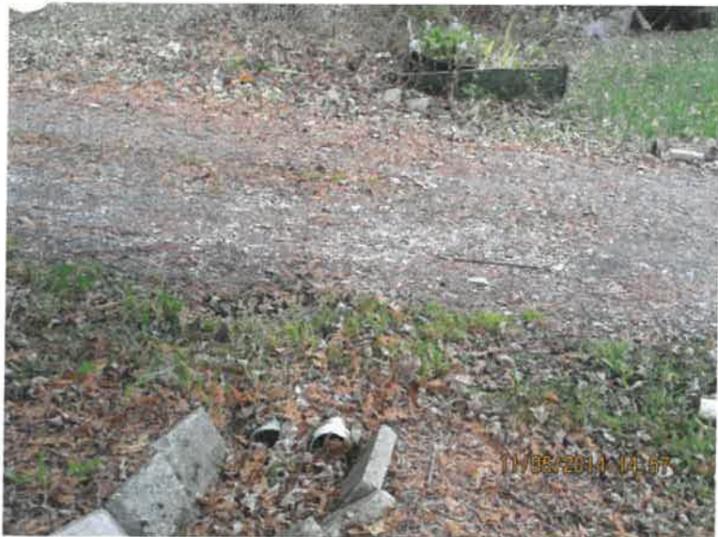
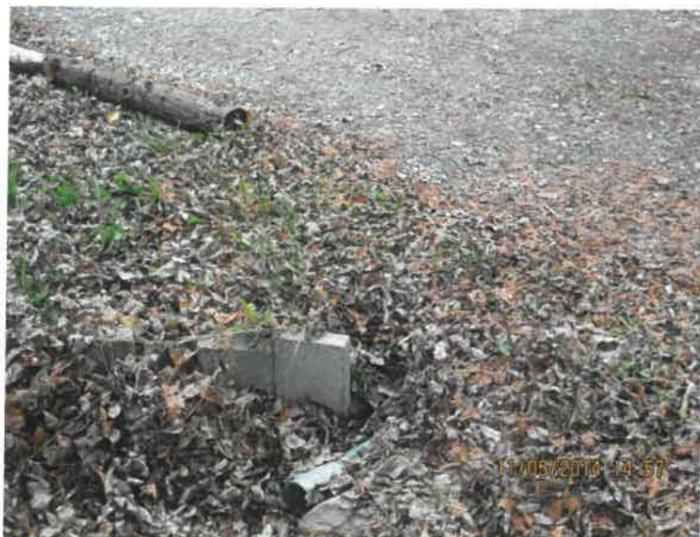
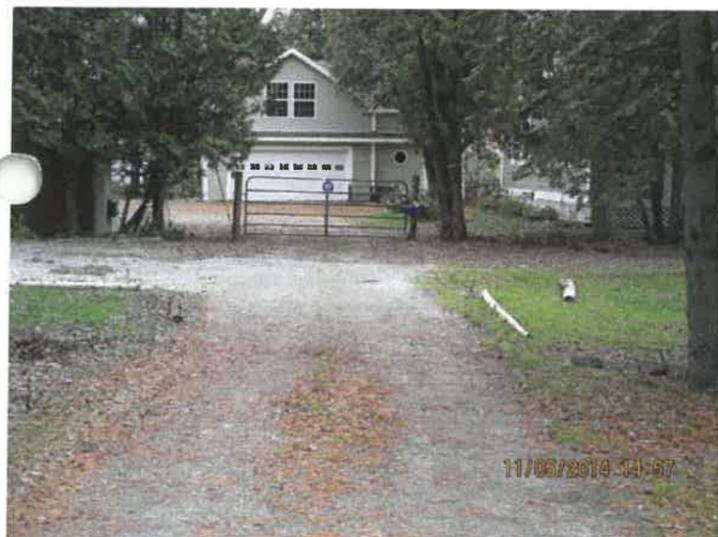
Vic's Crossing (7) Pictures

Road Name	Vic's Crossing	
TH #	N/A	
Site ID	VC- 7	
GPS	44.98694°	
	72.86415°	
Structure Type: Road - Ditch - Road Slope - Other	None	
Erosion Frequency	Spring Runoff - Rain Storms	
Dimensions	(2) 4" X 15' Flexible Drainage Pipe	
Priority - Low - Moderate - High		
Roadway Width	11	<i>Traveled Way</i>
Surface Type	Gravel	
Road Grade: % Grade	Flat	
Distance to edge of Lake Carmi	120' _/-	
Name of Stream	N/A	
		Inv. Date: 11/05/2014

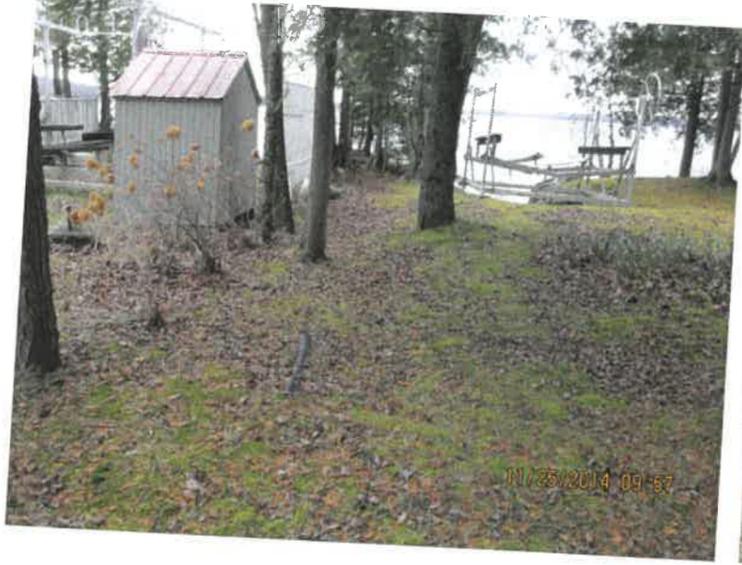
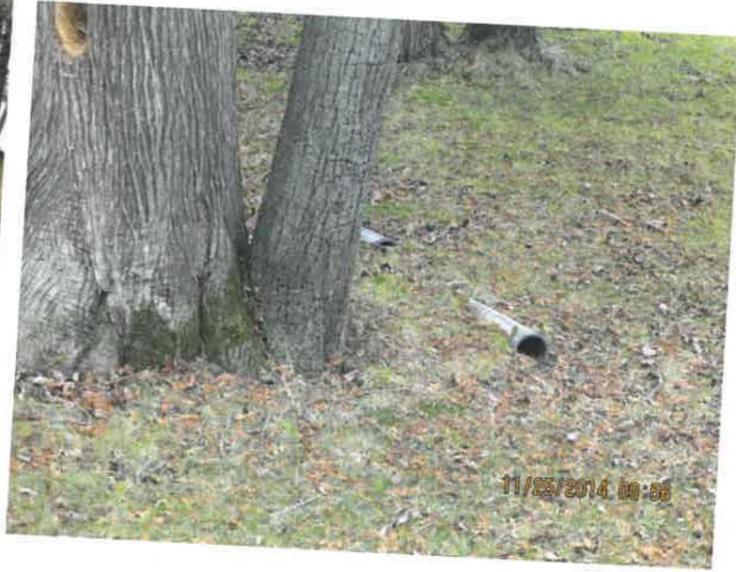
Shore Road (2) Pictures

Remarks:
Road Name	Shore Road	
TH #	n/a	
Site ID	SR - 2	
GPS	N - 44.98644°	
	W - 72.86297°	
Structure Type: Road - Ditch - Road Slope - Other	Culvert/Pipe	
Erosion Frequency	Spring Runoff - Storms	
Dimensions		
Priority - Low - Moderate - High		
Roadway Width	10'	Traveled Way
Surface Type	Gravel	
Road Grade: % Grade	Flat	
Distance to edge of Lake Carmi	100' - Road to Lake	
Name of Stream	N/A	
		Inv. Date: 11/25/2014

Recommended Treatment:
None
