LAKE CARMİ PRIVATE ROADS EROSION INVENTORY REPORT 2019

Franklin Watershed Committee

Catie Bartone, ECO AmeriCorps 2018-2019

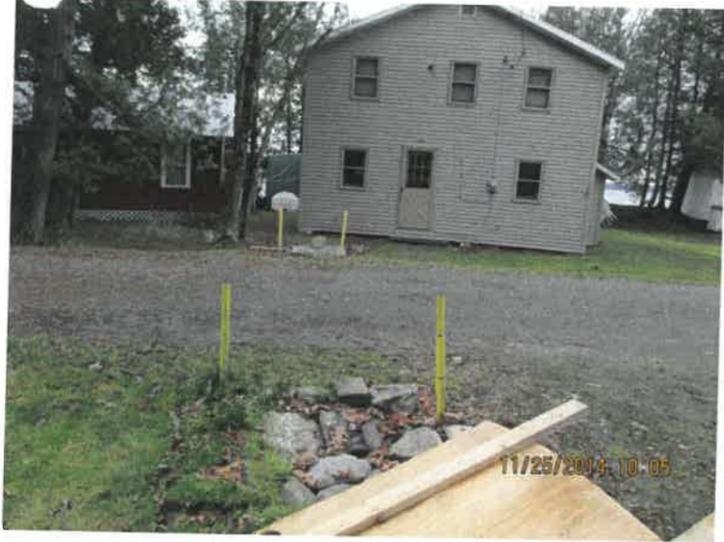
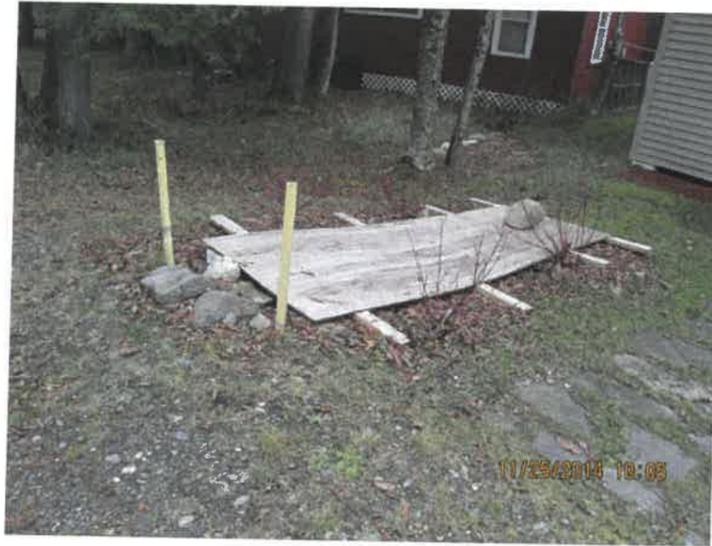
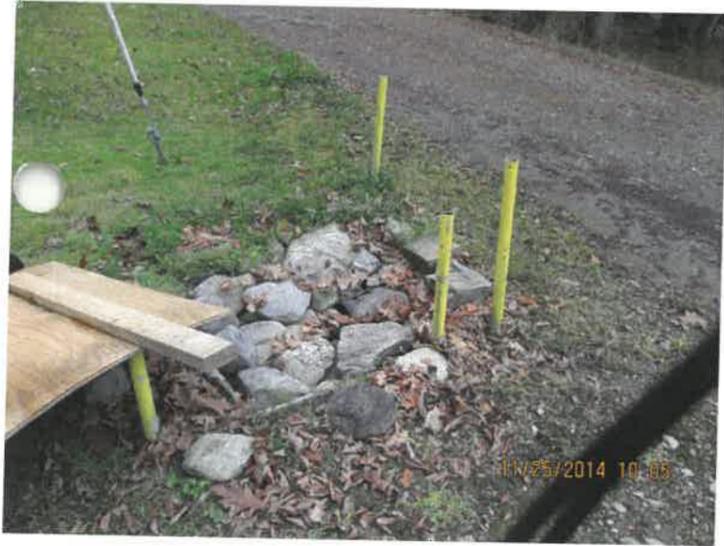
Shore Road (3) Pictures

Road Name	Hammond Shore Road	Remarks:
TH #	N/A	At intersection with Dewing Shore
Site ID	HS - 1	
GPS	N 44.98200° W 72.85298°	
Drainage StructureType: Road - Ditch - Road Slope - Other	Corrugated Metal Culvert	
Frequency	Spring Runoff & Rain Storms	
Dimensions	18" X ?	Can not find inlet
Priority - Low - Moderate - High		
Roadway Width	20'	Traveled Way
Surface Type	Gravel	
Road Grade: % Grade	Flat	
Distance to edge of Lake Carmi	50' +/-	
Name of Stream	N/A	
Recommended Treatment:		Inv. Date: 11/25/2014

Recommended Treatment:
Existing 6"X 20' Plastic culvert under road with Stone Lined inlet and outlet. Looks like a proper treatment.
No recommended treatment.

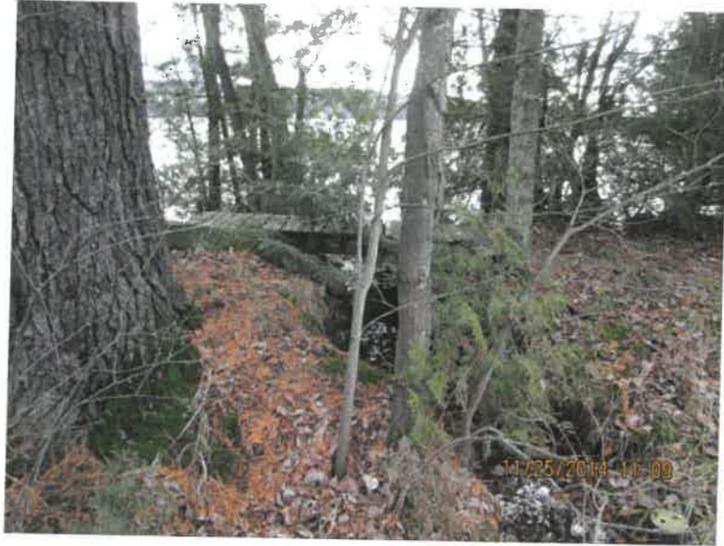
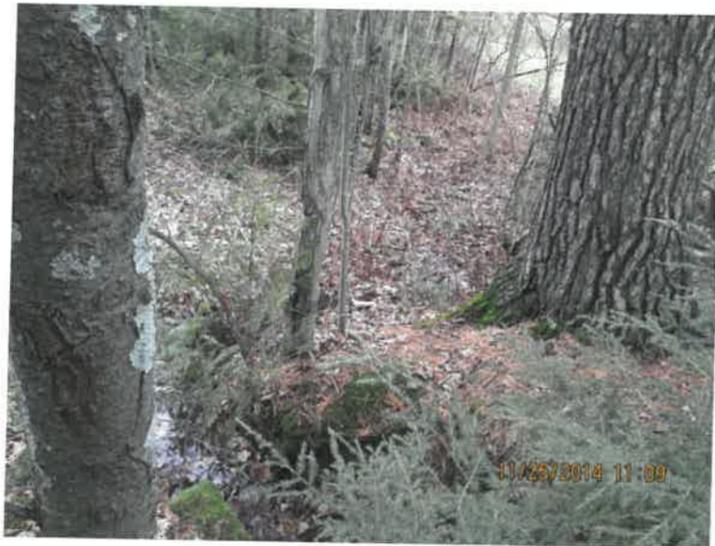
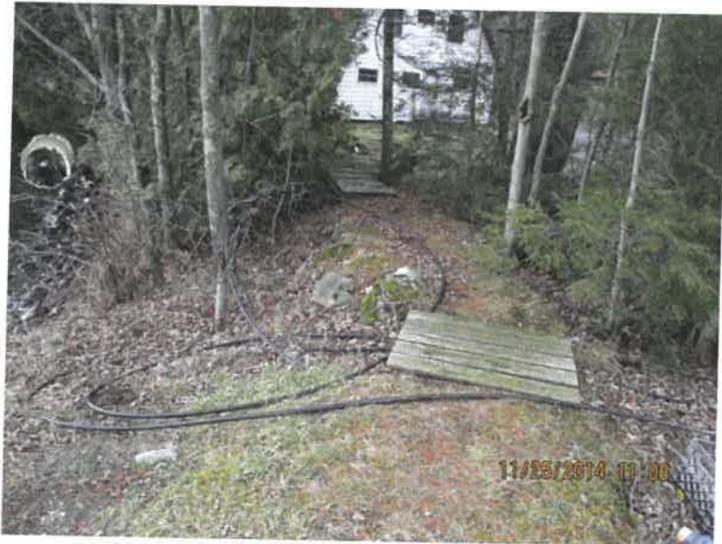
Kings Court (1) Pictures

Franklin Watershed		
Infrastructure Site Inventory for Water Quality Improvements		
		Remarks:
Road Name	Kings Court	
TH #		between
Site ID	KC - 1	
GPS	N - 44.98634°	66 King's Cut
	W - 72.85961°	at Lake
Drainage Structure Type: Road - Ditch - Road Slope - Other	Ditch/Swale	
Erosion Frequency	Spring Runoff/ Storms	runoff → TWSing
Dimensions	n/a	
Priority - Low - Moderate - High		
Roadway Width	n/a	Traveled Way
Surface Type	n/a	
Road Grade: % Grade	Flat	
Distance to edge of Lake Carmi	At Lake's edge	
Name of Stream	N/A	
		Inv. Date: 11/25/2014
Recommended Treatment:		
1. - Construct Stone Check Dam upstream of Foot Bridge 15' from lake's edge. (4 C.Y.) 2.- Stone Line ditch betwee check dam and lake. (2 C.Y.)		
<p style="text-align: center;">9' m estimate</p>		
Estimated Cost:		
See attached Sheet.		
Notes:

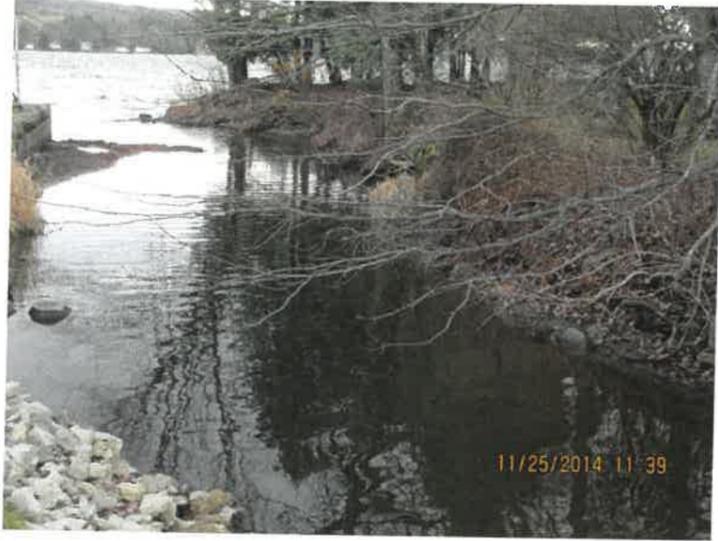
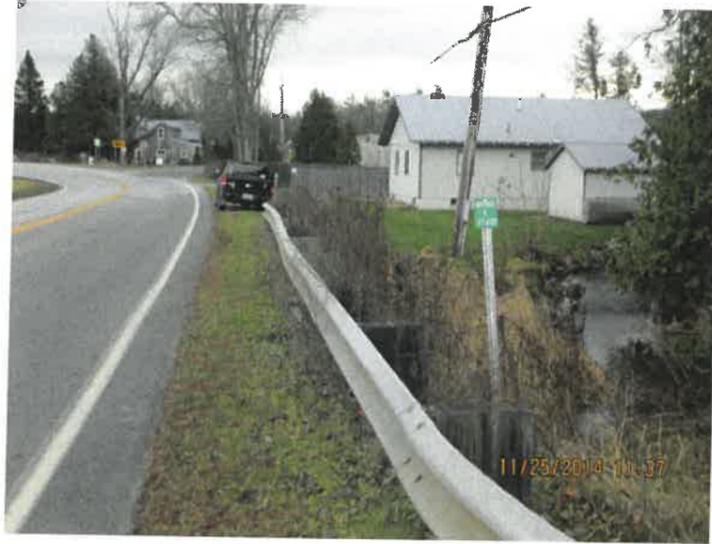
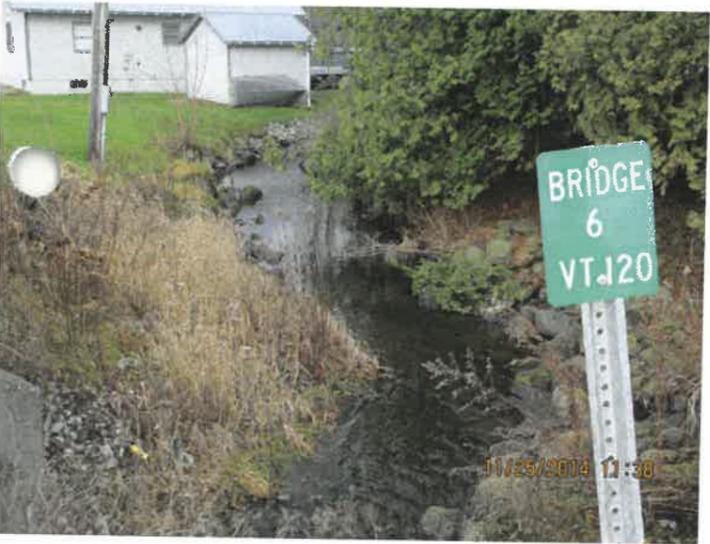
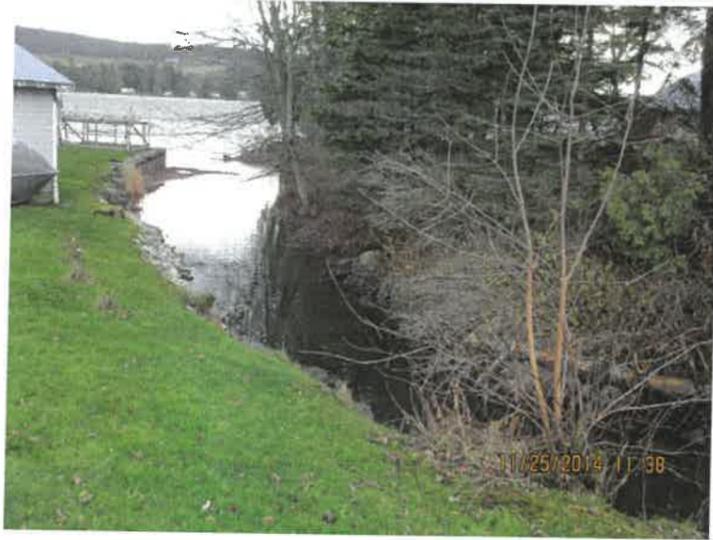
VT 120 Bridge 6 (1) Pictures

Some work has been done

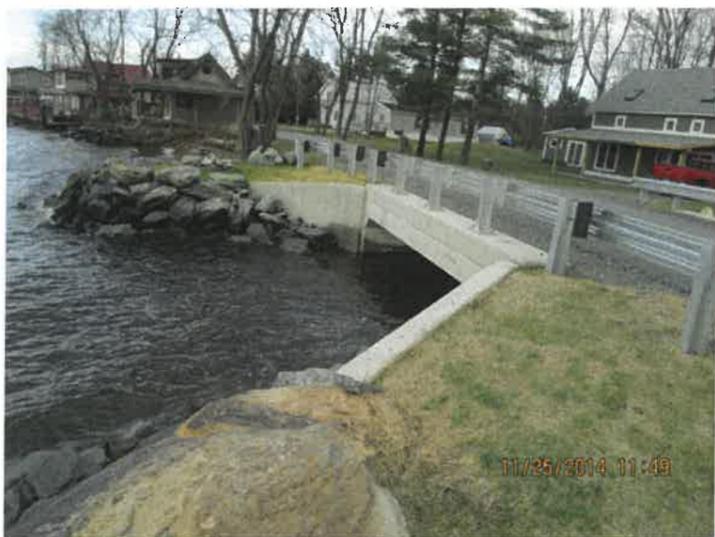
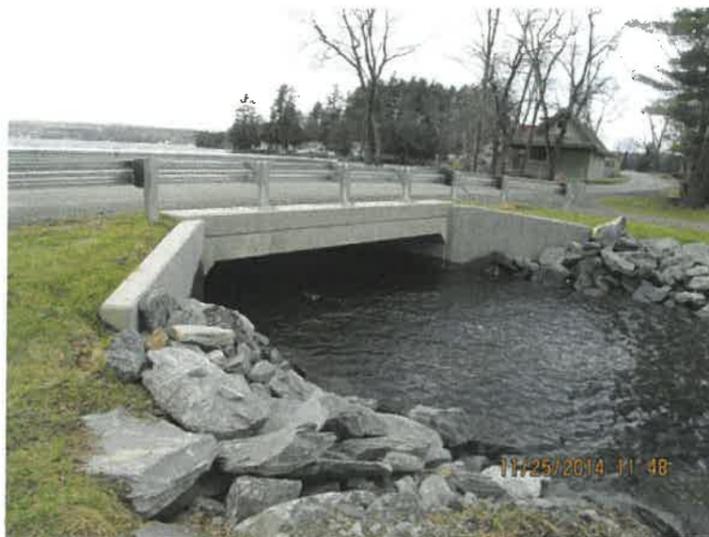
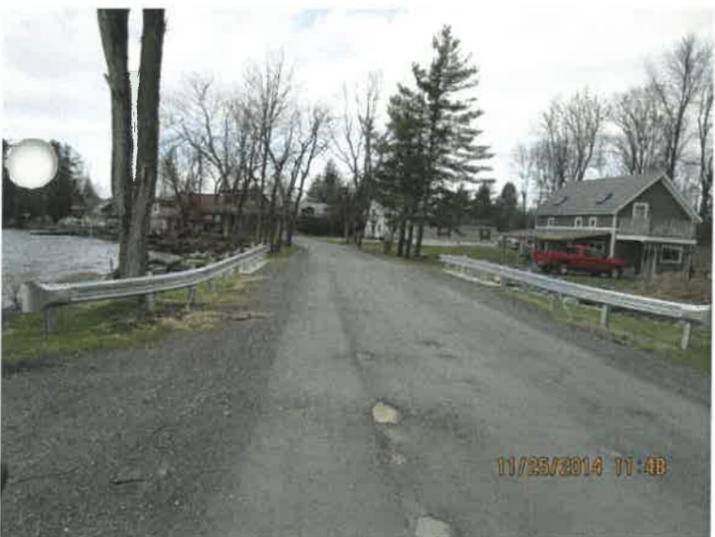
Dewing Shore (1) Pictures

Franklin Watershed		
Infrastructure Site Inventory for Water Quality Improvements		
		Remarks:
Road Name	Dewing Shore	
TH #	TH 18	
Site ID	DS - 1	
GPS	N 44.98607°	
	W 72.85473°	
Drainage Structure Type: Road - Ditch - Road Slope - Other	Concrete Bridge	New 2014
Erosion Frequency	Spring Runoff & Rain Storms	
Dimensions	20'X5'	24' wide roadway width
Priority - Low - Moderate - High		
Roadway Width	24'	Traveled Way
Surface Type	Gravel	
Road Grade: % Grade	Flat	
Distance to edge of Lake Carmi	At lake's edge	
Name of Stream	Lake Carmi Outlet	
		Inv. Date: 11/25/2014
Recommended Treatment: No Recommendations		
Estimated Cost: See attached Sheet.		
Notes:

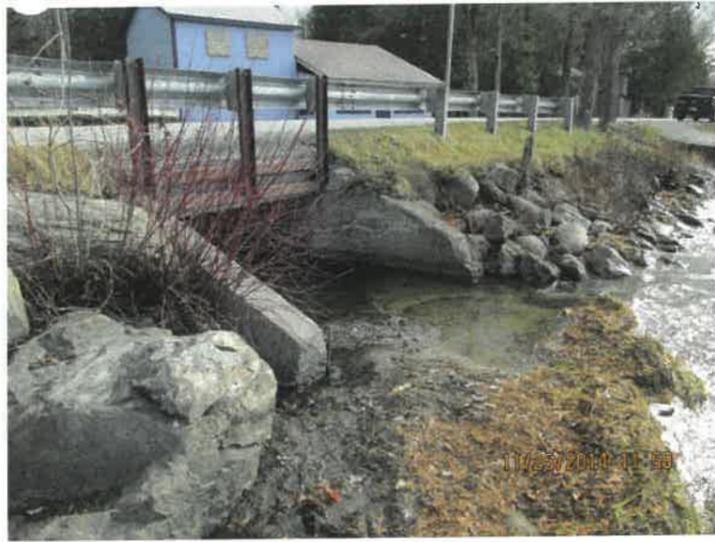
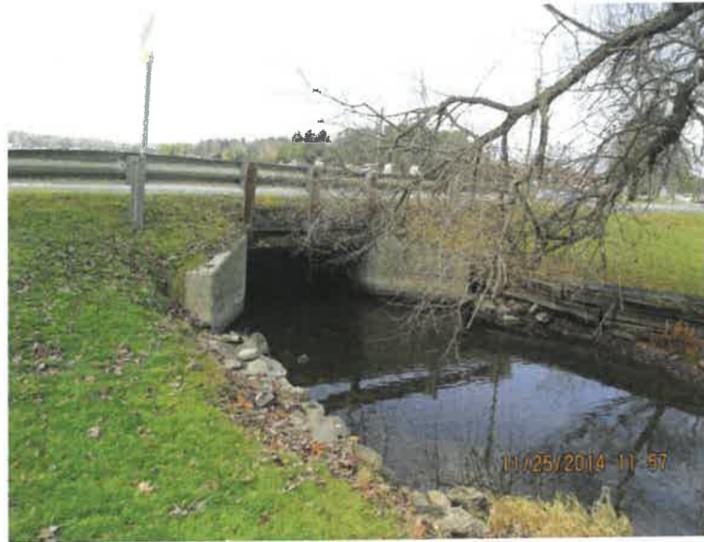
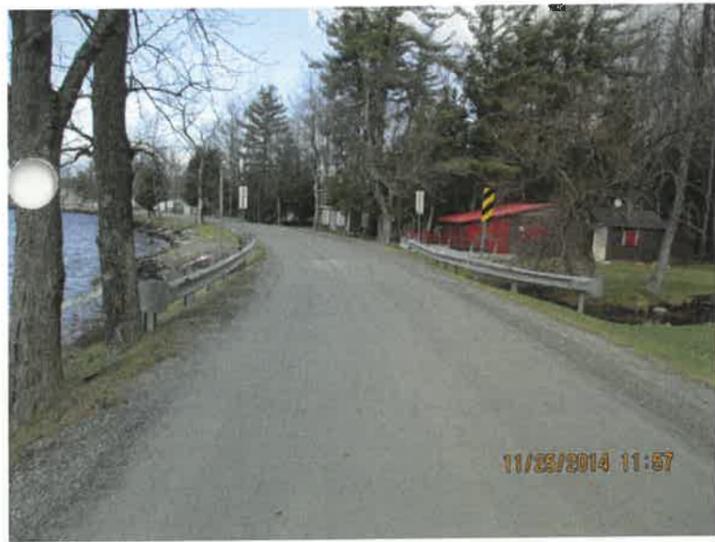
Dewing Shore (2) Pictures

Franklin Watershed		
Infrastructure Site Inventory for Water Quality Improvements		
		Remarks:
Road Name	Dewing Shore	
TH #	TH 18	
Site ID	DS - 2	
GPS	N 44.98460°	
	W 72.85357°	
Drainage Structure Type: Road - Ditch - Road Slope - Other	Concrete Bridge	
Erosion Frequency	Spring Runoff & Rain Storms	
Dimensions	8'X3.5'	21' wide
Priority - Low - Moderate - High		
Roadway Width	31'	Traveled Way
Surface Type	Gravel	
Road Grade: % Grade	Flat	
Distance to edge of Lake Carmi	At lakes' edge	
Name of Stream	N/A	
		Inv. Date: 11/25/2014
Recommended Treatment:		
Estimated Cost: See attached Sheet.		
Notes:

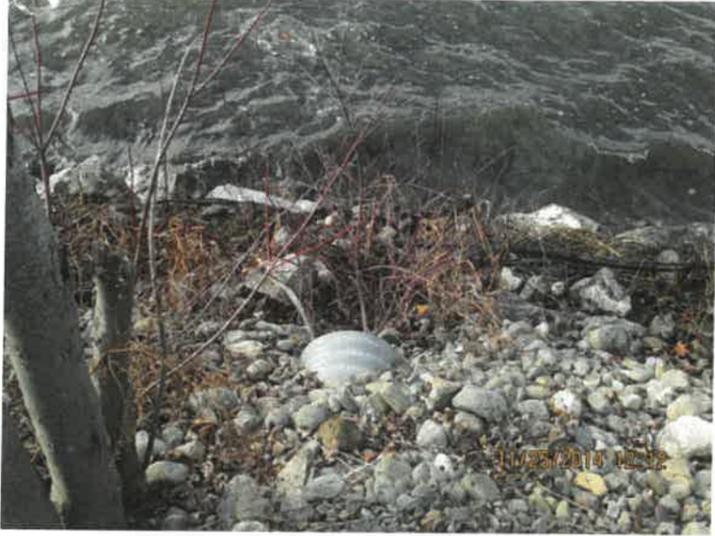
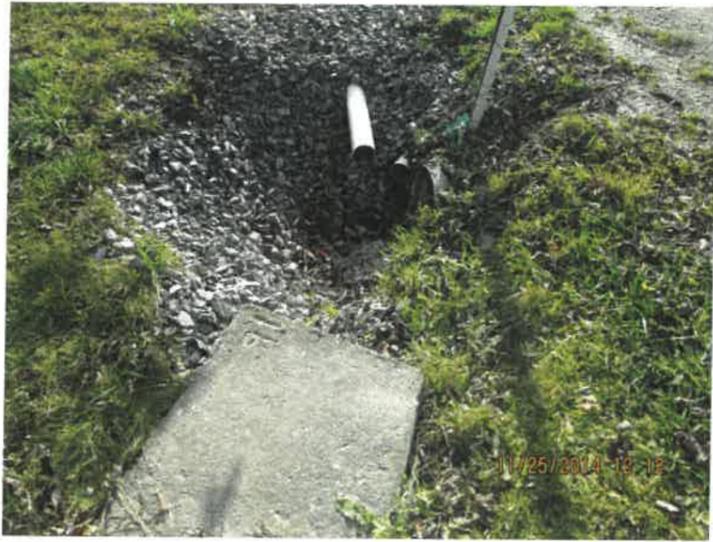
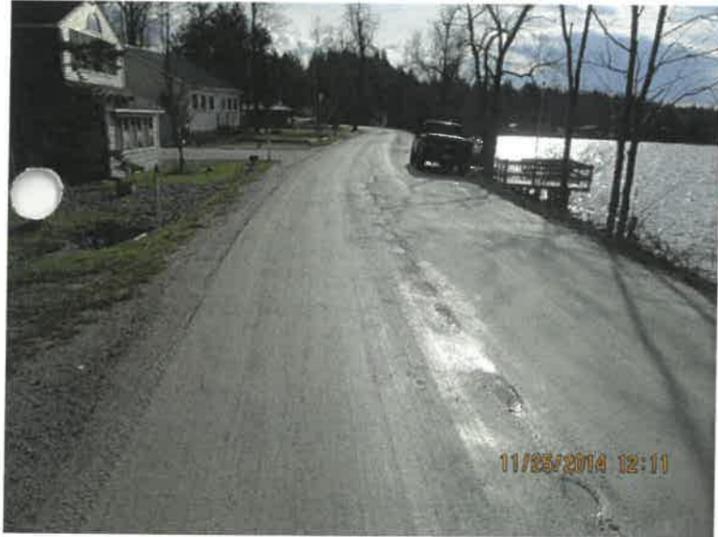
Dewing Shore (3) Pictures

Remarks:
Road Name	Dewing Shore	
TH #	TH 18	
Site ID	DS - 3	
GPS	N 44.98292°	
	W 72.85322°	
Drainage Structure Type: Road - Ditch - Road Slope - Other	Culvert	
Erosion Frequency	Spring Runoff & Rain Storms	
Dimensions	15" X 32' Corrugated Metal Culvert	Good Condition
Priority - Low - Moderate - High		
Roadway Width	18'	Traveled Way
Surface Type	Gravel	
Road Grade: % Grade	Flat	
Distance to edge of Lake Carmi	5'	
Name of Stream	N/A	
		Inv. Date: 11/25/2014

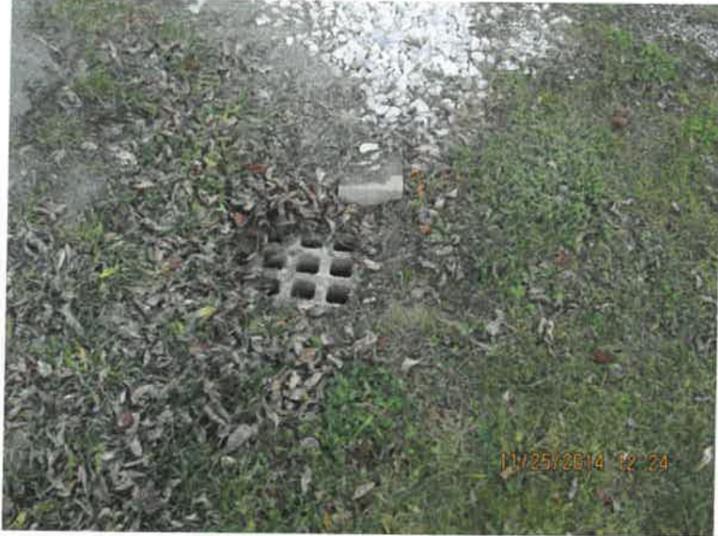
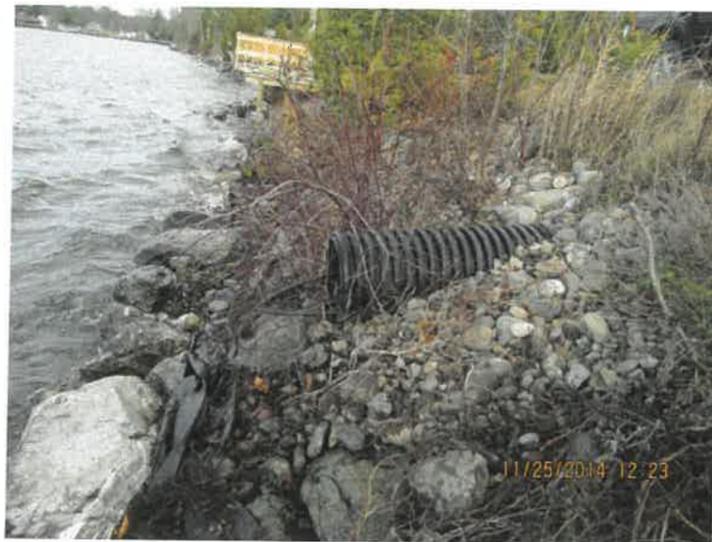
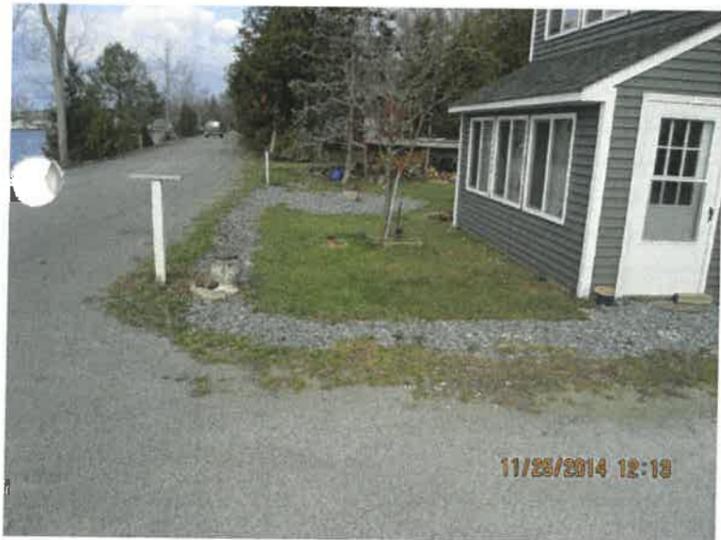
Dewing Shore (4) Pictures

Franklin Watershed		
Infrastructure Site Inventory for Water Quality Improvements		
		Remarks:
Road Name	Dewing Shore	
TH #	TH 18	
Site ID	DS - 4	
GPS	N 44.98265°	
	W 72.85316°	
Drainage Structure Type: Road - Ditch - Road Slope - Other	High Density Polyethelene Pipe (HDPEP)	Drop Inlet on Inlet end.
Erosion Frequency	Spring Runoff & Rain Storms	
Dimensions	15"X36'	Drop Inlet on Inlet end.
Priority - Low - Moderate - High		
Roadway Width	20'	Traveled Way
Surface Type	Gravel	
Road Grade: % Grade	Flat	
Distance to edge of Lake Carmi	At lake's edge	
Name of Stream	N/A	
		Inv. Date: 11/25/2014
Recommended Treatment:		
Estimated Cost: Pipe		
See attached Sheet.		
Notes:

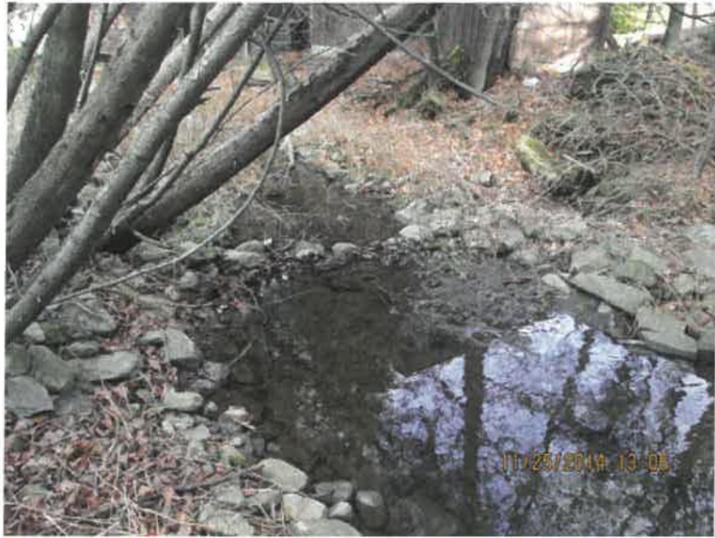
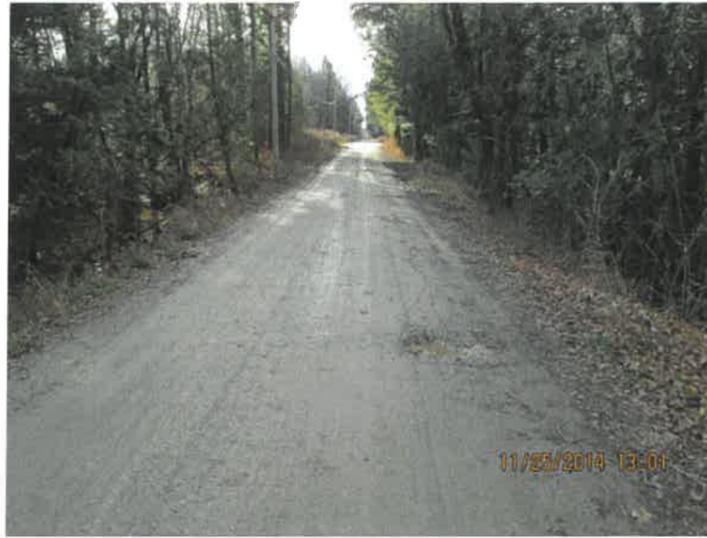
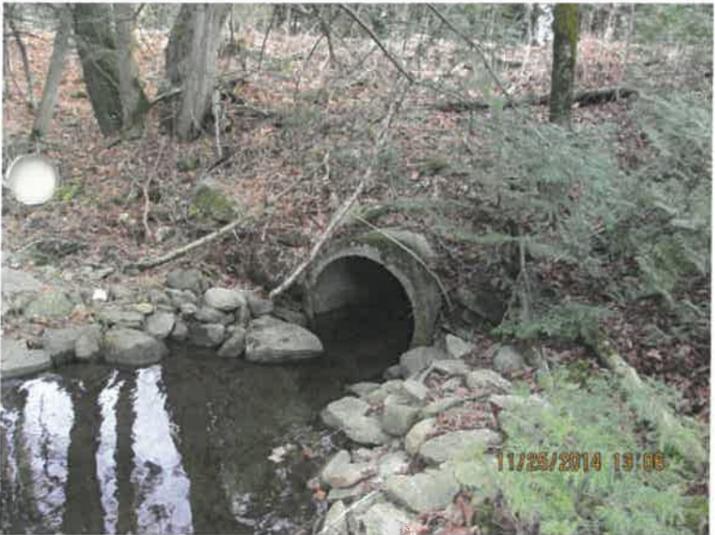
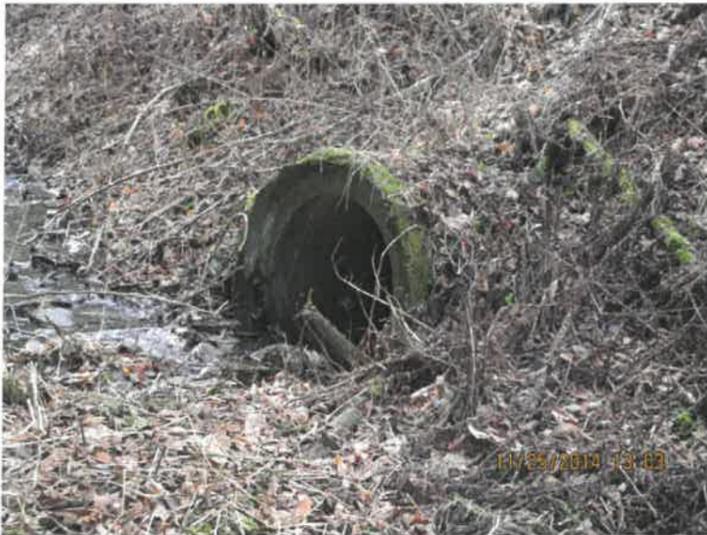
Hammond Shore (2) Pictures

Franklin Watershed		
Infrastructure Site Inventory for Water Quality Improvements		
		Remarks:
Road Name	Hammond Shore Road	
TH #	N/A	
Site ID	HS - 2	
GPS	N 44.98063°	
	W 72.85347°	
Drainage StructureType: Road - Ditch - Road Slope - Other	Reinforced Concrete Culvert	
Frequency	Spring Runoff & Rain Storms	
Dimensions	36"X 50'	
Priority - Low - Moderate - High		
Roadway Width	14'	Traveled Way
Surface Type	Gravel	
Road Grade: % Grade	Flat	
Distance to edge of Lake Carmi	100' +/-	
Name of Stream	N/A	
		Inv. Date: 11/25/2014
Recommended Treatment:	Has existing Stone Splash Pool & Check Dam

1.- Repair Splash Pool and Check Dam. 2.- Needs Headwall on Inlet end. 3.- Needs roadway embankment stabilization with Stone Fill (Type 3) 100x12x3 4.- Stone check Dam around culvert inlet. 5.- Recommend Hydraulic Study for this site prior to repairs.	
Estimated Cost:	See attached Sheet.	
	Type 1 - 141 CY Type 2 - 120 CY	
Notes:

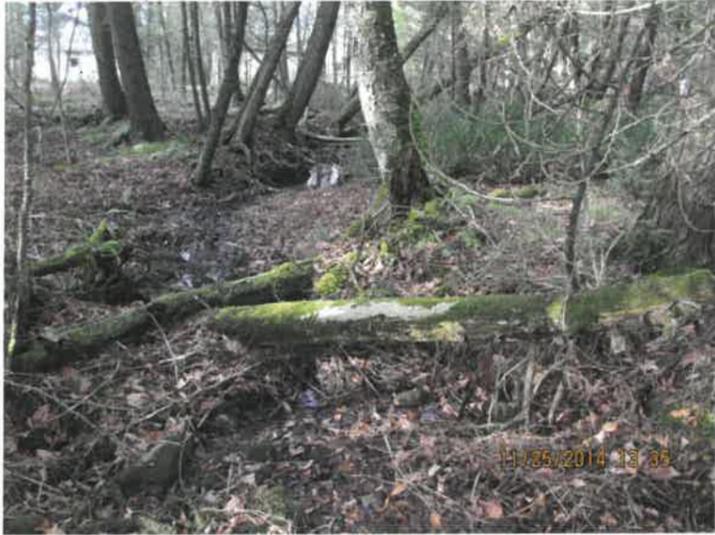
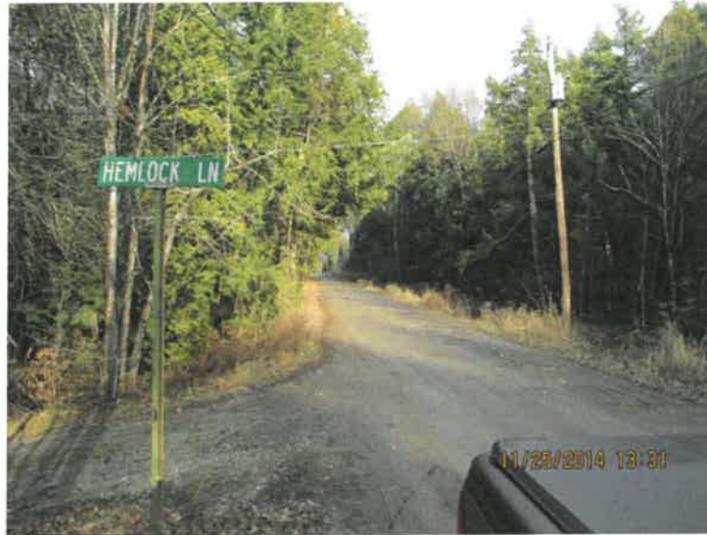
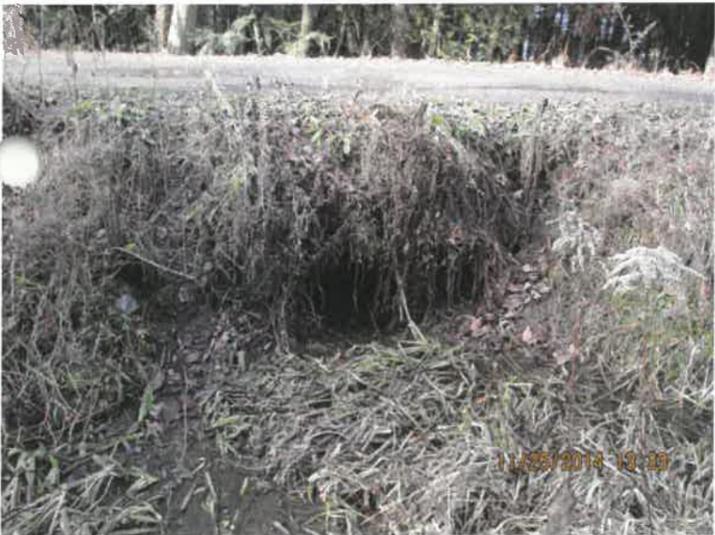
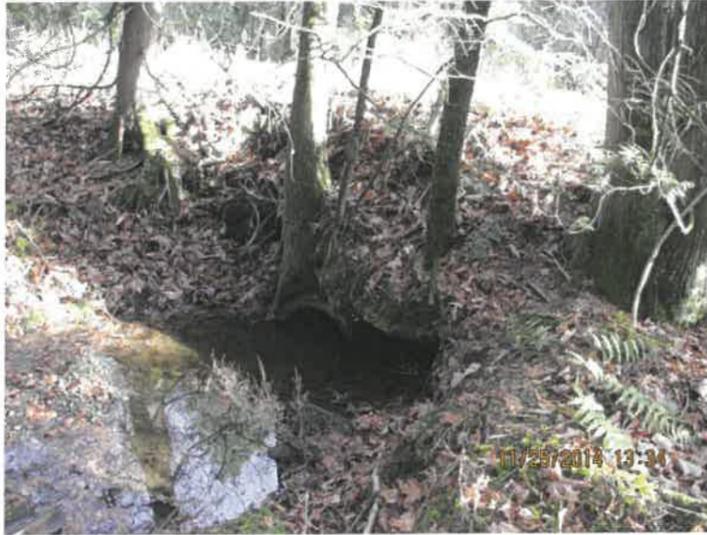
Hammond Shore (3) Pictures

Remarks:
Road Name	Hammond Shore Road	
TH #	N/A	
Site ID	HS - 3	
GPS	N 44.97820	
	W 72.85639	
Drainage StructureType: Road - Ditch - Road Slope - Other	Reinforced Concrete Culvert	Outlet end is half full.
Frequency	Spring Runoff & Rain Storms	
Dimensions	18"X24'	
Priority - Low - Moderate - High		
Roadway Width	16'	Traveled Way
Surface Type	Gravel	
Road Grade: % Grade	Flat	
Distance to edge of Lake Carmi	220' +/-	
Name of Stream	N/A	
		Inv. Date: 11/25/2014

Recommended Treatment:
1.- Recommend Hydraulic Study for this site prior to repairs.
2.-Replace Culvert - is too short for the roadway.
3.- Construct Stone Plunge Pool at culvert outlet and Stone check Dams at culvert inlet.

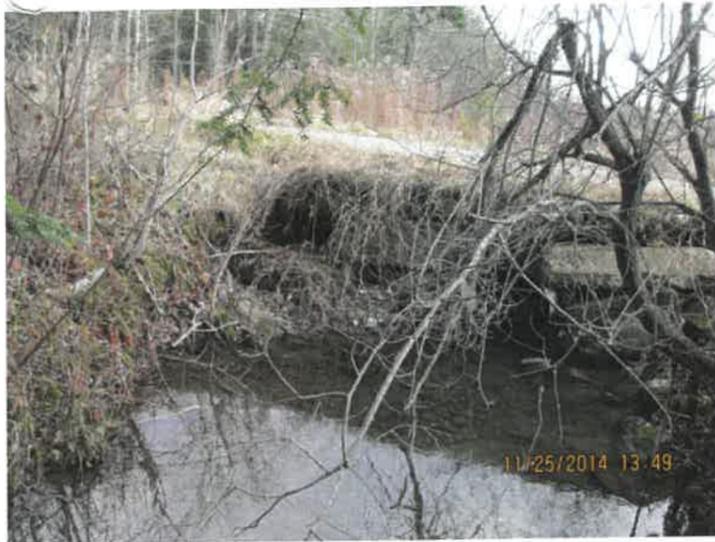
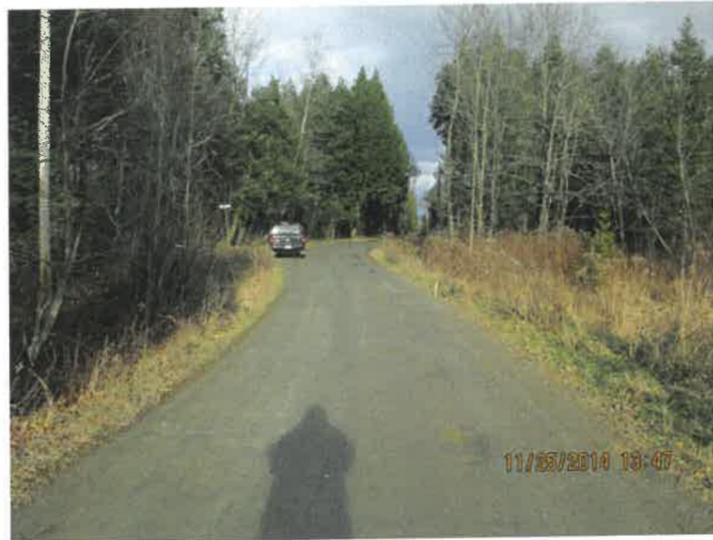
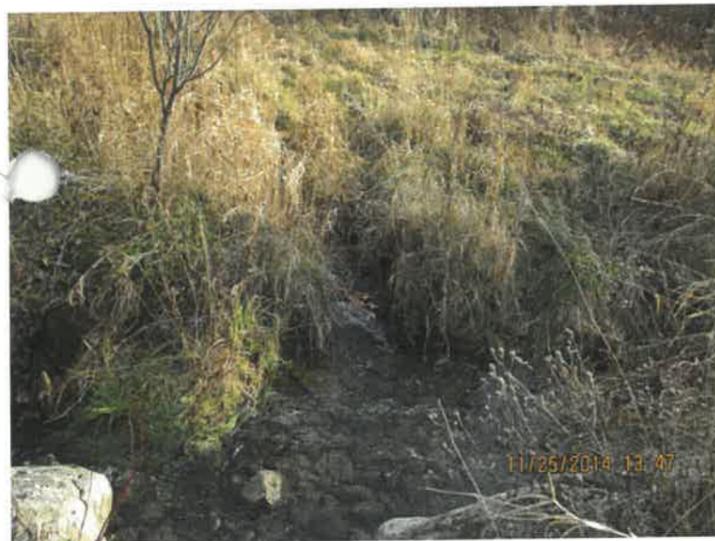
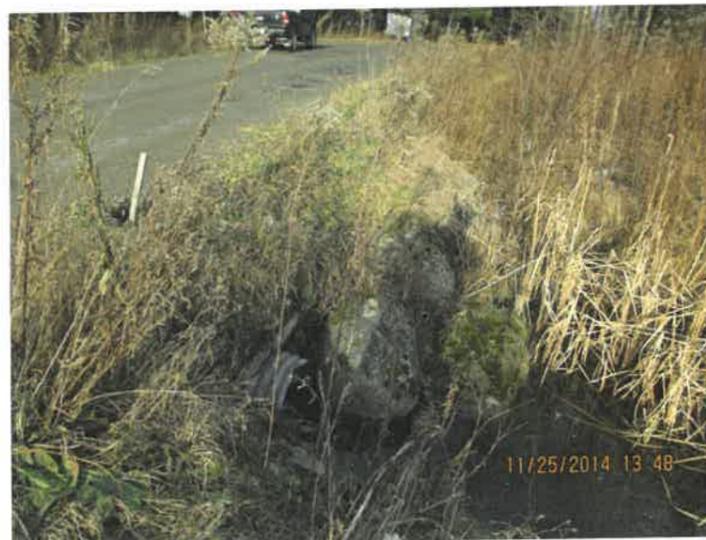
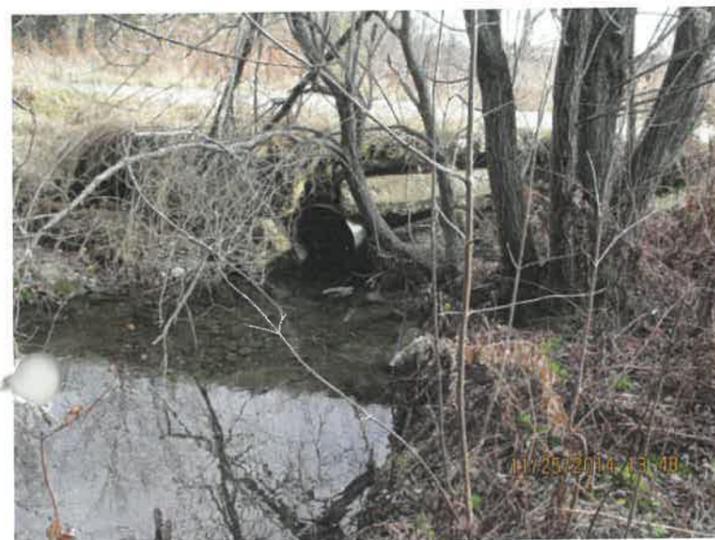
Hammond Shore (4) Pictures

Franklin Watershed		
Infrastructure Site Inventory for Water Quality Improvements		
		Remarks:
Road Name	Hammond Shore Road	
TH #	N/A	
Site ID	HS - 4	
GPS	N 44.97701	
	W 72.85793	
Drainage StructureType: Road - Ditch - Road Slope - Other	Corrugated Metal Culvert	
Frequency	Spring Runoff & Rain Storms	
Dimensions	24"X 20'	
Priority - Low - Moderate - High		
Roadway Width	13'	Traveled Way
Surface Type	Gravel	
Road Grade: % Grade	Flat	
Distance to edge of Lake Carmi	360' +/-	
Name of Stream	N/A	
		Inv. Date: 11/25/2014
Recommended Treatment: Replace Culvert 1.- Complete a Hydraulic Study 2.-Replace Culvert with redommended size. 3.- Construct Stone Plunge Pool at culvert outlet and Stone check Dams at culvert inlet.		
See attached Sheet.		
Notes:

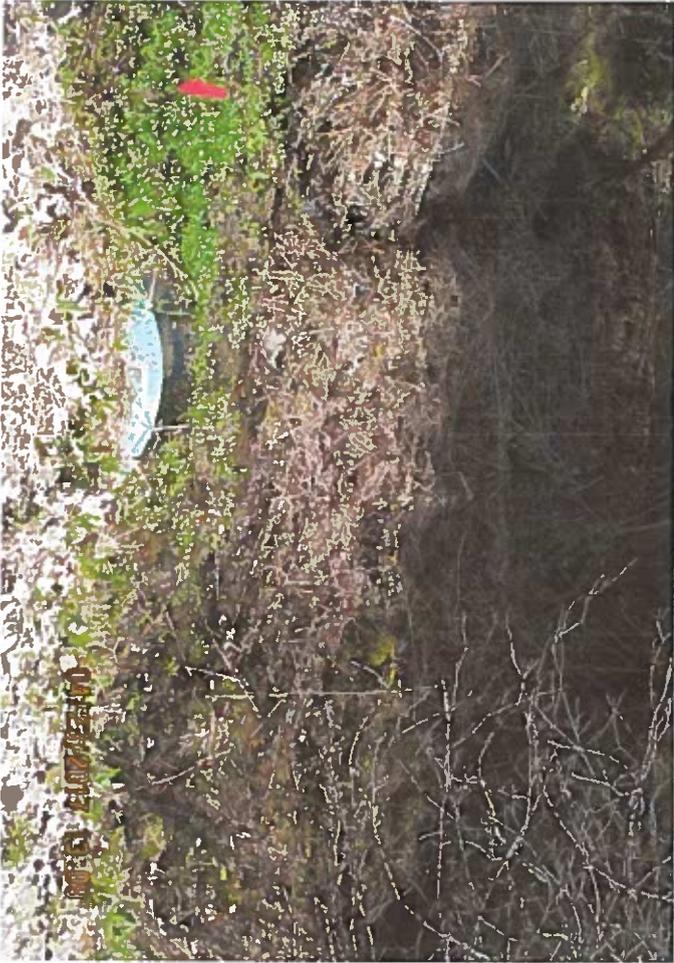
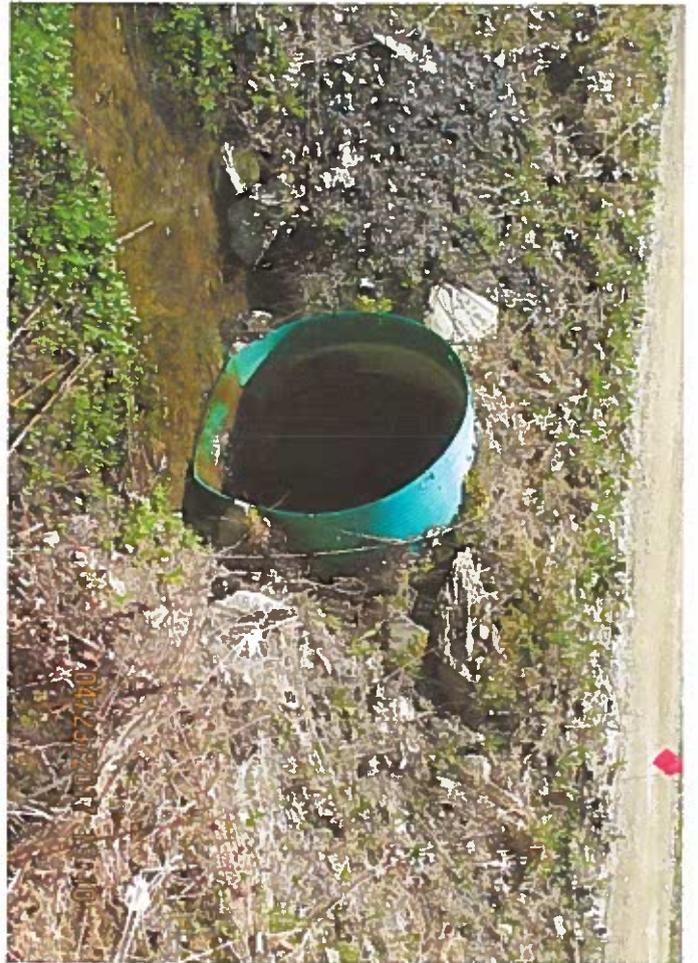
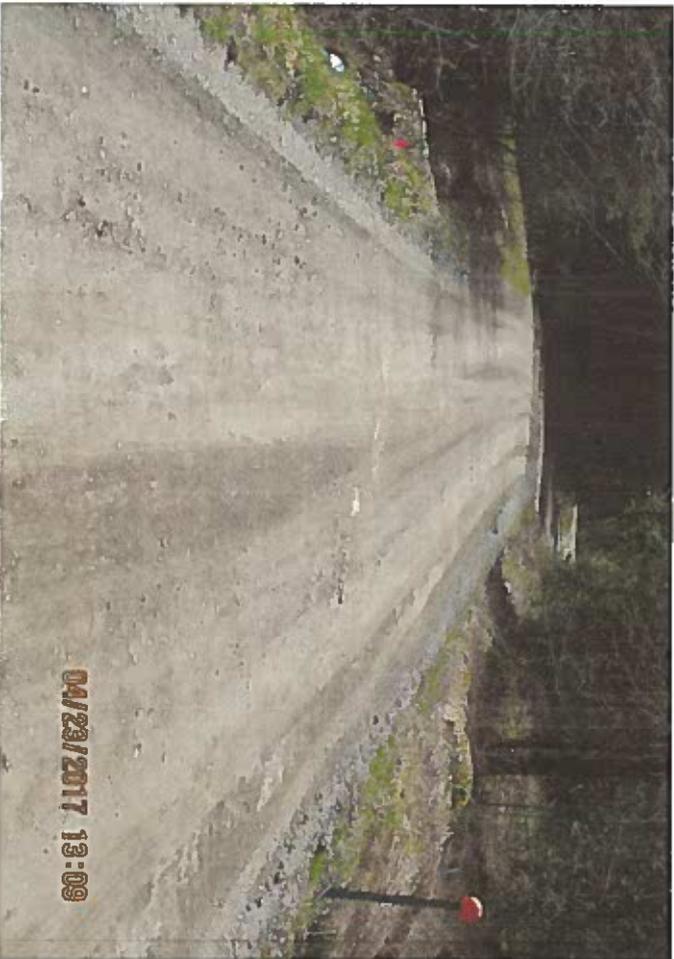
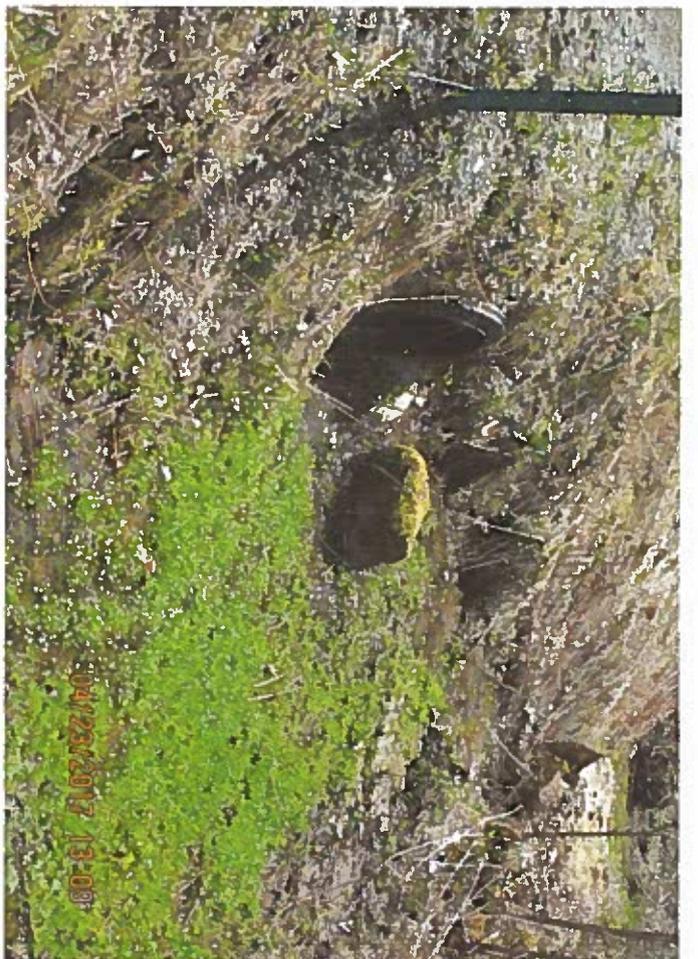
WSR-6

Franklin Watershed		Infrastructure Site Inventory for Water Quality Improvements	
		Remarks:	
Road Name	Wescott Shore Rd.		
TH #	N/A		
Site ID	WSR - 6		
GPS	N-44.96687° W-72. 89092°	40' +/- ' South of camp 187	
Drainage Structure Type: - Ditch - Road Slope - Other	Road Road Culvert - HDPEP	Good Condition	
Erosion Frequency	Spring Runoff - Rain Storms		
Dimensions	24" X 20'		
Priority - Low - Moderate - High	Low		
Roadway Width	14'	Traveled Way	
Surface Type	Gravel		
Road Grade: % Grade	0%		
Distance to edge of Lake Cami	318%		
Name of Stream			
	Inventory Date:	4/24/17	
Recommended Treatment:			
Construct 10' Round Plunge Pool - Outlet			
Check Dams north and South of Inlet in Roadway Ditches			
Estimated Cost:			
10' Round Plunge Pool - Outlet	3 C.Y, Type 1 Stone @\$50	\$	150.00

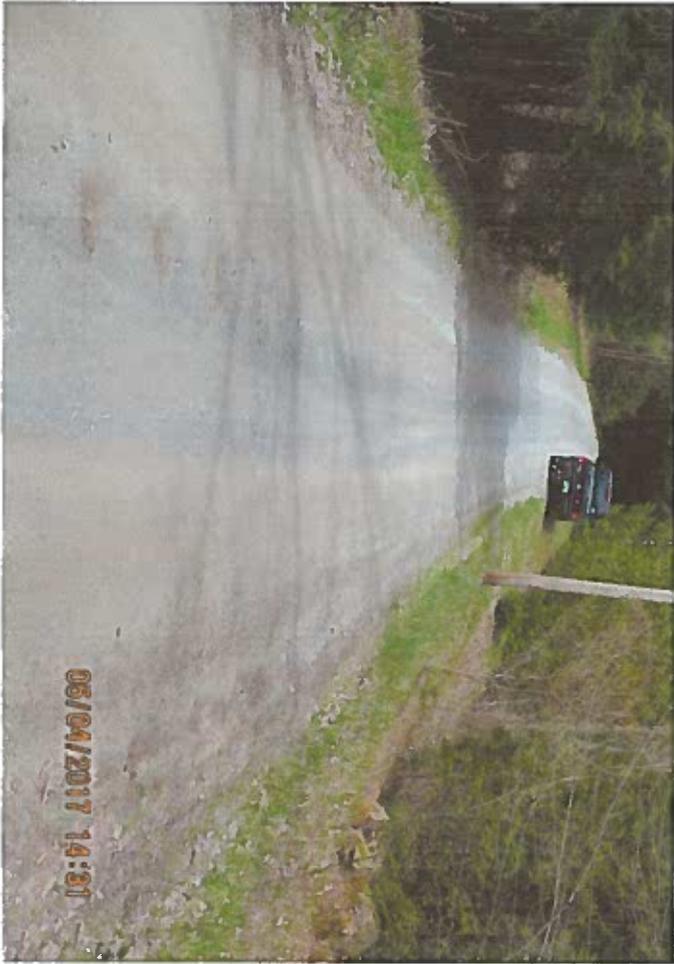
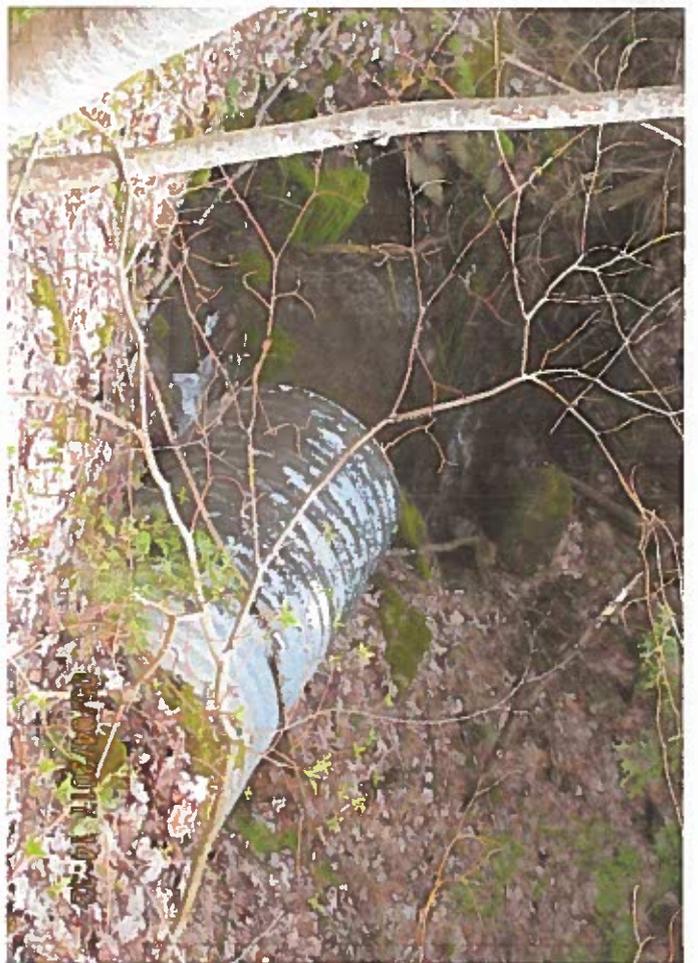
Remarks:
Road Name	Black Woods Road	
TH #	N/A	
Site ID	BWR - 3	
GPS	N-44.97506°	50' +/- North of Camp 127
	W - 72.88644°	
Drainage Structure Type: Road - Ditch - Road Slope - Other	Road Culvert - Corrugated Metal Pipe	
Erosion Frequency	Spring Runoff - Rain Storms	
Dimensions	30" X 54'	Good Condition
Priority - Low - Moderate - High	Moderate	
Roadway Width	13	Traveled Way
Surface Type	Gravel	
Road Grade: % Grade	2%	
Distance to edge of Lake Carmi	180'	
Name of Stream		
	Inventory Date:	05/04/17

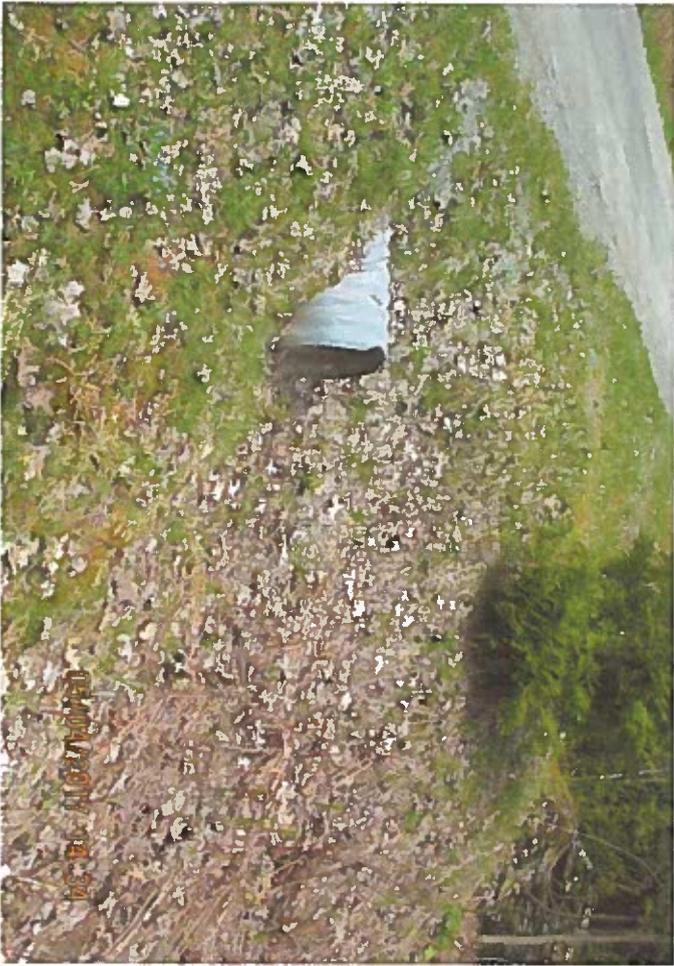
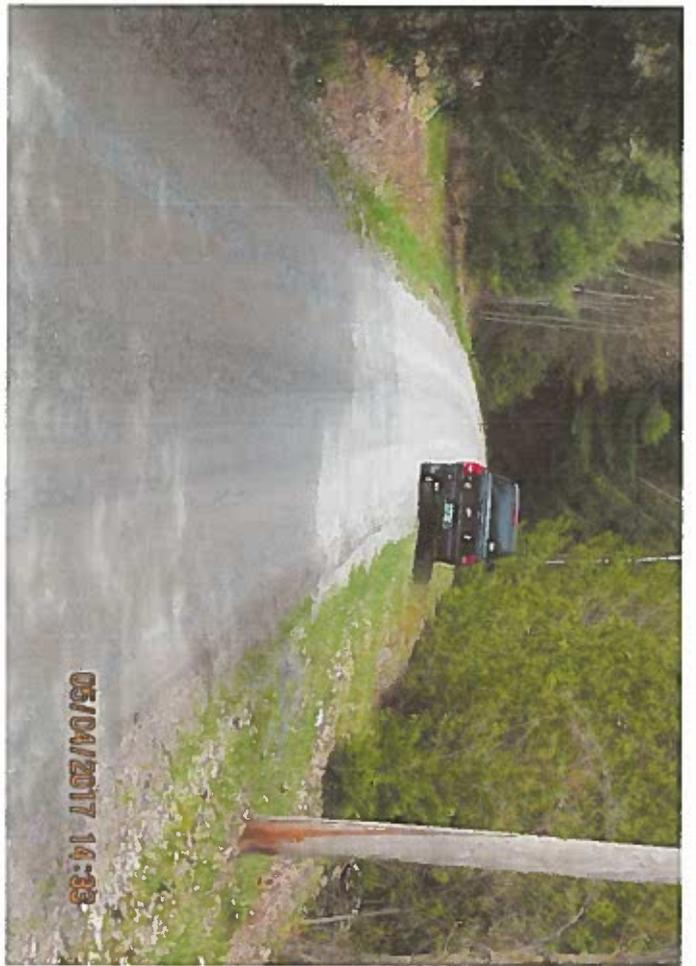
Franklin Watershed		Infrastructure Site Inventory for Water Quality Improvements
		Remarks:
Road Name	Black Woods Road	
TH #	N/A	
Site ID	BWR - 5	
GPS	N-44.97675°	60 +/- South of Sandy bay Rd.
	W - 72.88653°	
Drainage Structure Type: Road - Ditch - Road Slope - Other	Road Culvert - Concrete Pipe	
Erosion Frequency	Spring Runoff - Rain Storms	
Dimensions	18" X 60'	Fair Condition
Priority - Low - Moderate - High	Moderate	
Roadway Width	13	Traveled Way
Surface Type	Gravel	
Road Grade: % Grade	2%	
Distance to edge of Lake Carmi	345'	
Name of Stream		
	Inventory Date:	05/04/17
Recommended Treatment: 1. Stone line existing ditch (20' +/-) - Outlet. 2. Stone Check Dam on stream upstream of culvert		
Estimate		
10' Stone Check Dam	3.5 C.Y. Stone Fill- Type 1@\$50	\$175.00
20 L.F. Stone Ditch.	5 C.Y. Stone Fill- Type 1@\$50	\$250.00
	Total	\$425.00
Notes:
