LAKE CARMİ PRIVATE ROADS EROSION INVENTORY REPORT 2019

Franklin Watershed Committee

Catie Bartone, ECO AmeriCorps 2018-2019

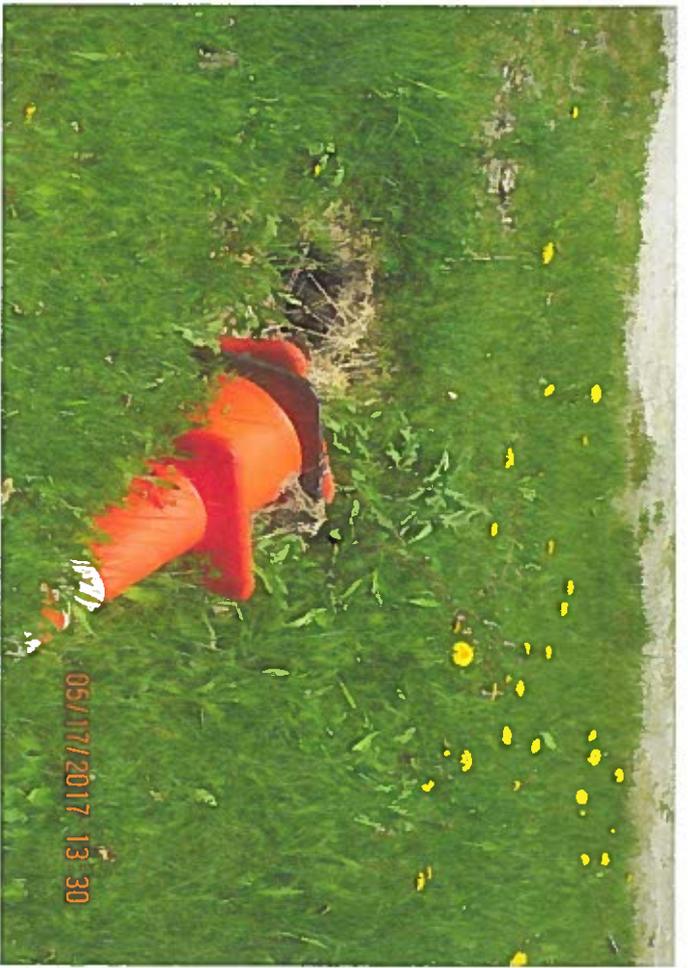
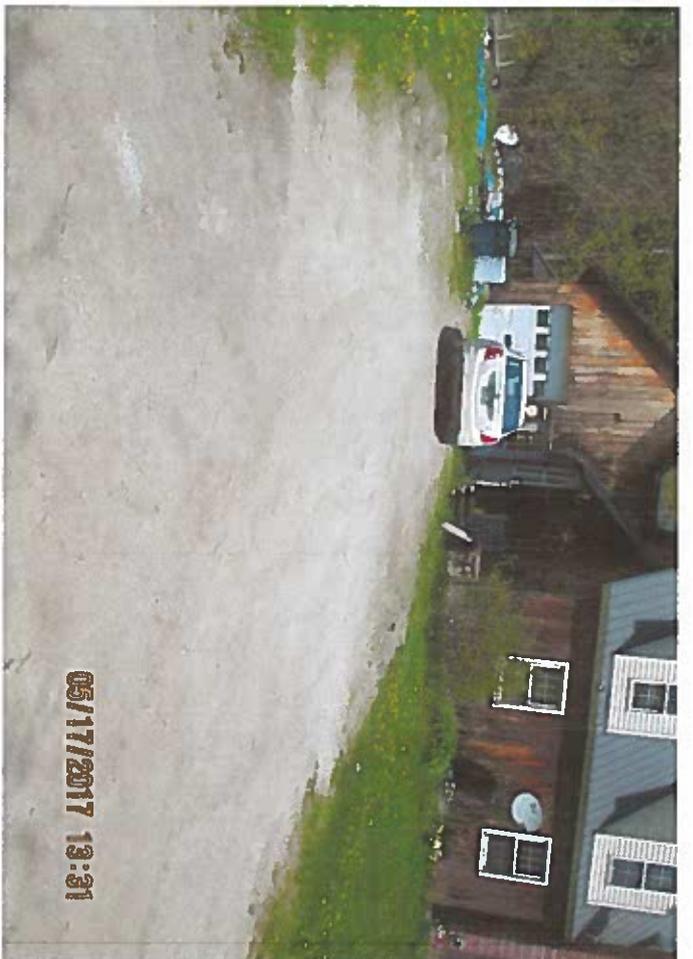
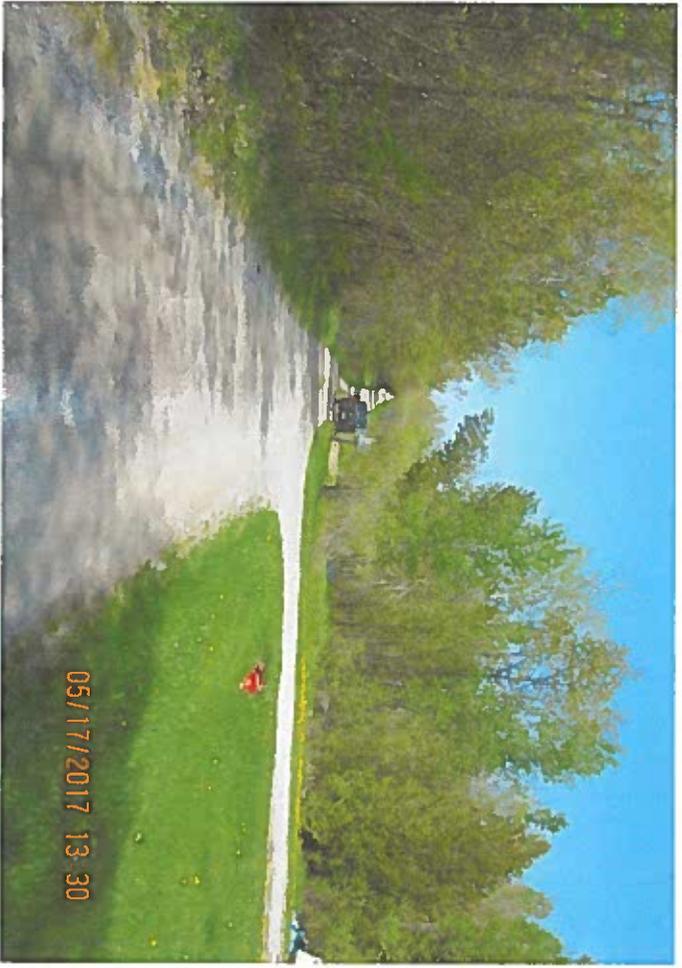
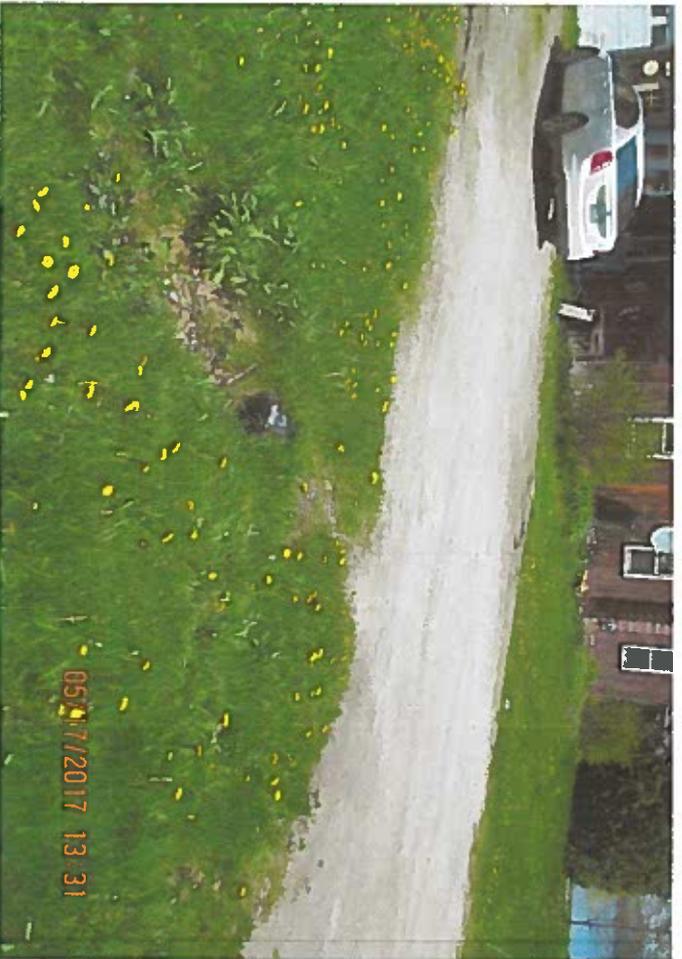
TWR-1

Can not find Inlet or Outlet. Pond of water on inlet end. No treatment needed at this time.

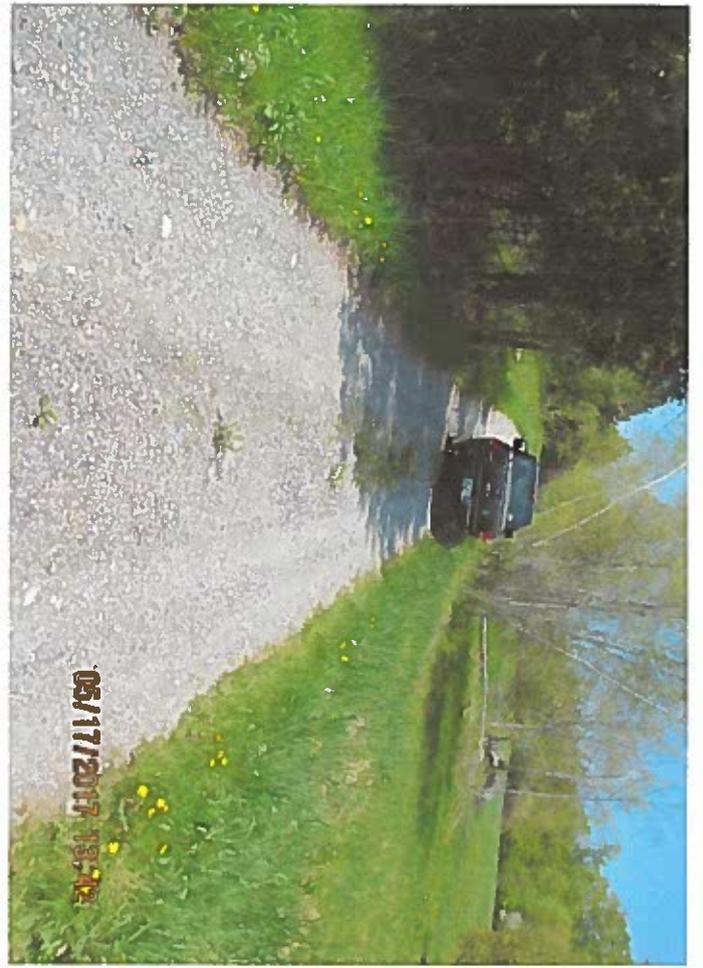
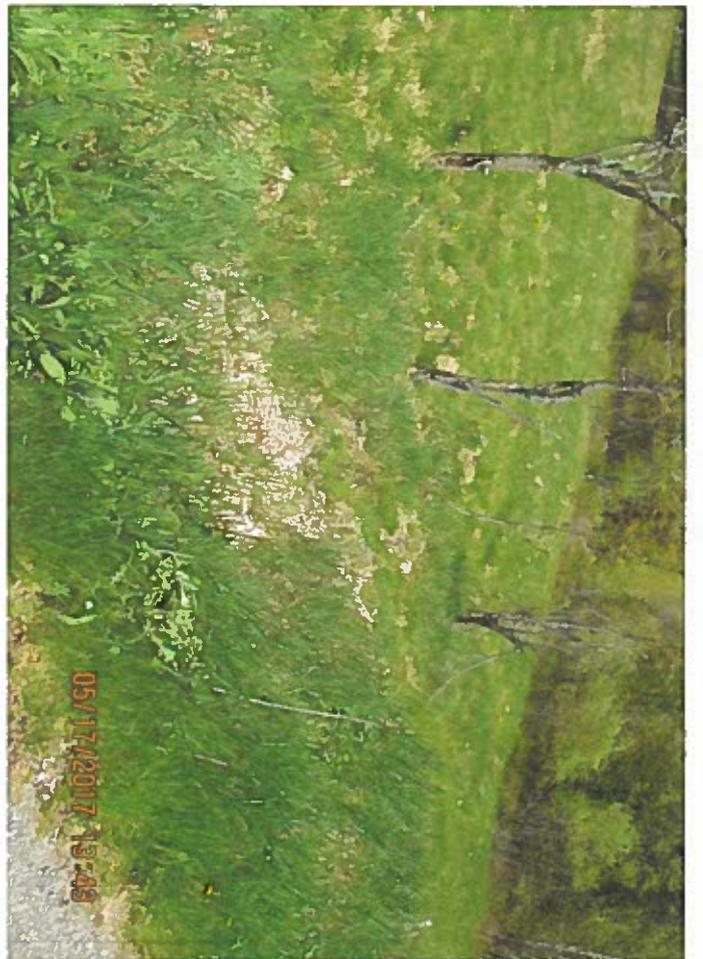
Remarks:
Road Name	Titemore Woods Rd.	
TH #	N/A	
Site ID	TWR - 3	
GPS	N-44.98232° W - 72.88265°	
Drainage Structure Type: Road - Ditch - Road Slope - Other	HDPEP Culvert	Good Condition
Erosion Frequency	Spring Runoff - Rain Storms	
Dimensions	8" X 20'	
Priority - Low - Moderate - High	Low	
Roadway Width	10	Traveled Way
Surface Type	Earth and Grass	
Road Grade: % Grade	0%	
Distance to edge of Lake Carmi	990'	
Name of Stream		
	Inventory Date:	05/17/17
Recommended Treatment: No treatment recommended at this time.		
Notes: Culvert also used as sap transfer line.

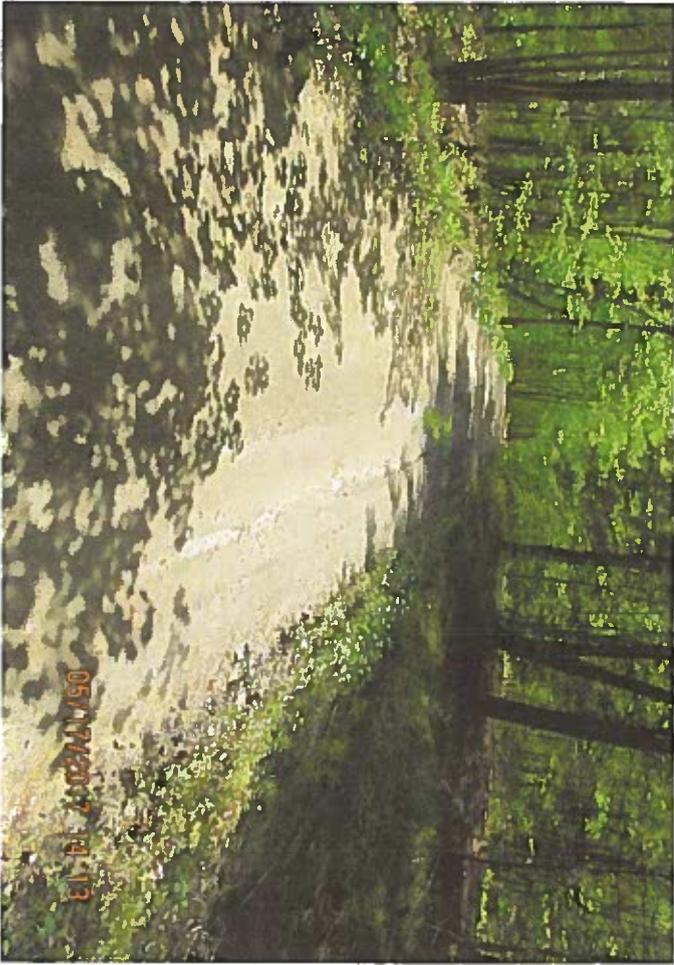
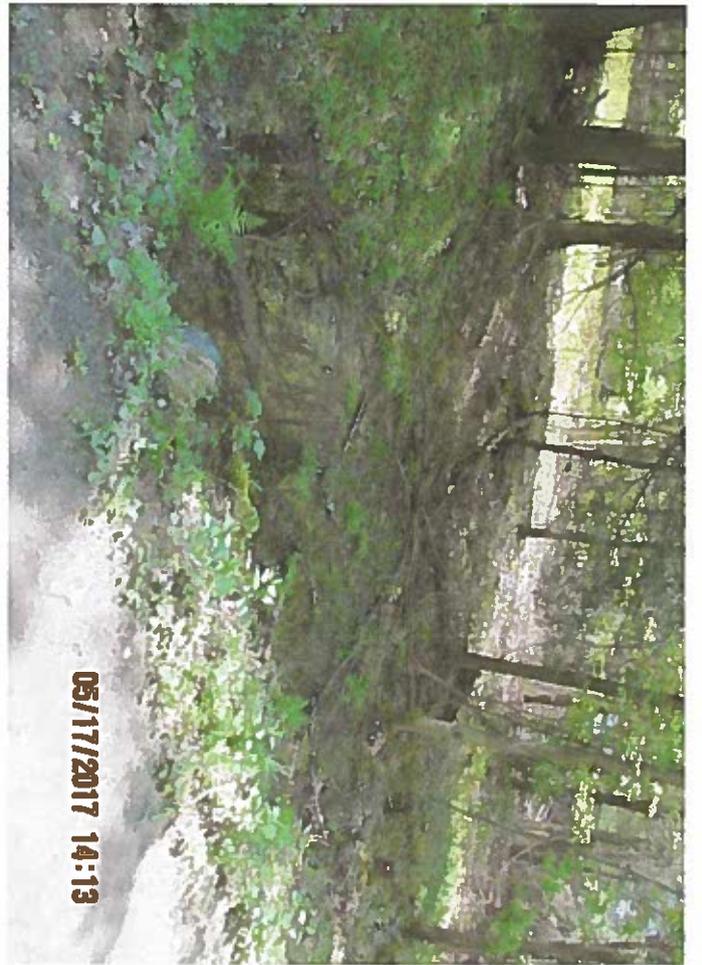
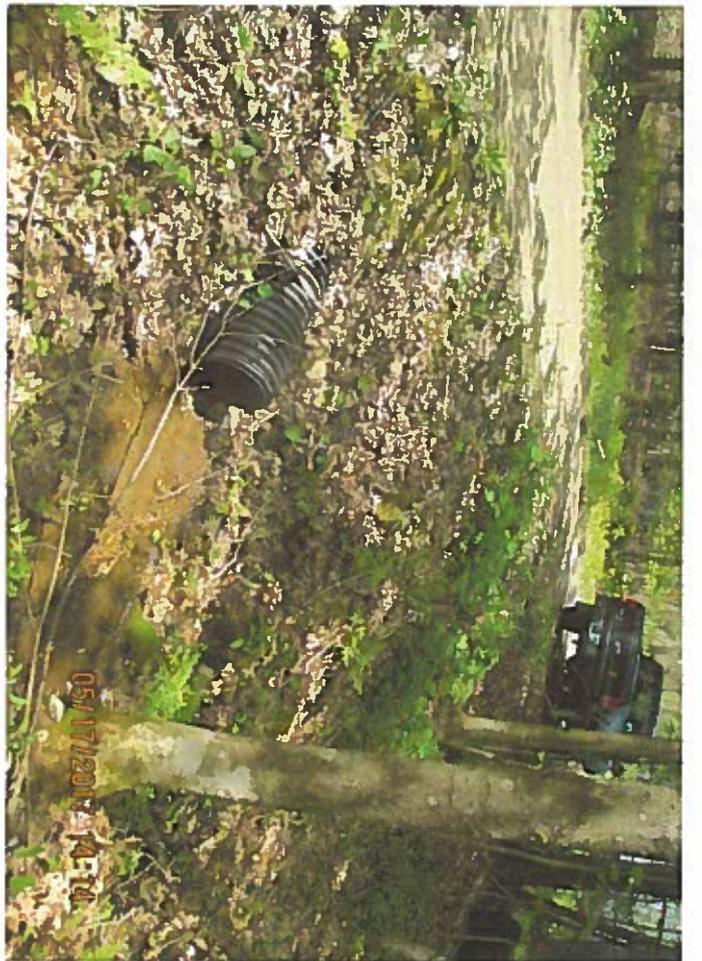
Franklin Watershed		Infrastructure Site Inventory for Water Quality Improvements
		Remarks:
Road Name	Titemore Woods Rd.	
TH #	N/A	
Site ID	TWR - 6	
GPS	N-44.98528°	
	W - 72.88322°	
Drainage Structure Type: Road - Ditch - Road Slope - Other	Concrete Catch Basin with Grate	Fair Condition
Erosion Frequency	Spring Runoff - Rain Storms	
Dimensions	2' X 2' +/-	
Priority - Low - Moderate - High	Moderate	
Roadway Width	10	Traveled Way
Surface Type	Gravel	
Road Grade: % Grade	0%	
Distance to edge of Lake Carmi	1685'	
Name of Stream		
	Inventory Date:	05/17/17
Recommended Treatment: None - Grass covered inlet and outlet.		
Notes: Was not able to locate outlet.
