# 2020 Stream Walk of Marsh Brook

December 28, 2020

Prepared by:  
Staci Pomeroy  
Regional River Scientist for VT DEC  
Rivers Program

Prepared for:  
Lake Carmi Watershed Association

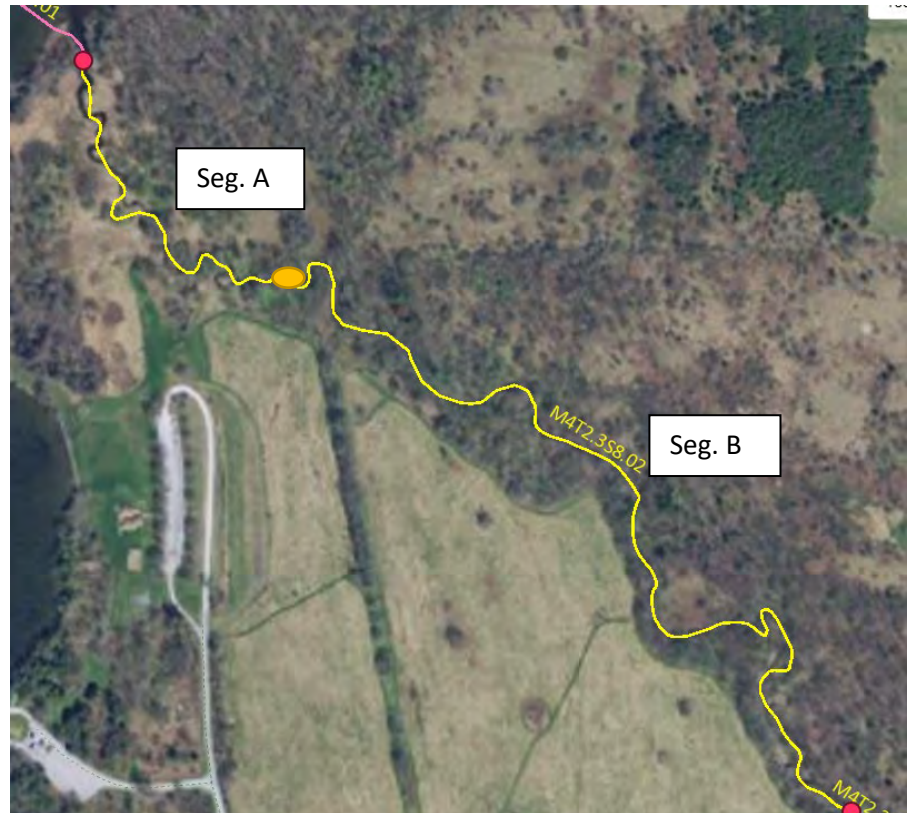
Figure 3 Reach M4T2.3S8.02

**Segment A:** Starting approximately 250 ft downstream of the State Park stream ford, the stream becomes a beautiful wetland stream. This reach was not segmented in the 2006 SGA work, but was determined to be important to create a segment in the 2020 stream walk to recognize the difference in stream type and process in this area as compared to the upper portions of this reach. The channel dimensions become narrower (~10-15 ft) and the banks higher (~4-5 ft). This is expected in this type of system as the slope is very low and the soils are cohesive; allowing the stream to set up a narrower width and deeper channel than expected from the Hydraulic Geometry Curve channel estimates. The stream has a very sinuous planform. The current planform shows several more meanders than the VHD streamline (released in 1999).

There was minimum bank erosion seen during the stream walk. While there are bare banks, there were no slumping/failed banks seen. Incision (the amount the stream is disconnected from its floodplain), was moderate; meaning that at those 1-2 year events there is limited floodplain access; but that at flows are in the 10-50 year events there is floodplain access available.

Evidence of sediment deposition in the floodplain was noted during the walk. The last large flood event in this area was Oct.30/Nov. 1<sup>st</sup>, 2019.

**Geomorphic Condition: Fair** – Extensive historic channelization was cause of the historic incision in the reach. Significant planform adjustment since at least the 1999 VHD (~ 20 years) has benefited the stream by creating a more sinuous channel, reducing the slope in the channel, developing habitat and creating some access to lower floodplain, but has also generated significant sediment as the meander development occurred. Current planform adjustment appears to be minimized.

- Explore potential floodplain restoration/lowering to provide more floodplain access during lower storm events.
- This area is a Class II wetland and has Rare and Uncommon Species noted on BioFinder

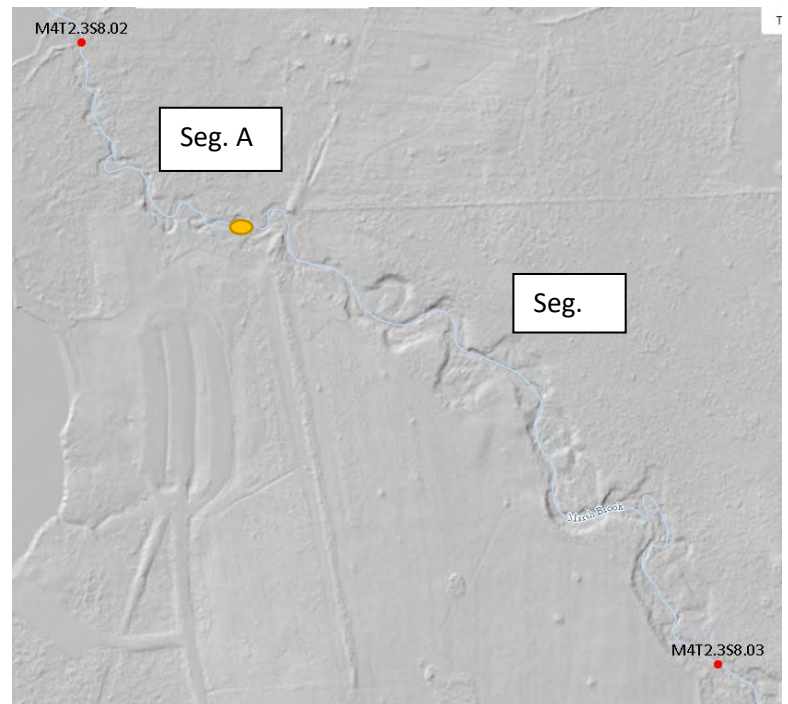
Figure 5: LIDAR imagery showing change in stream channel

Based on the stream walk, and LIDAR (Figure 5) evidence, the stream has regained a greater sinuosity than what was documented in 1999. This may be due to how the VHD was created using orthophotos and topographic maps as a basis for stream location, since LIDAR was not available at that time. Given the densely wooded riparian in this area, the stream is hard to see in detail on the orthophotos and, changes in the stream channel may not have been captured during the VHD process. For the purposes of this planning effort, it will be assumed that changes have occurred since the 1999 VHD layer was published. There have been several larger flood events that have occurred during the last 20 or so years, likely contributing to the channel changes that are seen.

There was minimum bank erosion seen during the stream walk. While there are bare banks, there were no slumping/failed banks seen. Bank erosion was generally associated with outside meander bends, channel along a valley wall, and locations of reduced riparian vegetation.

Incision was minor to moderate; meaning that this section of stream had lower floodplains that are being accessed at those 1-2 year events and have higher floodplains are accessed during the larger events. Evidence of sediment deposition on both areas of floodplain was noted during the walk. The 2006 SGA reported this segment to be in good condition; 14 years later, this segment is still in good condition for channel stability and connection with its floodplain.

**Geomorphic Condition: Good** –Extensive historic channelization was cause of the historic incision in the reach. Significant planform adjustment since at least the 1999 VHD (~ 20 years) has benefited the stream by creating a more sinuous channel, reducing the slope in the channel, developing habitat, and creating access to lower floodplain, but has also generated significant sediment as the meander development occurred. Current planform adjustment appears to be minimized. Stream is stabilizing as riparian vegetation has become well-established on both stream banks and floodplain. Sediment storage is seen in the channel as point bar development and associated with woody vegetation in the stream channel. Fine sediment storage was also noted on the floodplain.

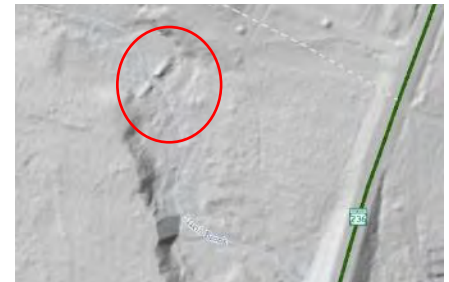
*Figure 10: LIDAR showing old dam location*

Approximately 520 ft downstream of the State Park Road (Rte. 236), there is evidence of an old dam. This can be seen on the LIDAR (Figure 10). In talking with a local landowner, this was likely associated with a historic mill. A large section of the old dam remains across the left (looking downstream) side of the valley. The structure is a very large dry-stacked stone wall (Figure 11). It is difficult to determine the full extent that the historic structure has contributed to the current condition of the stream. Historically, the structure may have contributed to upstream aggradation (build up) of sediment in the area of the impoundment, and downstream channel incision by creating hungry water. Hungry water is river flow with excess transport capacity. It has more stream power to transport than

available sediment. As a result, it tends to erode its bed and banks to compensate. When the longitudinal continuity of sediment transport is interrupted (e.g., from dams), hungry water results. The remaining portion of the dam does affect flooding in this area by creating a barrier across the left side of the floodplain. The valley wall across from the remaining dam section is very steep and evidence of past erosion/mass failure were noted. The erosion appears to be stabilizing, with limited bare soils seen and vegetation beginning to be established on the slope. This area is still vulnerable to erosion due to its location on the steep valley wall and limited floodplain access.

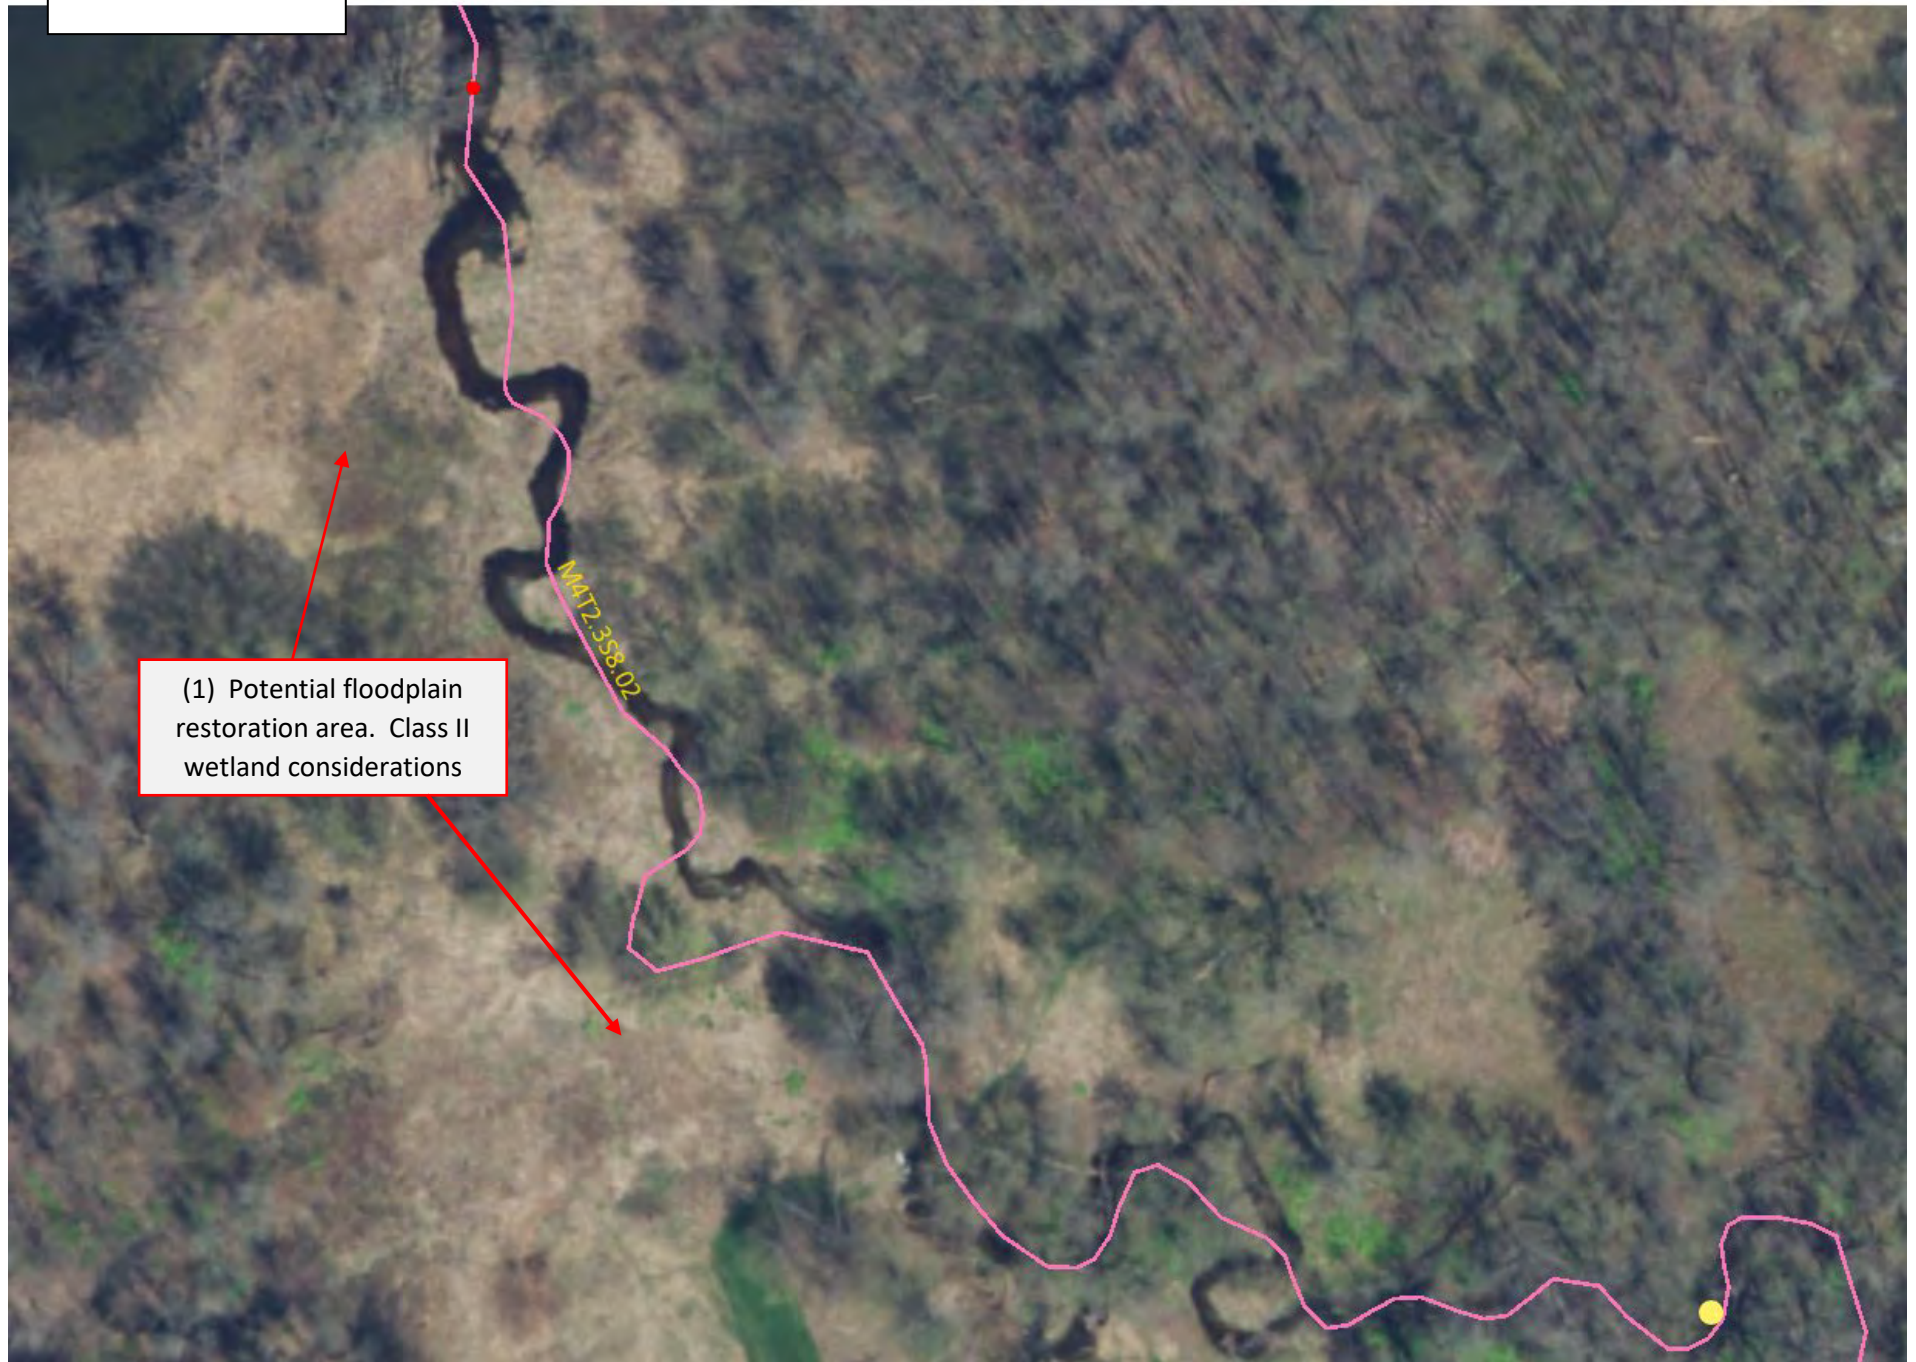
M4T2.3S8.02-A

(1) Potential floodplain  
restoration area. Class II  
wetland considerations

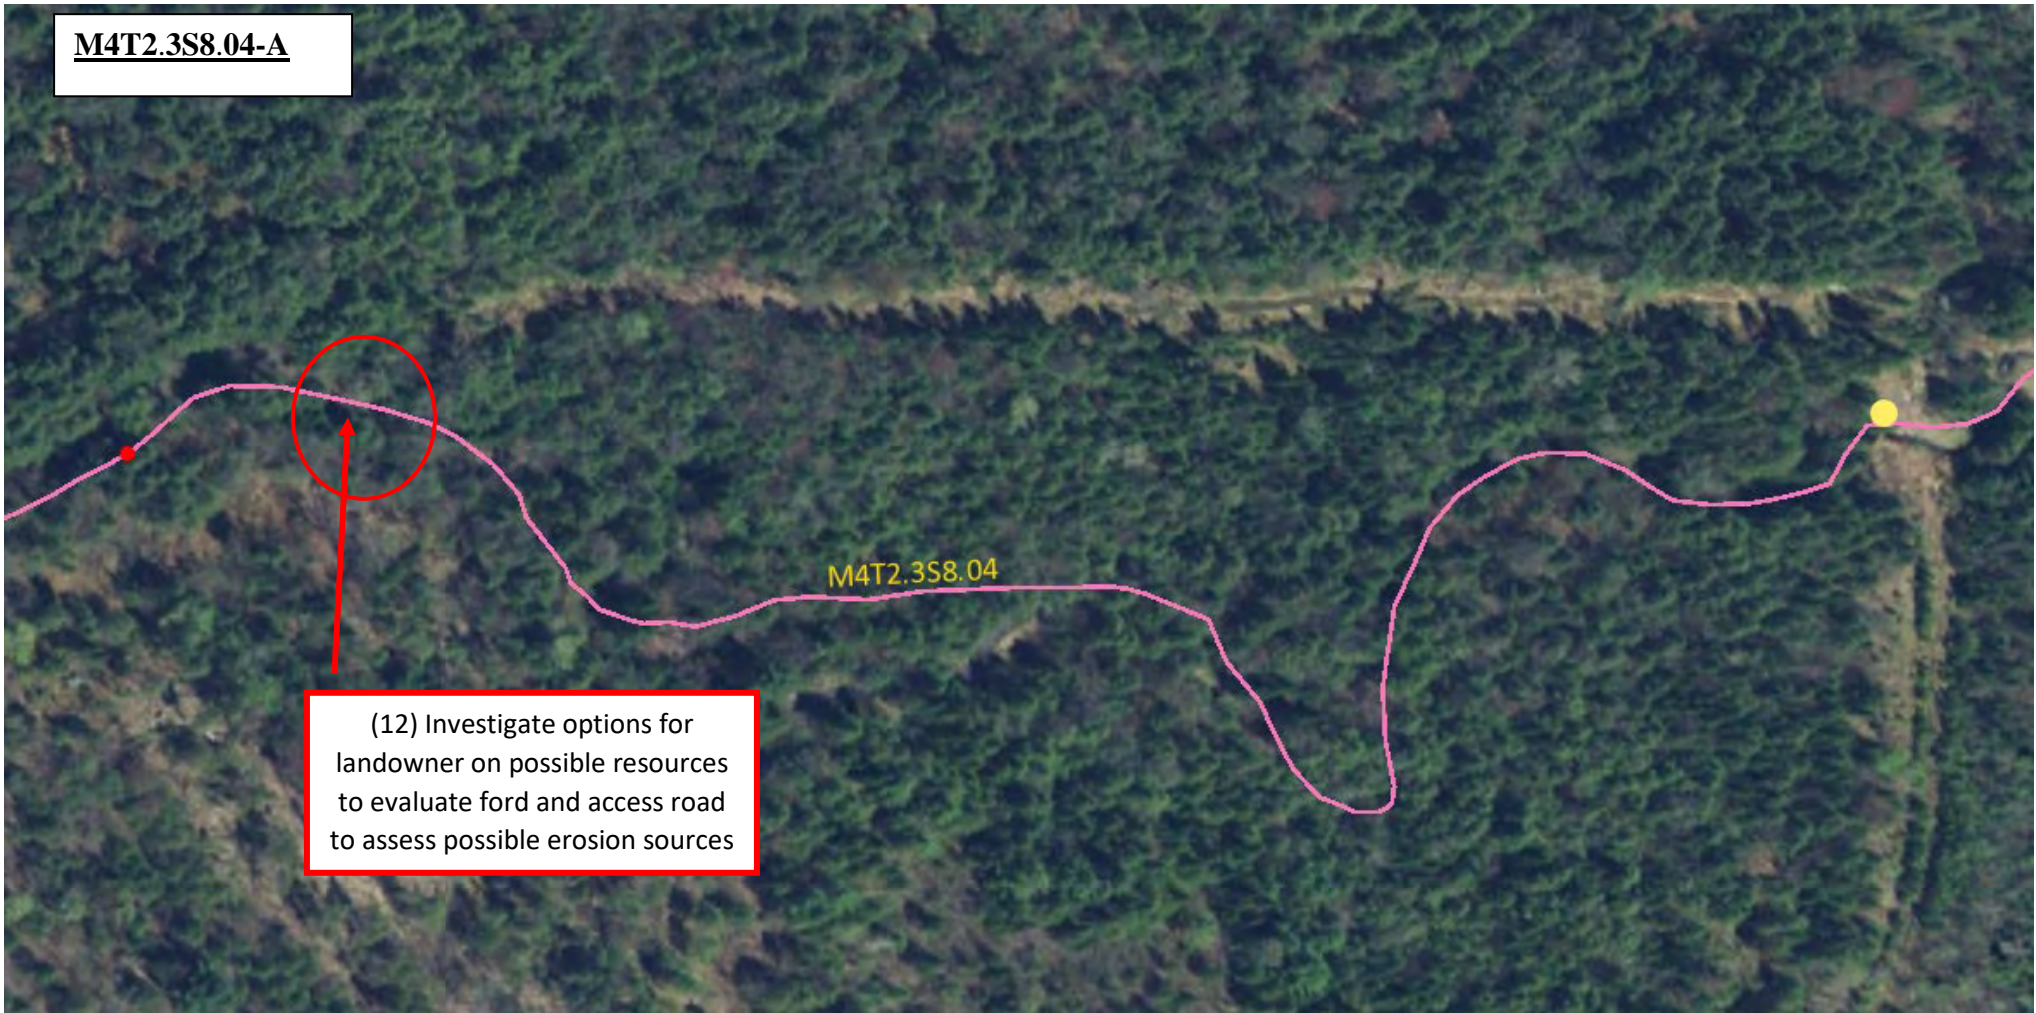
M4T2.3S8.04-A

(12) Investigate options for  
landowner on possible resources  
to evaluate ford and access road  
to assess possible erosion sources

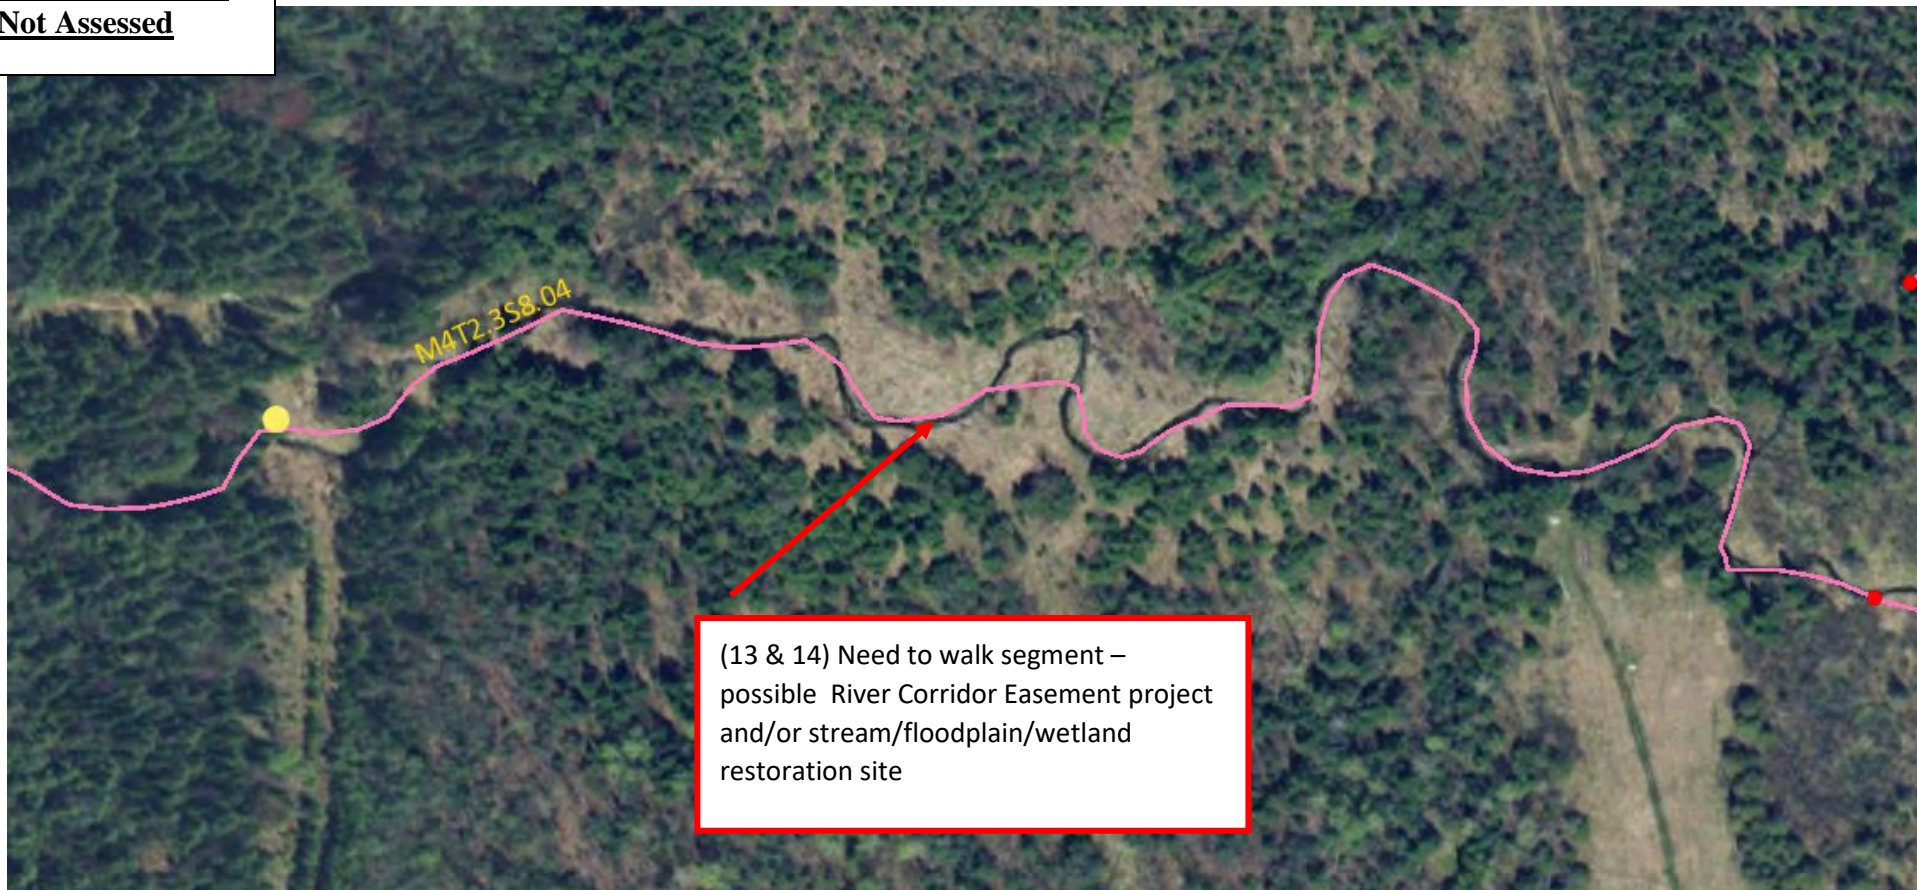
**M4T2.3S8.04-B -**  
**Not Assessed**

From imagery review channel conditions appear to be poor to fair condition. Considerations for additional site walks and investigation on this segment.

(13 & 14) Need to walk segment –  
possible River Corridor Easement project  
and/or stream/floodplain/wetland  
restoration site

- This area has hydric soils and is in a location of the watershed that would provide important attenuation assists. A review of potential wetland/stream restoration opportunities would be warranted.
  - Check with landowner to see if this area had beaver influence in the past and/or if recall any historic channel management. The downstream portion of this segment appears to be very straight; possibly indicating past channel management.
- River Corridor Easement – Passive restoration through reducing potential beaver / channel adjustment with landowner. May reduce need for/level of active restoration if beaver able to be reintroduced in this area.
- Buffer planting may be difficult as a stand-alone project. Based on the dense herbaceous vegetation it may be difficult to get trees established unless resources and methods available to do help trees out compete the grasses.

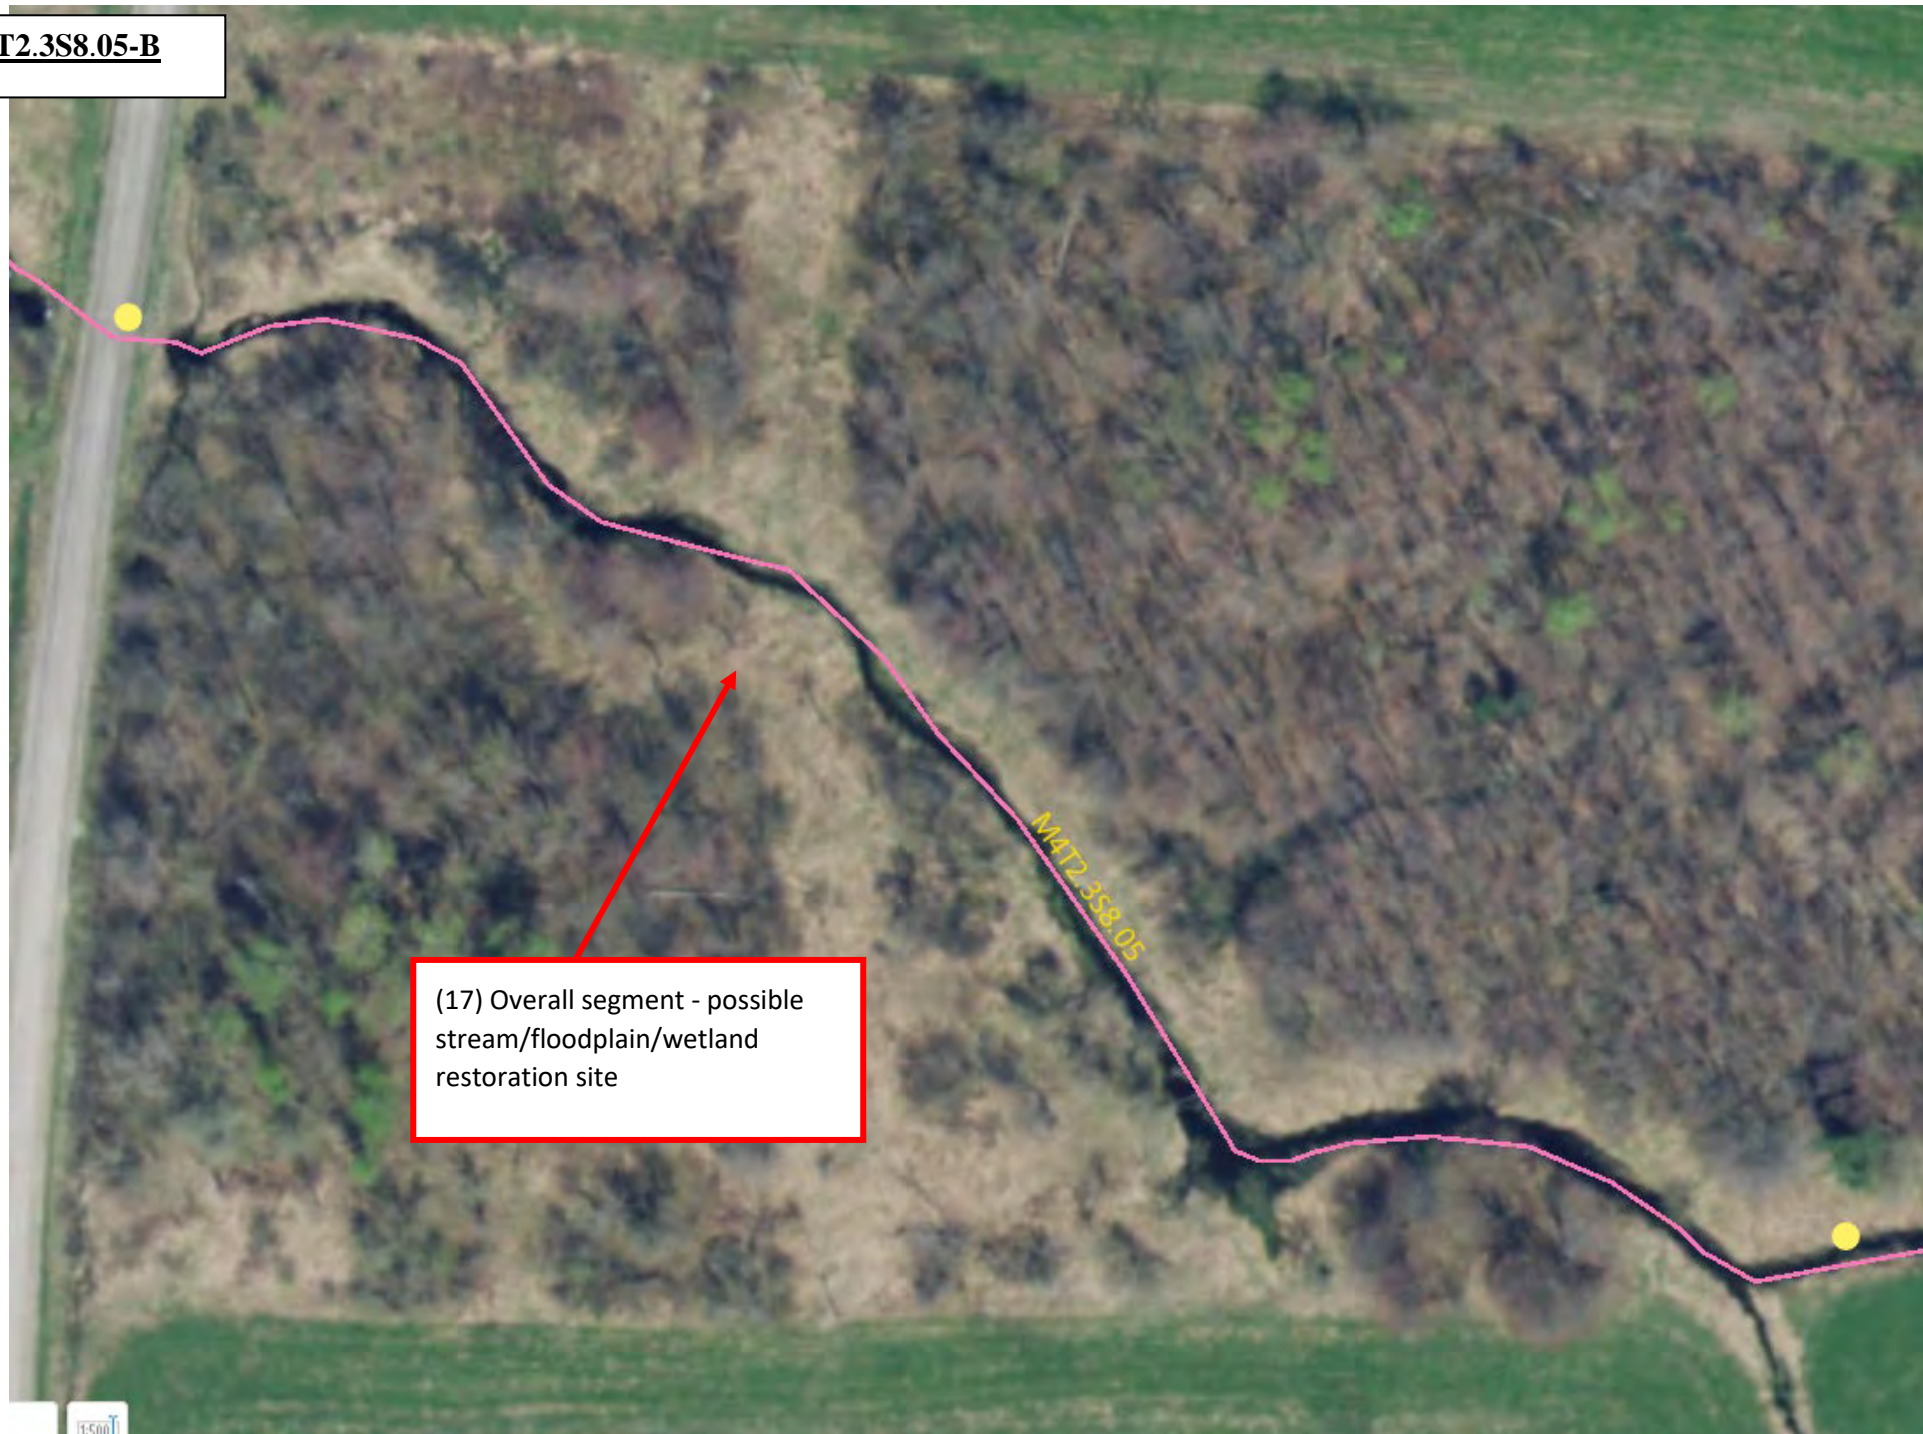
M4T2.3S8.05-B

(17) Overall segment - possible  
stream/floodplain/wetland  
restoration site
